# **Sustainability of Continuously Reinforced Concrete Pavement (CRCP) Containing Recycled Aggregate and Epoxy-Coated Reinforcing**

D.B.McDonald, Ph.D., P.E., FACI<sup>1</sup>

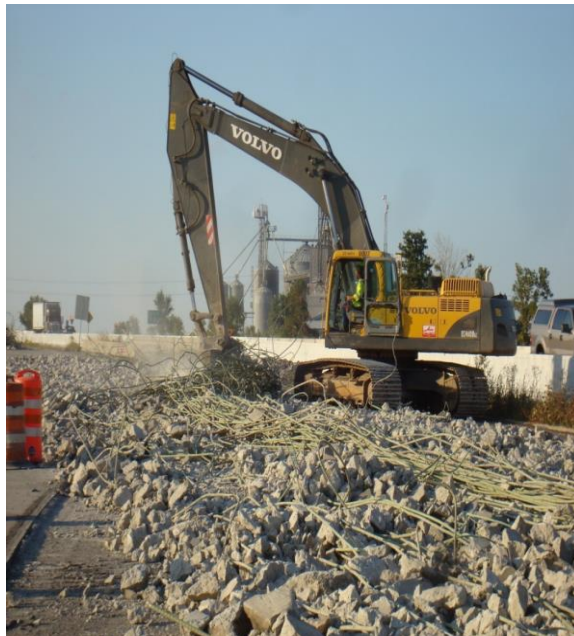
**Figure 6: Bar Extraction**

Due to the epoxy coating, the bars were readily separated from the concrete. When uncoated reinforcing bars are used without the coating, the concrete tends to adhere to the bar surface, making both extraction and recycling more difficult.

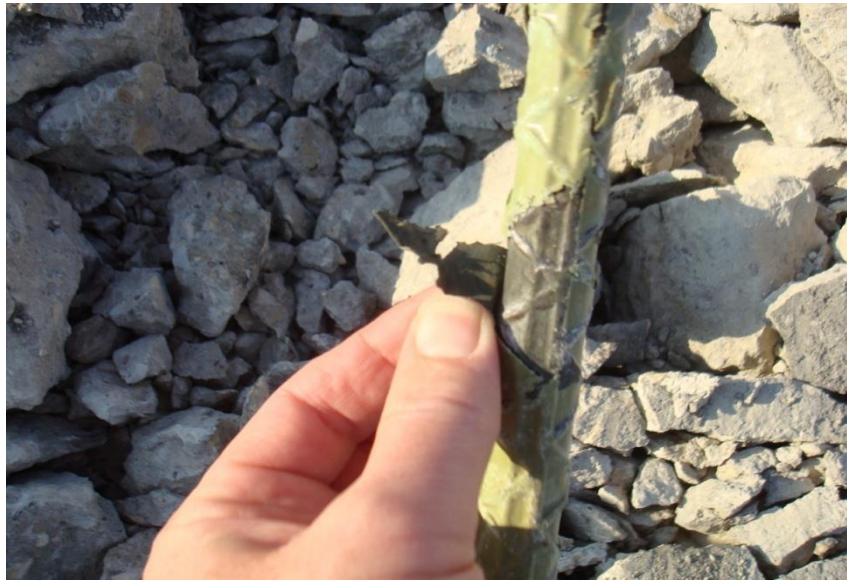
**Figure 8: Poor coating adhesion due to inadequate surface preparation of the steel**

**Coating Adhesion:** In many instances epoxy adhesion to the steel surface was poor as shown in Figure 8. Samples of bar were evaluated to determine the cause of this poor coating adhesion. From analysis of two submitted samples, it was reported that improper surface preparation had occurred prior to the coating being applied. There was little or no anchor pattern on the steel and was likely the main contributing factor to coating delamination. Based on a visual inspection of the extracted bars, no correlation between bars with poorly bonded coating to those with oxides could be determined. In 1991, CRSI introduced an Epoxy Coating Plant Certification Program that requires plants to monitor steel surface properties prior to coating and coating performance after coating. This program has significantly reduced the incidence of poor coating adhesion.

7. Epoxy-coated steel reinforcing bars had been exposed to high levels of chlorides for more than 25 years with limited corrosion products visible.
8. A significant portion of the epoxy-coated bars had poor coating adhesion due to poor reinforcing steel surface preparation.

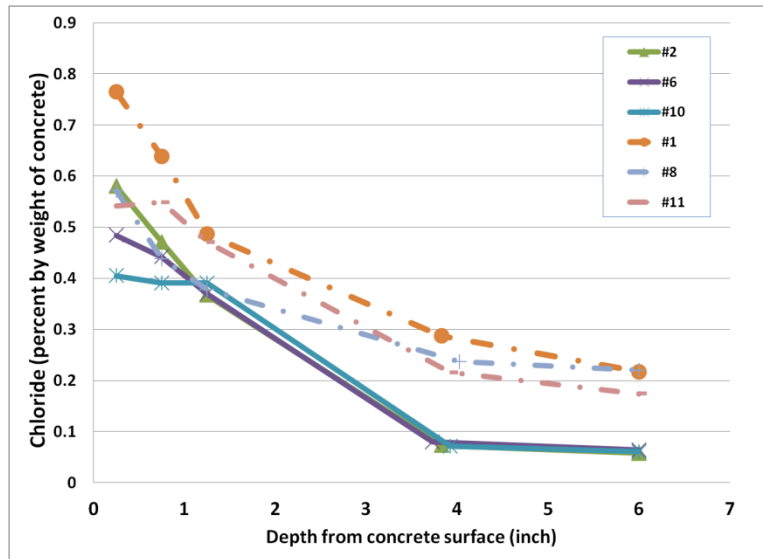
**Figure 9: Chloride data from cracked and uncracked cores**

**Chloride Analysis:** Six cores were evaluated for acid-soluble chloride according to ASTM C1152. Three of the cores were from cracked locations (Cores 1, 8 and 11) and three were from non-cracked locations (Cores 2, 6 and 10). The resulting chloride contents are shown in Figure 9.

The background chloride level for the uncracked cores was approximately 0.06 percent by weight of sample, which was almost twice that of the commonly assumed corrosion threshold of 0.035 percent. Thus, at the time of construction the bars were exposed to sufficient chlorides to initiate corrosion of uncoated black bars. The source of the chlorides was the recycled concrete as aggregates in the mixture.

The surface chloride values showed very little deviation for the three uncracked cores, with chloride ranging from 0.46 to 0.58 percent by weight of concrete. The uncracked cores had an apparent diffusion coefficient from  $1.56 \times 10^{-12} \text{ m}^2/\text{yr}$  ( $2.41 \times 10^{-9} \text{ in}^2/\text{yd}$ ). As expected, the cracked cores exhibited considerably higher chloride contents, both at the bar level and at a depth of six inches from the top of the concrete cores. Considerable chloride was found throughout the uncracked cores, ranging from 0.058 to 0.071 percent by weight of concrete at the 150 mm (six-inch) level.

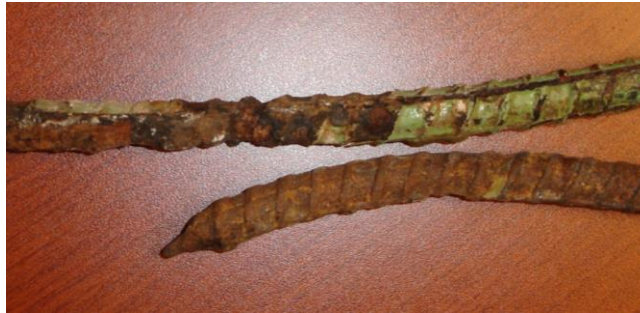
**Figure 10: severely corroded bars at longitudinal joint**

Some of the tie bars were in poor condition with localized corrosion at the joint location (Figure 10). Upon further inspection, no epoxy-coating patching was evident and the coating would have most certainly been damaged during construction. It is generally recommended that epoxy-coated tie bars are not bent in the field.

9. Minor corrosion products of epoxy-coated bar tend to occur at concrete cracks.
10. Transverse “tie” bars in the 1984 CRCP exhibit significant localized corrosion at the longitudinal shoulder joint due to bending during construction and the location of the construction joint between pours. Field bending of epoxy-coated tie bars is not recommended.
