## **Alberta Transportation's First Concrete Pavement Preservation and Rehabilitation Project**

### **Abstract**

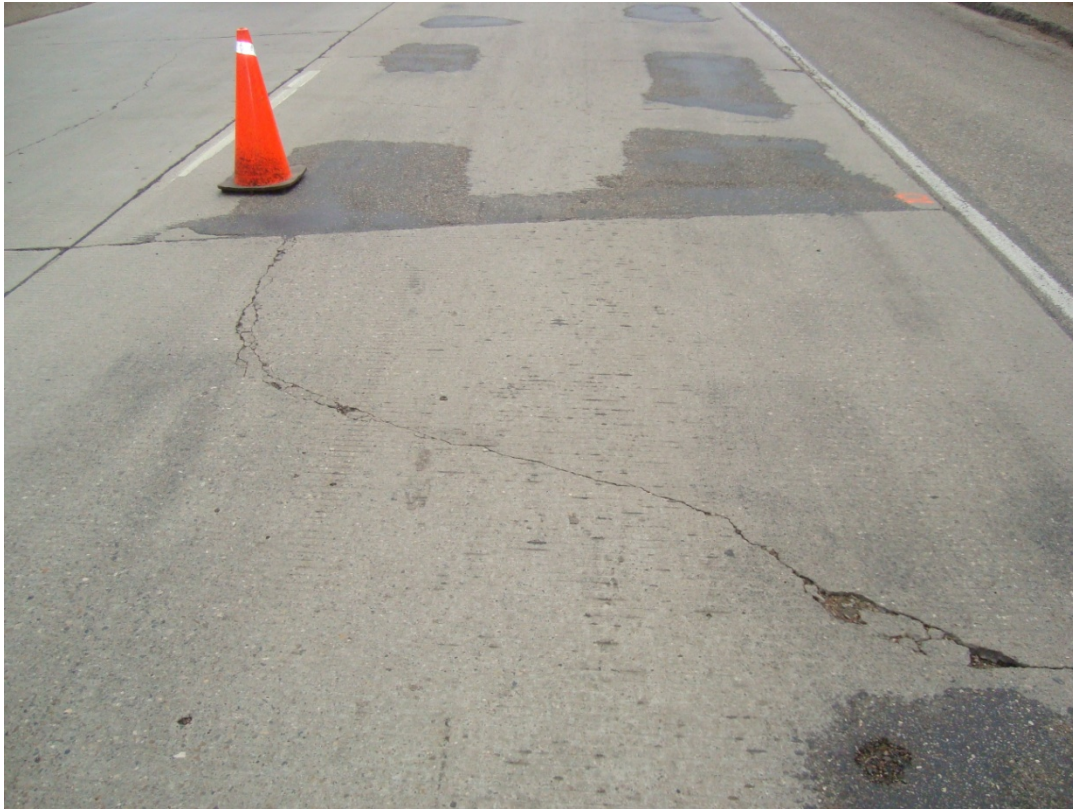
The condition of the concrete pavement prior to rehabilitation was poor. The concrete, which was thought to be undowelled, has skewed transverse joints spaced randomly at 2.0 to 5.9 m. 115 of the 976 through lane panels were cracked with nearly 50% of these being in section 1. Asphalt patching had been used to repair a number of these cracks. Joint faulting was measured from 0 to 20 mm. The faulting and patching resulted in a rough ride with average IRI values within the four sections ranging from 3.6 to 4.4 mm/m. Figures 2 and 3 show the concrete pavement prior to rehabilitation.

**Figure 2. Photo of cracked concrete panel in the outer lane of section 1**

**Concrete panel replacement.** Prior to removing the existing concrete panels the joints were to be cut full depth. A key way cut was required anytime a separate panel was to be removed or at the start and end of continuous panel removals. The key way was cut approximately 150 mm from the transverse joint and was the first and last piece to be removed so as to protect adjacent panels. Tie bars at the longitudinal joints were encountered, as expected; however, most of the transverse joints were unexpectedly found to be dowelled except for those in section 2.

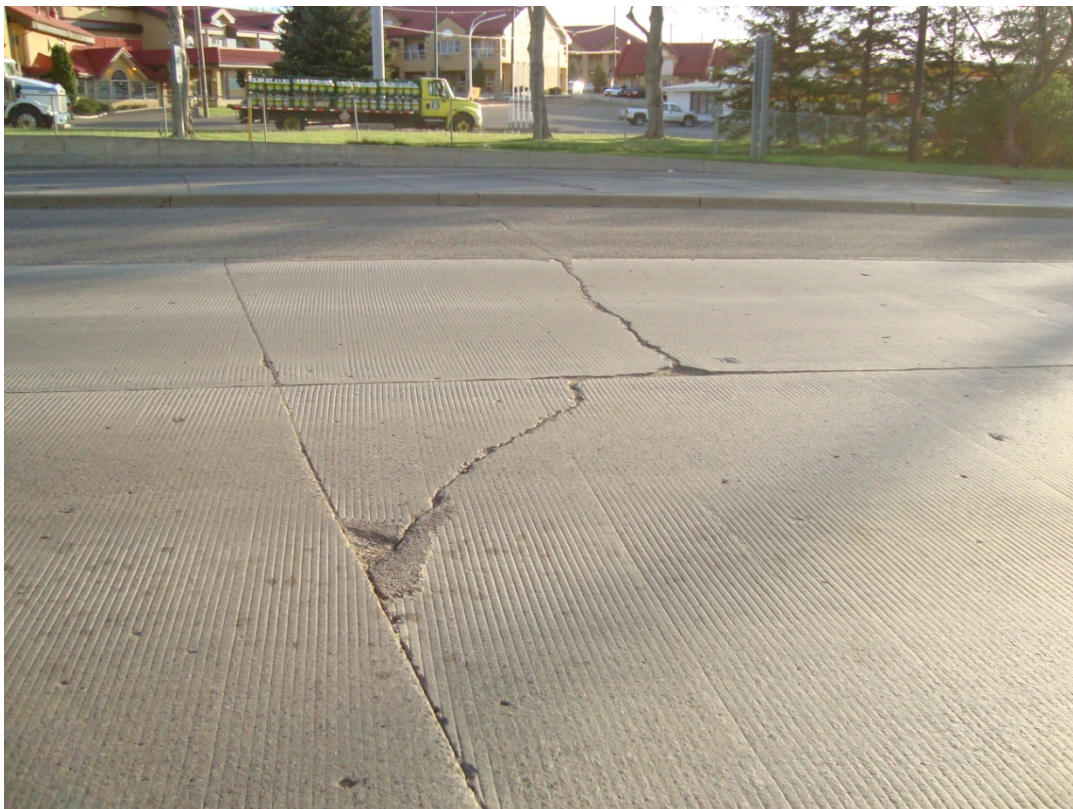
**Figure 3. Photo of cracked concrete panels section 3**

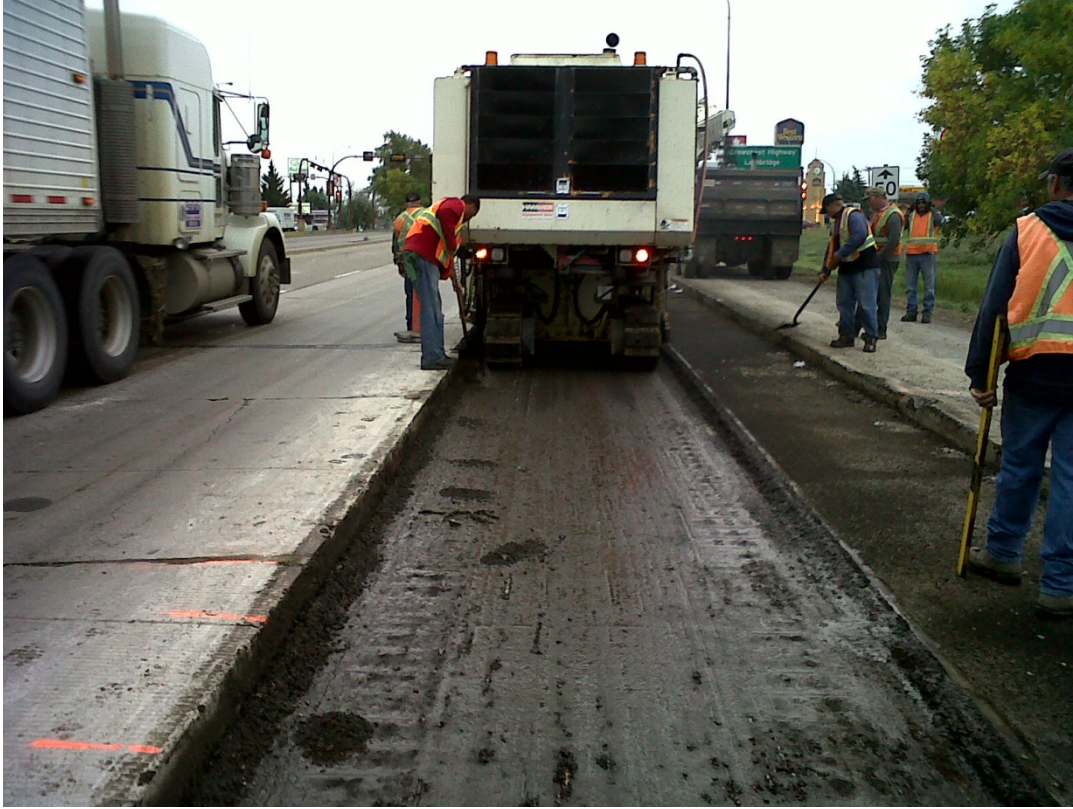
After the panels were removed subbase preparation was required. In most of section 1 the existing 180 to 190 mm of PCCP was found to be on top of an asphalt concrete pavement (ACP) of varying thickness. For the long continuous stretch of panel replacement in section 1, the contractor used a milling machine, as seen in Figure 4, to remove approximately 50 mm of ACP to obtain the 230 mm new concrete minimum thickness. Shorter single and double panel replacements could not accommodate a milling machine and therefore the ACP was removed and backfilled with granular subbase. Some of the existing ACP was extremely thick and difficult to remove without damaging the surrounding panels.

**Figure 4. Milling of asphalt beneath concrete pavement**

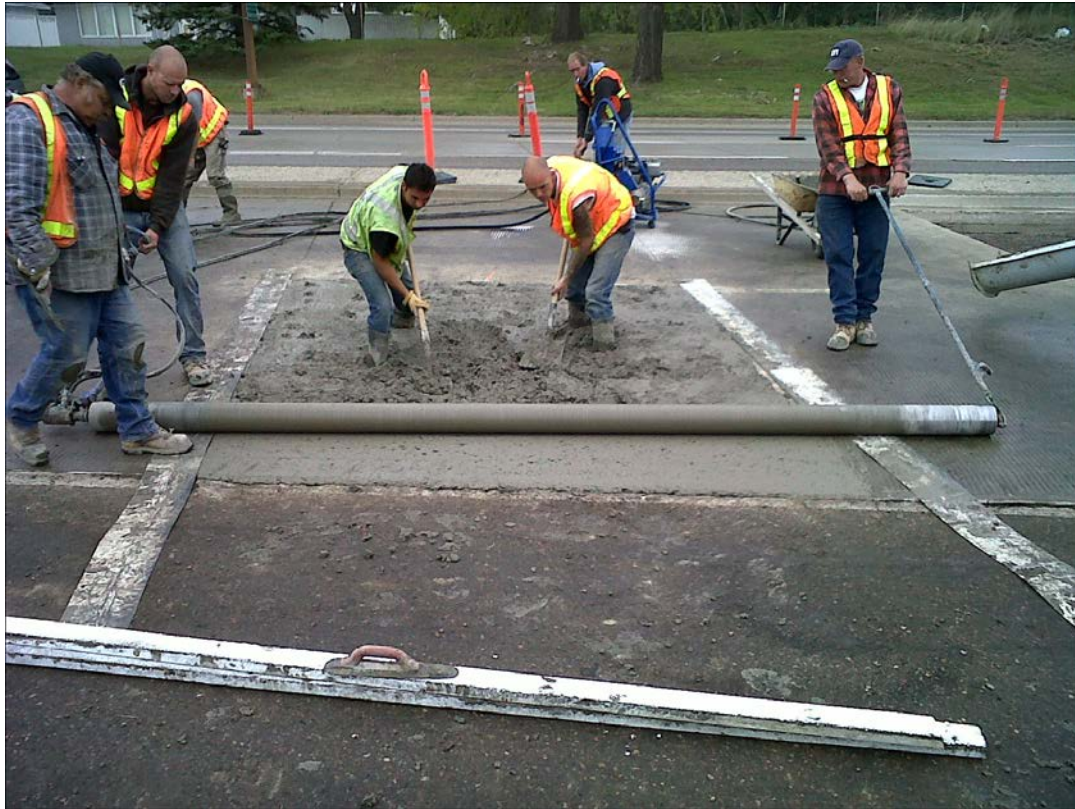
Placement and finishing of the PCCP went smoothly. A power roller screed was used to finish the concrete surface. The roller screed straddled the adjacent concrete lane and shoulder and was pulled by hand across the fresh concrete. The roller screed had an internal vibrator to smooth the surface. A curing compound was used. Compressive strength tests were completed on field cured cylinders prior to opening to traffic. The minimum strength requirement of 20 MPa was met within 48 to 72 hours of placement.

**Figure 5. Power roller screed for concrete finishing**

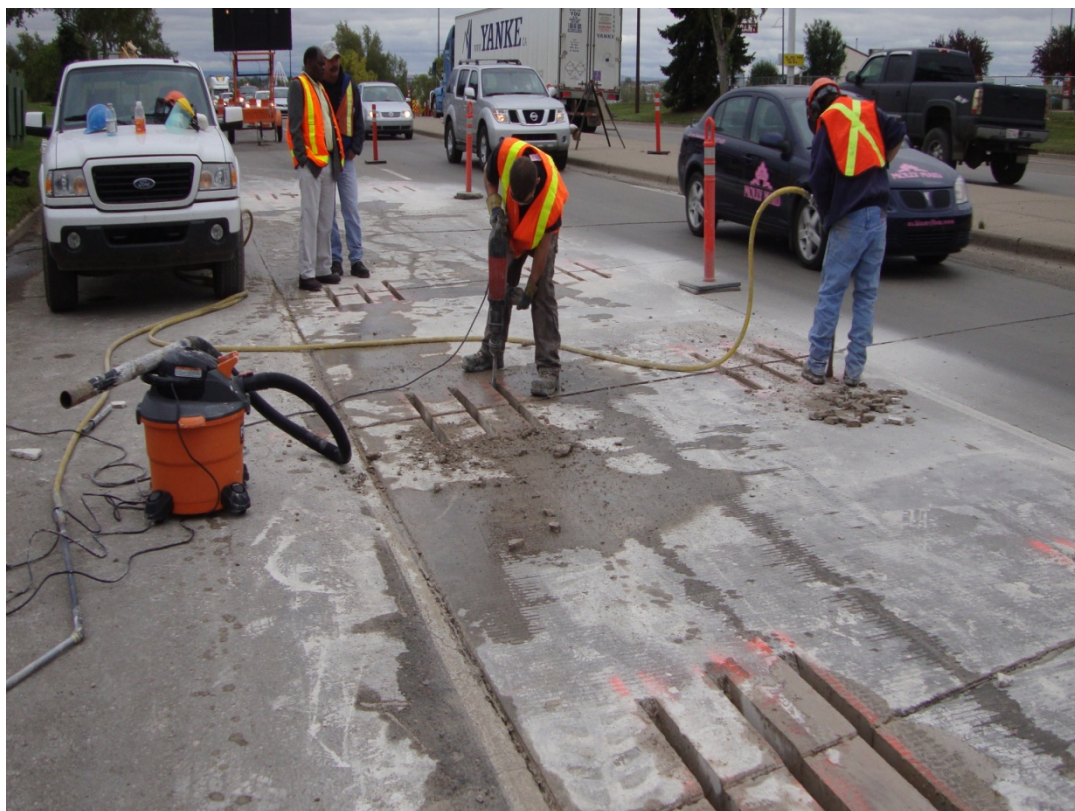
***Dowel bar retrofit.*** All the transverse joints in the outer lane of section 2, except for those adjacent to panel replacements, were treated with six dowel bar retrofits (three per wheel path). The cutting of the channels for the dowel bars needed to be precise for width and depth in order to ensure that the dowel chair properly supported the dowel bar and that the bar was at mid slab depth. After cutting, the channels were chipped out using a light duty jack hammer as seen in Figure 6. It was important to have a smooth and square

**Figure 6. Saw cuts and jack hammering for the dowel bar retrofit**

channel to allow for proper placement and alignment of the dowel bar. Each channel was sand blasted clean to remove all unsound concrete. The dowel chair and bar were positioned in the channel and then backfilled with a rapid setting chemical mortar (SikaSet® 45).

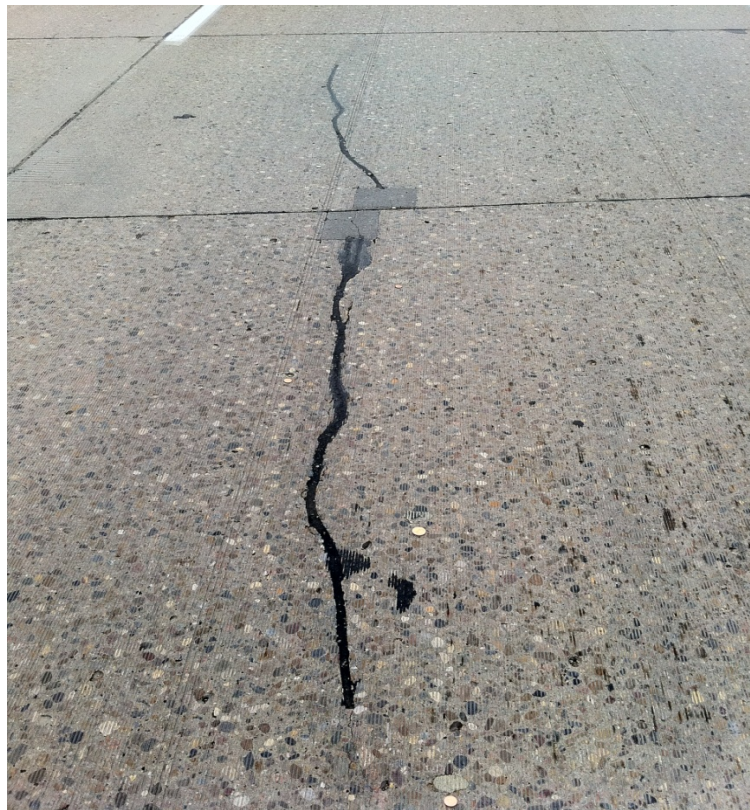
***Random crack repairs and cross-stitching of longitudinal cracks.*** Less serious random cracks were repaired by routing, cleaning and sealing of the crack. Some of the longitudinal cracks were also reinforced by cross-stitching with tie bars inserted across the crack. The process involved drilling angled holes (35° from horizontal) spaced 600 mm apart at a specified offset from the crack. The drill holes, which proceeded along and alternated sides of the crack, are meant to intersect the crack at the mid-depth of the slab and extend nearly to the bottom of the slab. An epoxy was then poured into each hole and the tie bar inserted so as to be fully immersed in the epoxy and recessed for the surface. Some of the cross-stitched cracks also required partial depth spall repairs as can be seen in Figure 7.

**Figure 7. Cross-stitched and spall repaired longitudinal crack**

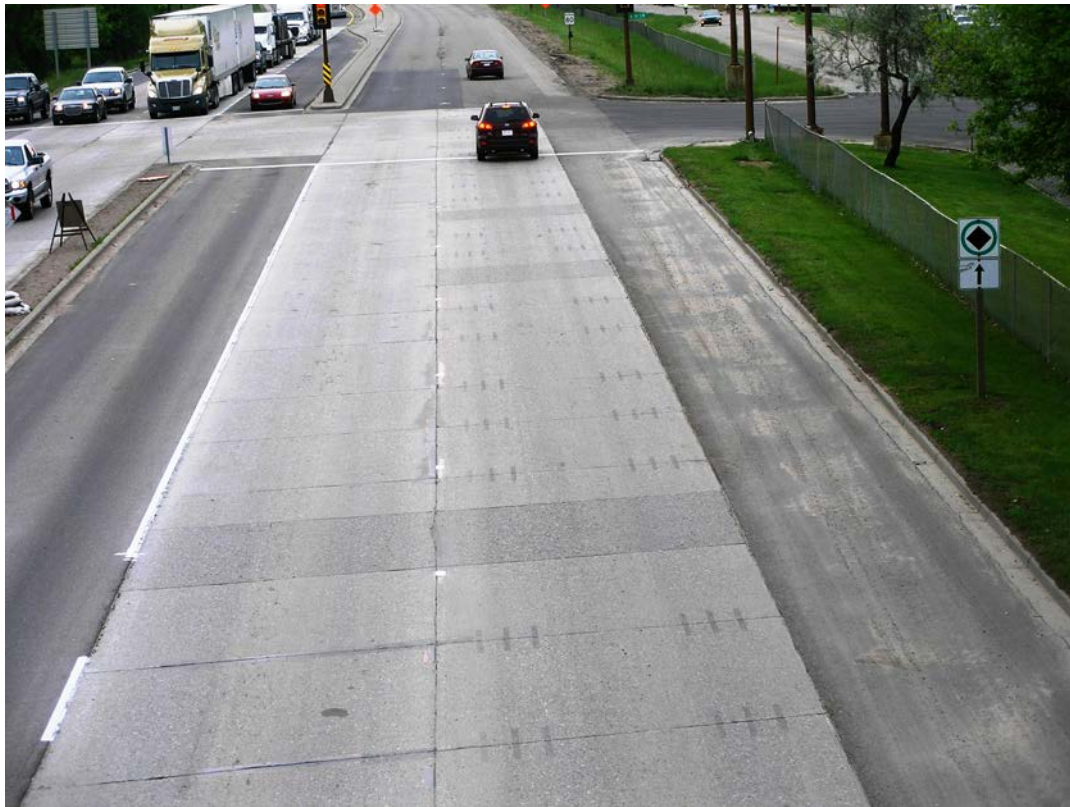
noted. There are no performance concerns with the full or partial panel replacements. As reported in Table 2, smoothness testing, confirms a much improved riding quality. The improvement in mean IRI values (post versus pre rehabilitation) was on the order of 60% to 75%. The dowel bar retrofit is also performing well as seen in Figure 8.

**Figure 8. 2011 view of completed dowel bar retrofit and partial panel replacement**
