# Long Term Performance of Sustainable Concrete Pavement Preservation Strategies in Canada

Tom Kazmierowski<sup>1</sup> and Susanne Chan<sup>2</sup>

## 1.0 Introduction

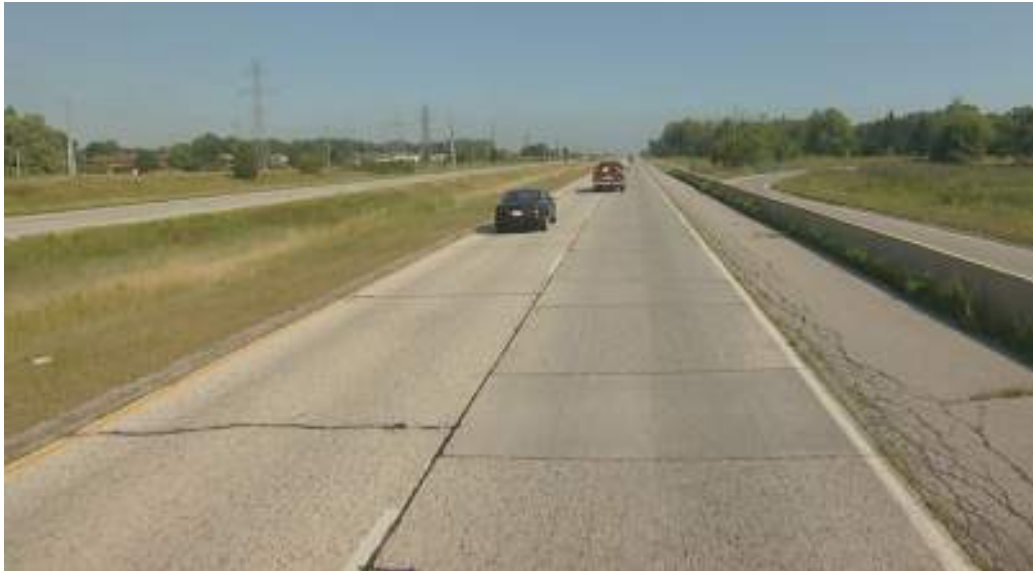
**Photo 1.** Recent Photo on Northbound Lanes

| Year | Year after Rehab | Pavement Condition / Remarks |
|---|---|---|
| 2011 | 22 | The pavement is in good condition with good ride since the major CPR in 2009. Few slight meandering cracks and few slight joint spalling. No major distress identified. |

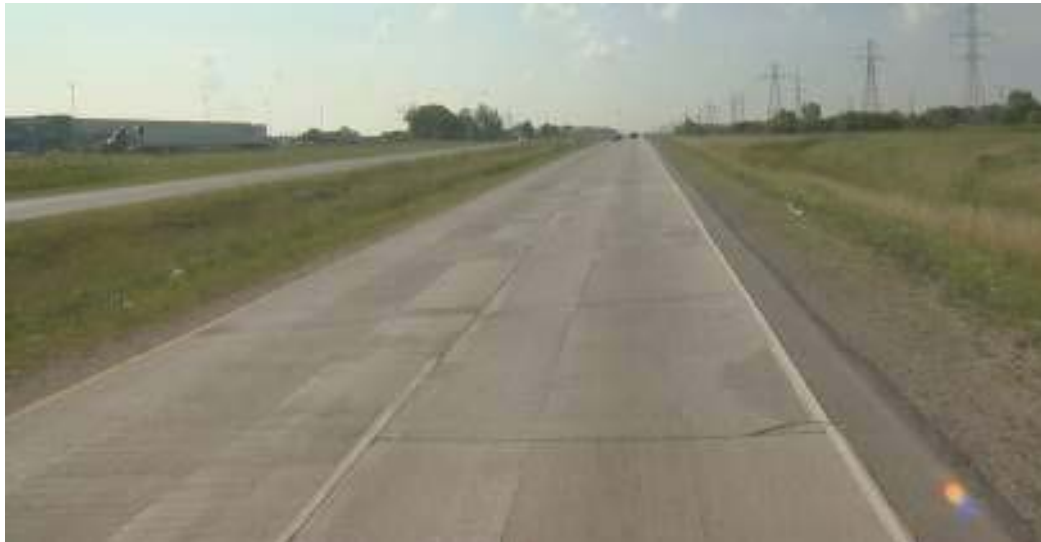
**Photo 2.** Recent Photo on Southbound Lanes

| Year | Year after Rehab | Pavement Condition / Remarks |
|---|---|---|
| 2011 | 22 | The pavement is in good condition and good ride since the major CPR in 2010. Few slight diagonal corner & edge crescent cracks. No major distress identified. |

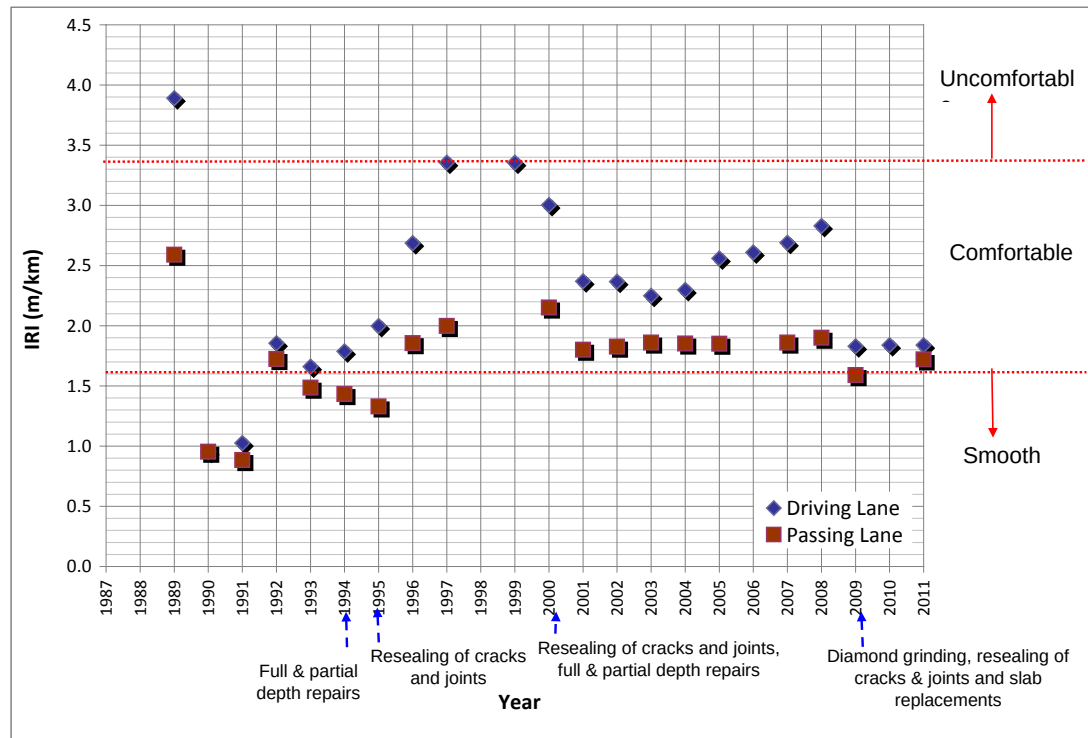
**Figure 4.** Summary of Roughness (IRI) in Northbound Lanes

**5.3.1 Roughness Measurement Northbound Lanes.** Roughness in the NBLs improved significantly after the concrete pavement surface was diamond ground in 1989, with an improvement in IRI from initially 3.9 to 0.9 m/km and 2.6 to 0.9 m/km in the driving and passing lanes respectively, see Figure 4. The ride data for the diamond ground surface indicates that the initial roughness values deteriorated to an approximate value of 1.8 after two years and has remained fairly constant over the following three years. These IRI values are in the comfortable range of the ride categories. The ride quality levels (smooth, comfortable, uncomfortable) indicated on the graph are converted based on the established ride comfort index (RCI). RCI between 10 to 8 is smooth (IRI = 0.76 to 1.60 m/km); 8 to 6 is comfortable (IRI = 1.60 to 3.36 m/km); and below 6 (IRI > 3.36 m/km) is considered to be uncomfortable ride (Chong et al. 1995).

The IRI values between 1996 to 2000 appear elevated probably as a result of an erroneous transfer function used in converting PURD measurements into IRI values. The conversion was based on limited correlation data.

The ARAN surveys from 2001 to 2004 indicates the roughness remained constant over these years, with an average IRI of 2.3 and 1.8 m/km for the driving and passing lane respectively. From 2005 to 2008, the driving lane roughness data shows a mild trend of deterioration with an average deterioration rate of 0.1 IRI every year. The roughness data for the passing lane are still fairly constant between 2005 to 2008, with an average IRI of 1.9 m/km.

The second CPR was applied to the NBLs in 2009, and the IRI values then significantly improved from 2.8 to 1.8 m/km and 1.9 to 1.6 m/km in the driving and passing lanes respectively.

Overall, the first CPR techniques used on the NBLs are performing well within the comfortable category even before applying the second round of CPR in 2009. The CPR techniques used are well within the anticipated life cycle parameters.

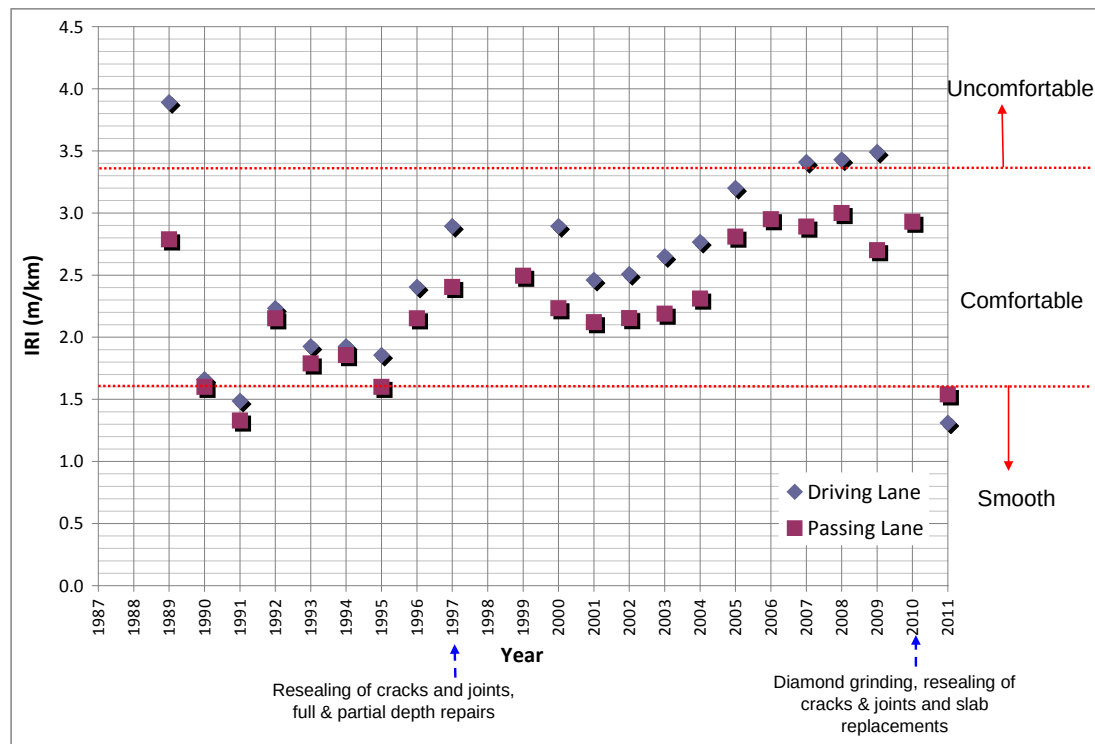
**Figure 5.** Summary of Roughness (IRI) in Southbound Lanes

**5.3.2 Roughness Measurement Southbound Lanes.** The unbonded overlay rehabilitation on the SBLs in 1989 resulted in an improvement in roughness (IRI) from 3.9 to 1.7 m/km and 2.8 to 1.6 m/km in the driving and passing lanes respectively; see Figure 5.

The newly tined surface texture on the unbonded overlay was very aggressive and had contributed to some of the initial roughness. The roughness in both the passing and driving lanes in the southbound direction demonstrate fairly constant IRI values from 1990 to 1995, with an average IRI of 1.8 and 1.7 m/km in the driving and passing lane respectively.

Incorrectly correlated transfer function used to convert PURD data to RCI coupled with several additional cycles of remedial work resulted in the survey data from 1996 to 2000 being out of trend.

The surveys from 2001 to 2010 indicate the roughness has slowly deteriorated over these years, with an average deterioration rate of 0.1 m/km IRI every year. The passing lane is still within the comfortable range, and the driving lane just bordering into the uncomfortable range.

The second CPR was applied to the SBLs in 2010, and the IRI values then significantly improved from 2.93 to 1.54 m/km in the passing lane.

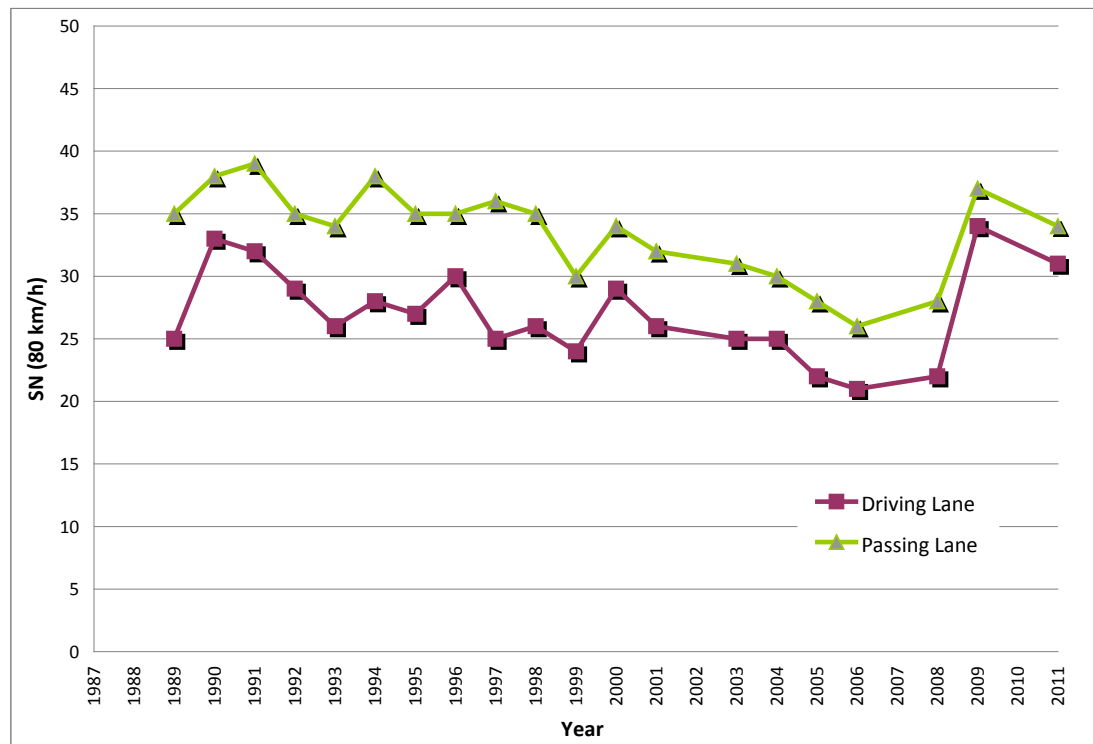
**Figure 6.** Summary of  $SN_{80}$  in Northbound Lanes

**5.4.1. Skid Testing on Northbound Lanes.** For the diamond ground surface on the NBLs, the skid numbers improved immediately after construction in 1989, from an average of 25 to 33 and 35 to 38 for the driving and passing lanes respectively. Skid numbers of this magnitude indicate a good friction factor and are similar to numbers obtained on premium hot mix surface courses in Ontario (Ryell et al. 1978).

As shown in Figure 6, the skid resistance has stayed fairly constant since 1990 to 2000, with the driving lane ranging from 24 to 33 (average of 28) and the passing lane ranging from 30 to 39 (average of 35). From 2001 to 2008, the skid resistance starts to decline slowly, from 26 to 22 in the driving lane; and from 32 to 28 in the passing lane. After the second CPR in 2009, the skid resistance that was collected soon after the diamond grinding application has improved from 22 to 34 in the driving lane and 28 to 37 in the passing lane.

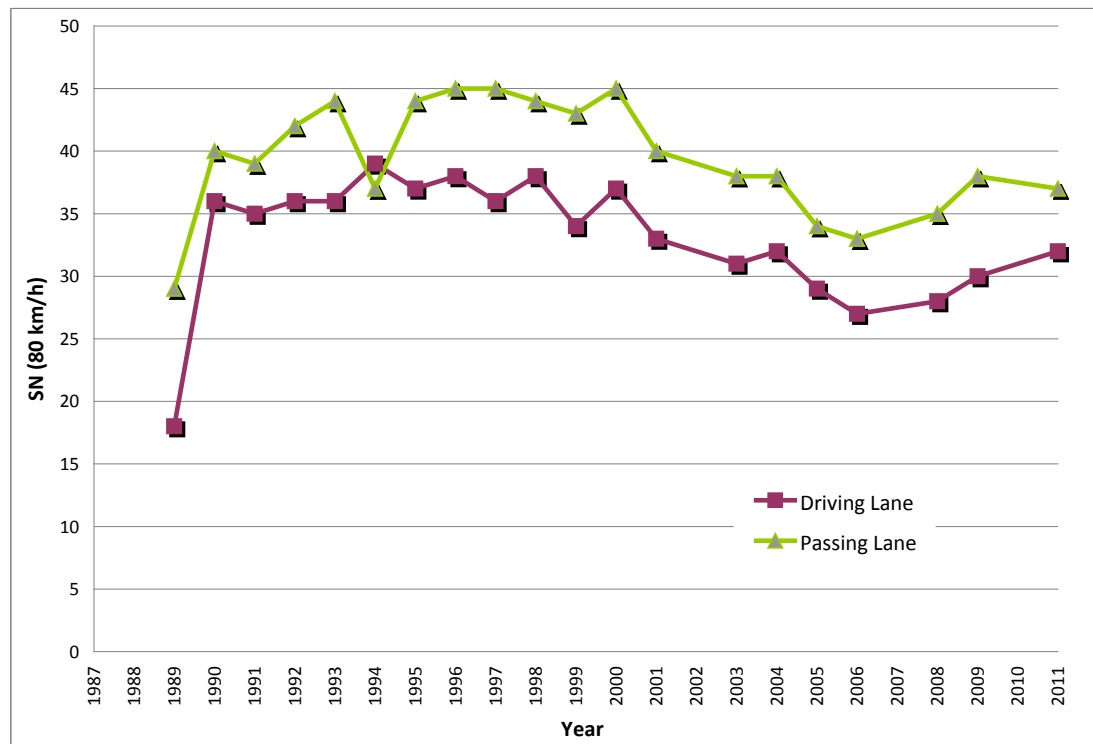
**Figure 7.** Summary of SN<sub>80</sub> in Southbound Lanes

**5.4.2. Skid Testing on Southbound Lanes.** The skid numbers in the SBLs increased from  $SN_{80}$  of 18 to 36 (driving lane) and 29 to 40 (passing lane) immediately after the overlay in 1989. See Figure 7 for an annual summary of the skid resistance in the SBLs.

The skid resistance has stayed fairly constant since 1990 to 2000, with the driving lane ranging from 34 to 39 (average of 37) and the passing lane ranging from 37 to 45 (average of 43). From 2001 to 2008, the skid resistance starts to decline slowly, from 33 to 28 in the driving lanes and from 40 to 35 in the passing lane. The skid resistance starts to improve a little in 2009 and 2011. The second CPR which includes diamond grinding was applied to SBLs in 2010. The skid resistance for 2011 was 32 for the driving lane, 37 for passing lane.
