# EARLY-AGE SPALLING ON USAF AIRFIELD PAVEMENTS

Raymond S. Rollings<sup>1</sup>, Ph.D., P.E., member ISCP; Toy S. Poole<sup>2</sup>, Ph.D.;  
Craig Rutland<sup>3</sup>, Ph.D., P.E.; and Marian P. Rollings<sup>1</sup>, Ph.D., P.E.

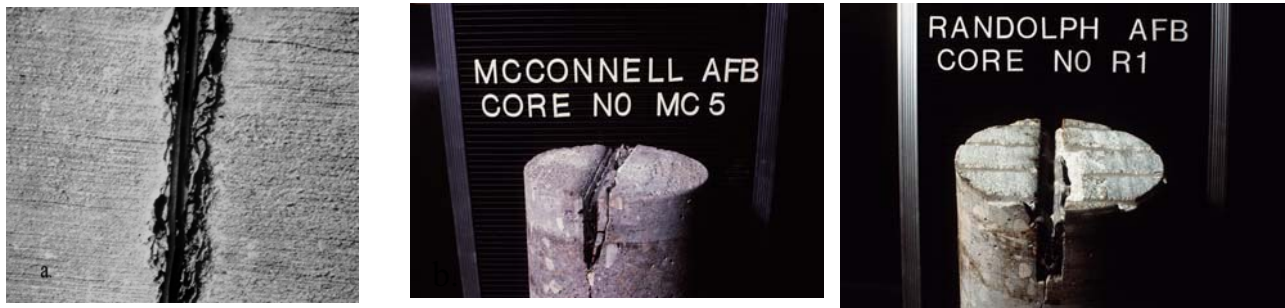
the first year after construction; sometimes even appearing before construction has finished. Causes of this early-age spalling at joints is the focus of this paper. The most common and troublesome of these early-age spalls include sliver spalls (Figure 1) and failure of improper edge-slump repairs (Figure 2).

Figure 1. Examples of early-age sliver spalling on joints: (from left to right) a. Grissom AFB, IN freeze-thaw damage due to low entrained air content, b. McConnell AFB, KS freeze-thaw damage due to low entrained air content, and c. Randolph AFB, TX aircraft traffic abrasion and environmental effects damaging a thick covering of weak surface grout with low entrained air and high water-cement ratio.

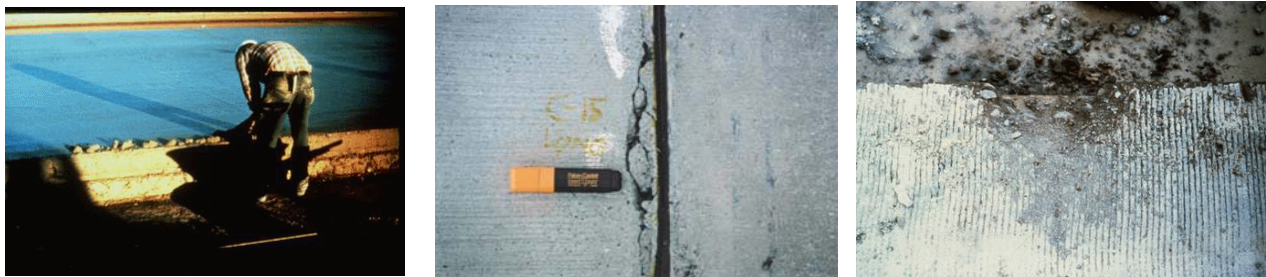
Figure 2. Examples of spalling of edge-slump repairs: (from left to right) a. attempt to repair edge slump using mortar at Travis AFB, CA, b. resulting spalling of these weak edge-slump repairs at Travis AFB, CA, and c. edge-slump repair spalling at Kelly AFB, TX (note original down-slumped surface before repair visible at bottom of spall).

When a slipform paver moves forward, the edge of the concrete extruded from the rear of the machine may slump downwards (edge slump). This is unacceptable as it will fail to meet military airfield smoothness requirements and will result in water collecting along the longitudinal joints. The defect cannot be repaired during construction by adding slurry or mortar

to the restore the surface (Figure 2 a) as such repairs later spall and separate from the originally placed pavement (Figure 2b and c). Adjustments to the concrete mixture proportions or the equipment are needed to correct this defect. Ellsworth, Kelly, Tonopah, and Travis AFBs in Table 1 had spalling predominately from edge-slump repairs as their primary cause of early-age spalling. Malmstrom AFB had significant edge slump repair spalling but also had some potential problems with poor bond between aggregates and paste in some areas that compounded the spalling problems.

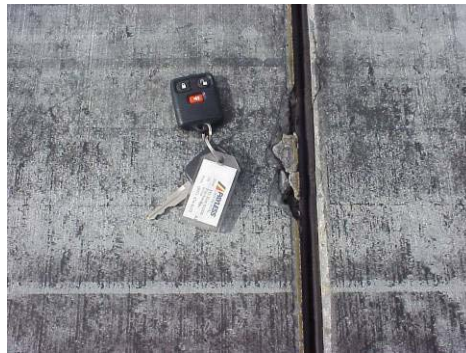
Figure 3. Example of sliver spall on beveled joint.

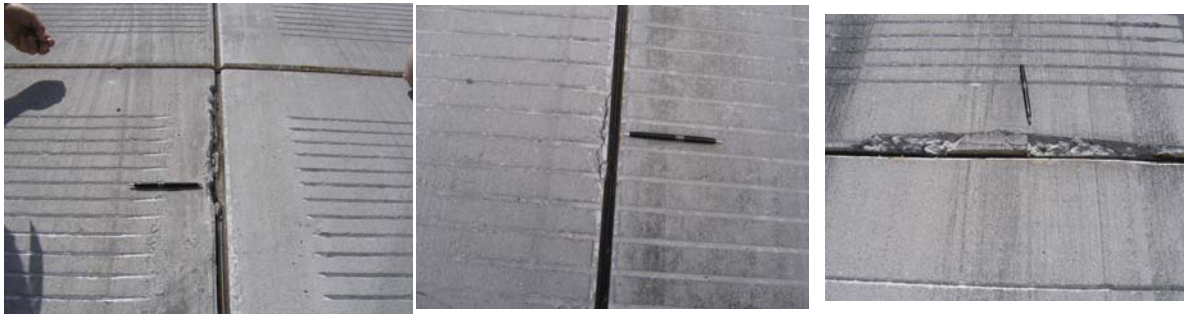
Between June and November of 2006, portions of a concrete runway and two taxiways at an airbase in the Midwest (hereafter identified as Airbase A) were replaced with new 21-in. thick concrete. In March 2007, USAF began observing spalling on this new pavement (Figure 4) which was producing an unacceptable amount of debris that posed a significant FOD hazard (Figure 5).

Figure 4. Examples of runway spalling at Airbase A along (from left to right) a. a centerline joint, b. a longitudinal construction joint, and c. a transverse joint.

The construction agency for the spalling pavement inspected the damage and concluded that the damage was from snowplow operations by the base personnel. The base personnel and Major Command (MAJCOM) for the base took exception to this finding and noted that there was significant spalling damage that visibly was identical to that previously associated with poor concrete durability (e.g., compare Figure 4 with Figure 1).
