# Case Study of US 75: Assessment of Full Depth Repair Effectiveness

Youn su Jung<sup>1</sup>, Tom J. Freeman<sup>2</sup>, Dan G. Zollinger<sup>3</sup>, Member ISCP and Andrew J. Wimsatt<sup>4</sup>

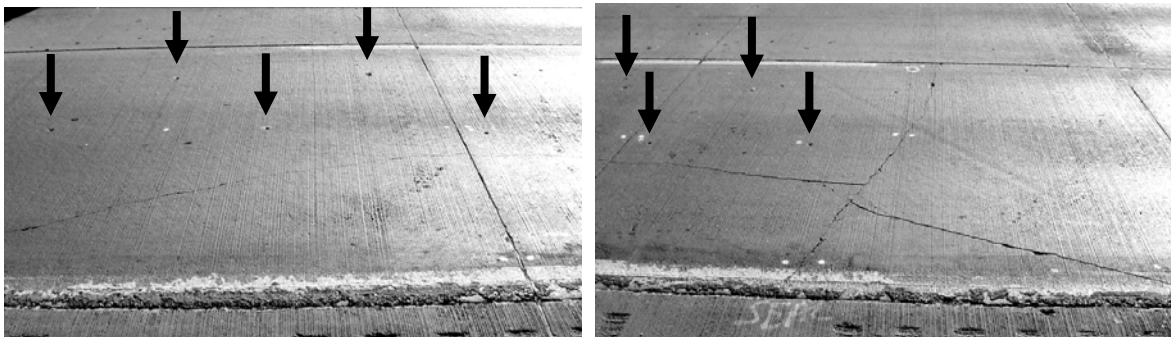
**Figure 2 Locations of Slab Jacking Holes and Cracks on Slabs in Poor Condition.**

Joint repairs were performed in 1996 and then a major rehabilitation involving slab jacking using polyurethane material was undertaken in 2004 to fill voids under the slab and eliminate eroded areas below the affected slabs due to pumping action. After the repair, generally, very little settlement was observed for the first two years, however, some slabs started to crack and pavement conditions soon worsened. This problem could possibly have been caused by inadequate undersealing and a saturated base and subgrade conditions by damaged joint seals. Performance observations indicated a greater incidence of corner cracking after the undersealing work shown in Figure 2. Note the cracks formed between these holes and the transverse joint or shoulder.

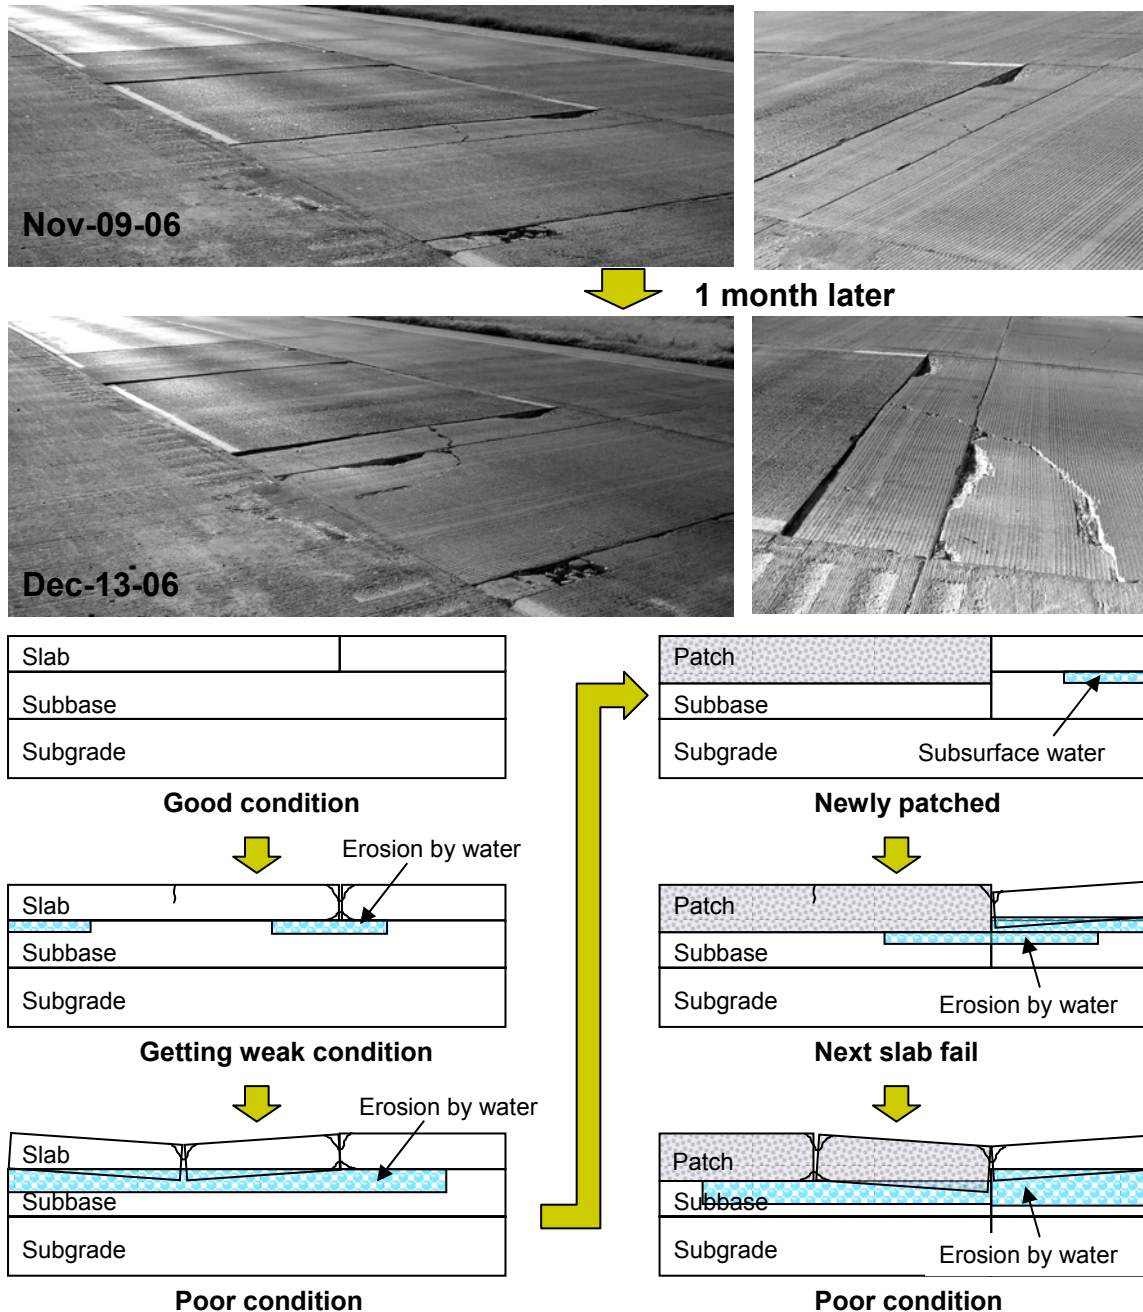
Damaged joint seals (especially along the shoulder joint) often allow for the penetration of water in the joint which can be problematic particularly if it is not removed prior to resealing of the joint. Figure 3 shows the pictures how quickly patching areas deteriorate especially with intrusion of water due to a lack of joint sealing. Moreover, rocking of the slab caused by insufficient load transfer efficiency (LTE) and poor base/subgrade compaction resulted in significant faulting within the patch sections.

the newly patched section had the lowest LTE (which was less than 40 %). Two out of five test locations associated with new patches had good LTE (approximately 80 % and 90 %) while the other three joints had poor LTE (approximately 50 %, 10 %, and 7 %). The older patch sections providing better performance than the new patch sections had also low load transfer (approximately 50 % to 60 %). The test data suggests the reason for the failure of the FDR shown in Figure 3 was low LTE and a degraded base support condition.

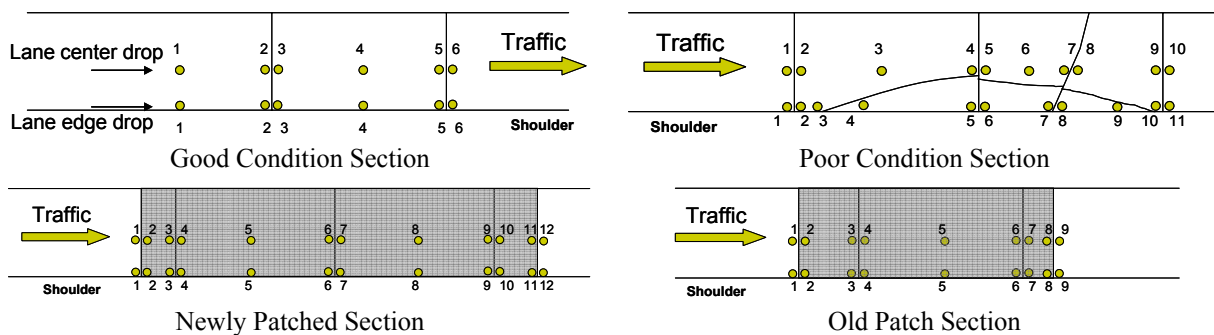
a) Test Sections and FWD Location ID Numbers

Test locations consisted of testing before and after the joint and at the mid slab location. These locations were tested along the edge, in the wheel paths, and at the center of the slab. Figure 4a illustrates FWD testing locations. Figures 4b and 4c are bar charts showing joint LTE at the center and the edge of slab over a range of pavement conditions. Unexpectedly, the poor condition section had the highest LTE along the slab edge, while the newly patched section had the lowest LTE (which was less than 40 %). Two out of five test locations associated with new patches had good LTE (approximately 80 % and

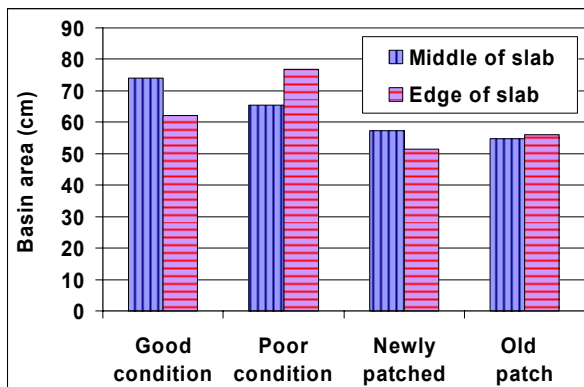
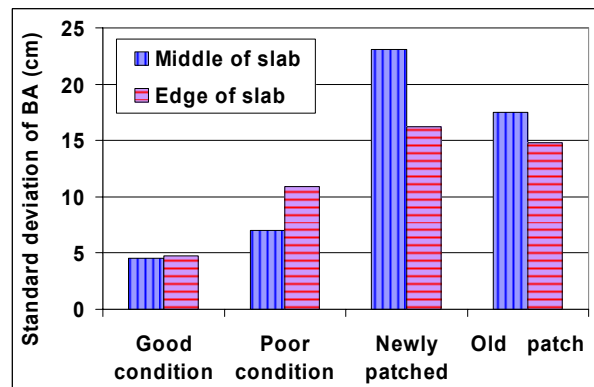
d) Mean and Standard Deviation of Basin Area

Figure 4d shows the mean and standard deviation of FWD basin areas. Patched sections showed a lower mean basin area with a higher standard deviation than the cracked poor performing areas, which means the general structural capacity of FDR was lower than even the problematic pavement areas manifesting non-uniform support and premature slab shattering.

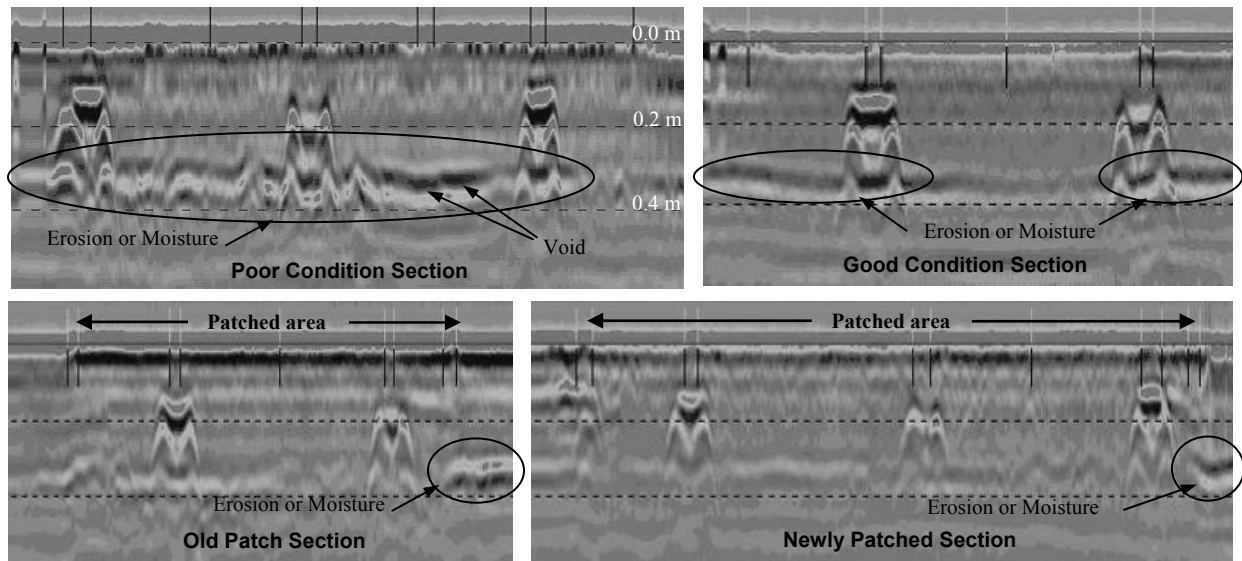
a) GPR along FWD Lane Center Drop Points

**Ground Penetrating Radar (GPR) Testing.** GPR testing appears a fast and effective test method to determine base conditions such as voids and the presence of water trapped in the layers (Zollinger et al. 2003). Figure 5 shows GPR images which represent voids as black areas and eroded or wet areas as a bright zone. Poor performing sections showed many voids and wet areas while the good performing sections showed some areas with erosion and moisture. The patched areas did not show significant moisture damage, but adjoining areas showed the presence of water which could affect the adjacent patched area in the future as previously noted in Figure 3. The line at the bottom in Figure 5b indicates the surface dielectric value which indicates the moisture level of the subgrade. The test data tends to suggest when a DC value of the concrete surface is higher than 9, a wet subgrade condition below the subbase may exist.

**Subdrain or Edge Drain System.** When the dielectric constant of the existing patch to be replaced is higher than 9 using GPR, inadequate drainage may exist and base and subgrade integrity may be an issue. Retrofitting of a drainage system may be needed to mitigate weakened subgrade areas. However, edge drainage is not recommended if the base is unstabilized and contains more than 15 % of fines (passing No. 200 sieve), or the pavement structure is simply undrainable. As mentioned earlier, some or all disturbed base material in a repair situation should be replaced with concrete or a flowable fill of 6,900 kPa or greater. Figure 9 shows the applicable drainage system details used by Iowa DOT; a 7.5 cm slotted corrugated pipe or longitudinal subdrain is employed for FDR granular subbase. (Iowa DOT 2007).

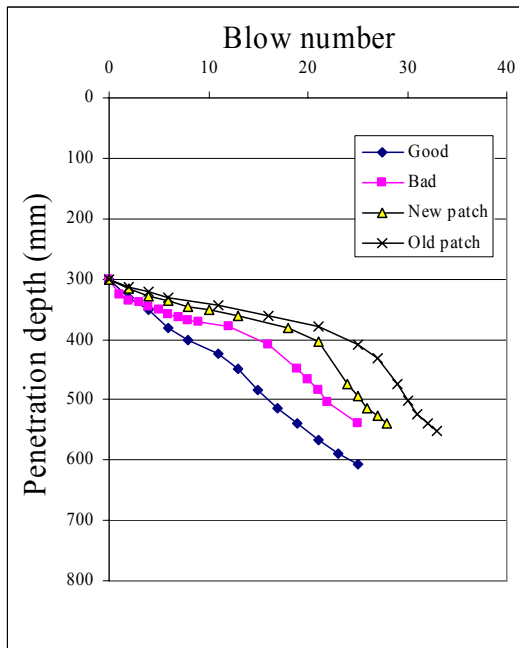
a) Penetration vs. Blow Number

The base type for all sections investigated was an unbounded aggregate base where the estimated elastic moduli appeared to be quite low as shown in Figure 6. The base in the good performing areas had nearly the same modulus as that of the subgrade and there appeared to be a significant loss of base strength in the unrepaired areas; typical elastic modulus for an unbounded aggregate base ranges from 100 to 300 MPa (Huang 2004).

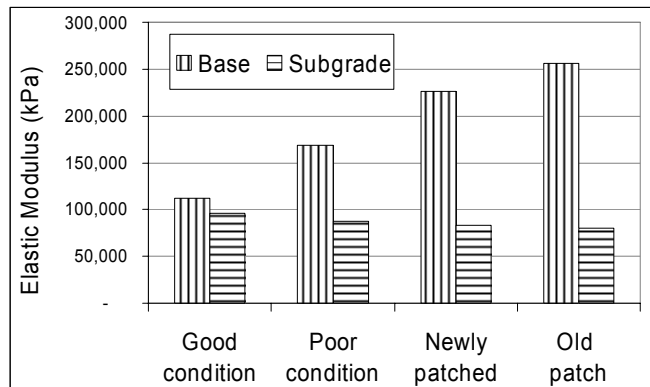
b) Elastic modulus vs. depth and pavement conditions

The patched areas showed relatively higher modulus than the unrepaired sections for the base layer but no significant difference for the subgrade layer. The low modulus for the subgrade seemed to indicate that a wet condition was prevalent which seemed to correlate with the presence of standing water along the shoulder joint strongly suggesting the possibility of poor surface drainage. The accumulation of surface water most likely contributed to the degradation of the base and subgrade modulus particularly where the longitudinal joint seal was damaged and weathered.

**FDR Subbase and Base Preparation.** After the old concrete material has been removed, the base course should be examined and any disturbed material removed and recompact before placement of the patch. Replacing some or all disturbed base material (or material shown to have a modulus is less than 70 MPa based on DCP test results) with concrete or flowable fill may be the best alternative if it is difficult to adequately compact granular material inside the patched area. If proper compaction is not achieved, the base could settle and a void develop under the slab. If excessive moisture exists in the repair area, it should be removed or dried before replacing.

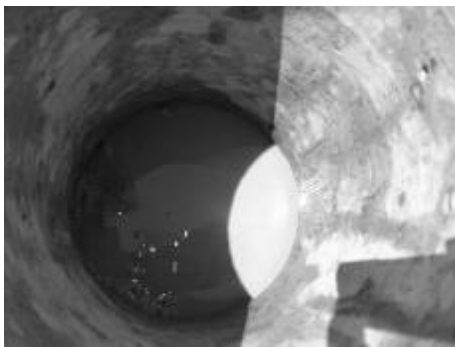
**Coring Samples.** Core samples were taken as a means to measure the compressive strength of the concrete and to indirectly estimate the modulus of the concrete layer. The core hole also provided for a means of visual observation of voids and eroded base areas (Zollinger et al. 2003). Figure 7a shows a core hole located in a poor performing section exposing a voided area of the base material due to erosion.

a) Void and Erosion Under the Concrete Slab of Poor Condition Section

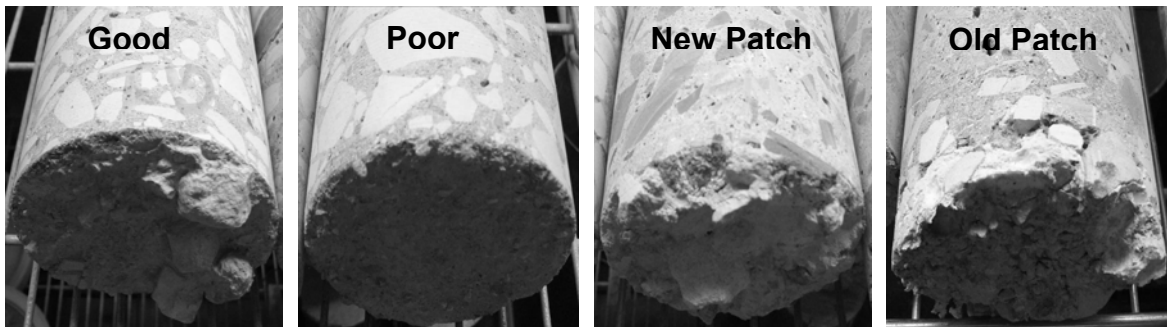
Figure 7b shows the bottom surface of a core indicating the condition of the bond between the concrete and base. The core sample from the poor condition section showed evidence of separation (caused by erosion and pumping action) while the sample from the good condition section showed partial debonding between the concrete slab and base. Cores from patched areas did not show any evidence of separation. Concrete strength test results, shown in Figure 7c, indicate that the concrete material was sound and there was no evidence of weakened concrete.

b) Top and Bottom Surface of the Cores
