# **CPR Techniques in Canada - 18 Years of Performance Experience**

## **Abstract**

In the summer of 1989, the Ministry of Transportation of Ontario (MTO) undertook the rehabilitation of an exposed concrete pavement exhibiting various distress manifestations. Highway 126 in Southwestern Ontario is a four-lane divided arterial with 22,000 AADT and 9.6% commercial traffic in year 2000. The existing pavement constructed in 1963 consisted of 230 mm mesh reinforced Portland Cement Concrete (PCC) pavement with dowelled joints at a spacing of 21.3 m. The rehabilitation of the highway in the northbound lanes consisted of using the latest concrete pavement restoration (CPR) techniques, material specifications and construction methods. The rehabilitation techniques included full depth repair, partial depth repair, diamond grinding and joint sealant replacement on the northbound lanes which had experienced moderate deterioration. The southbound lanes received a 180 mm thick plain jointed unbonded PCC overlay to address the severe 'D' cracking and spalling at all the joints and cracks. This paper will discuss the eighteen-year evaluation of this rehabilitated pavement in terms of smoothness

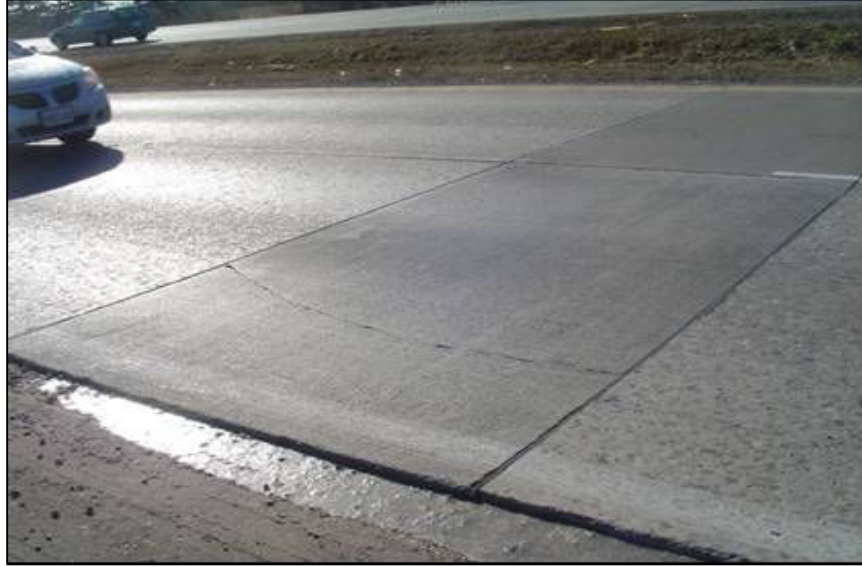
*3.1.5 Northbound Lanes – At 18 years of service.* A recent windshield pavement visual condition inspection was carried out in January 2008, after eighteen years of rehabilitation, the NBLs pavement was considered to be in fair condition with an average PCR of 55. There were a few moderate longitudinal and meandering cracks; frequent severe to very severe transverse cracking; moderate faulting throughout; intermittent moderate joint and crack spalling. See Photo 1 below showing a full depth repair exhibiting a slight longitudinal crack. Note the concrete pavement outside the full depth repair is polished, particularly in the wheelpath.

**Photo 1.** Northbound Lane Full Depth Repair Section

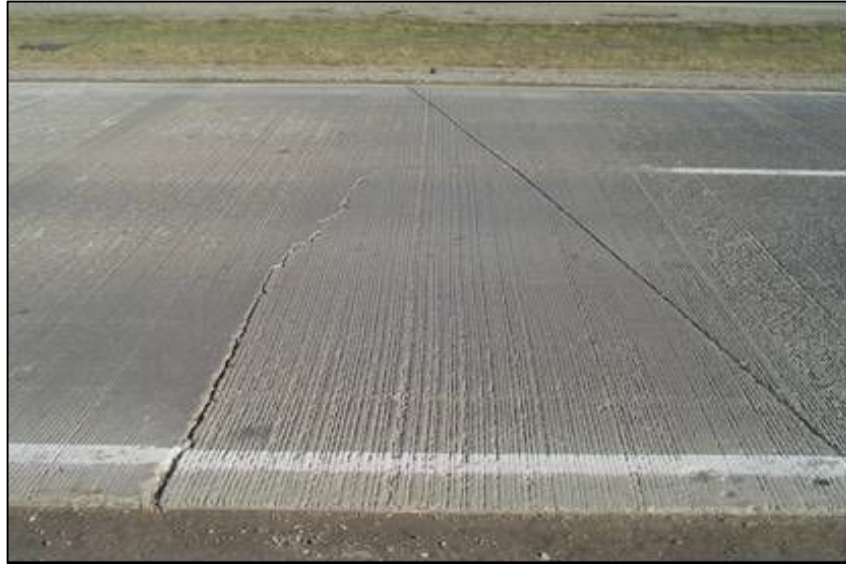
*3.1.8 Southbound Lanes – At 18 years of service.* A recent windshield pavement visual condition inspection was carried out in January 2008, after eighteen years of rehabilitation, the southbound lanes pavement was considered to be in fair condition with an average PCR of 52. There were a few to intermittent crescent cracks; intermittent severe longitudinal cracks; moderate longitudinal and meandering cracks; frequent slight to moderate transverse cracking; moderate faulting throughout; few moderate joint and crack spalls; few areas of moderate raveling/coarse aggregate loss. See Photo 2 below for the typical southbound driving lane condition showing a moderate transverse crack. Note that the surface still has a tined macro-texture.

**Photo 2.** Typical Transverse Crack in Unbonded Concrete Overlay Section

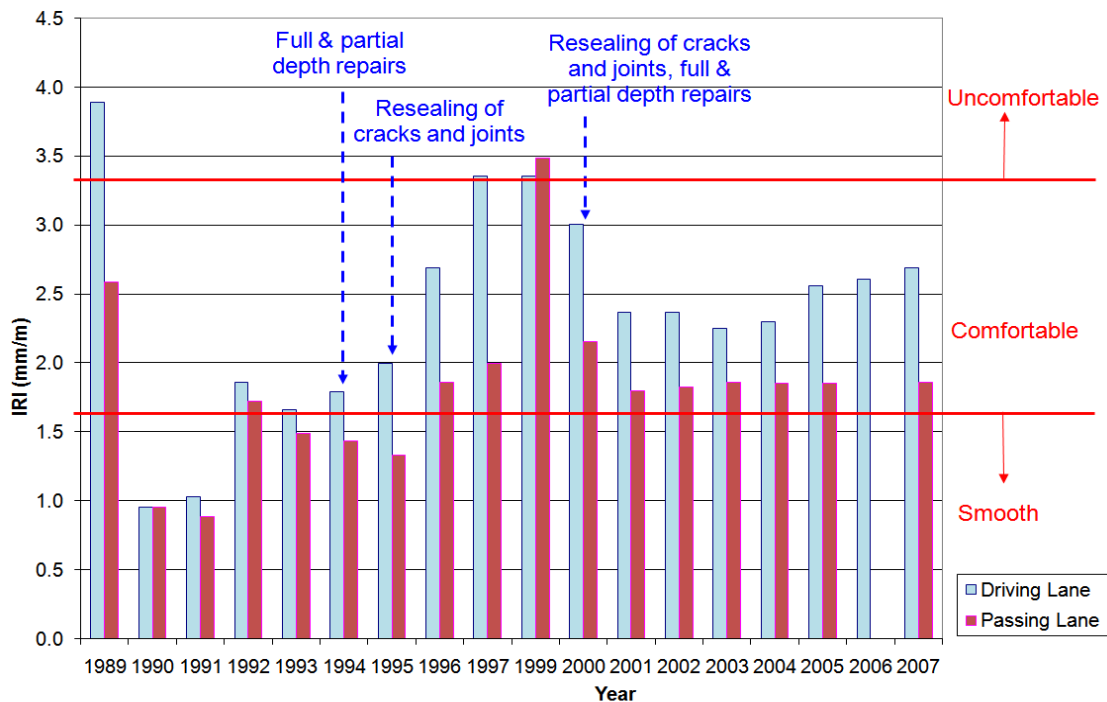
**3.3.1 Roughness Measurement Northbound Lanes.** Roughness in the NBLs improved significantly after the concrete pavement surface was diamond ground in 1989, with an improvement in IRI from initially 3.9 to 0.9 and 2.6 to 0.9 in the driving and passing lanes respectively, see Figure 1. The ride data for the diamond ground surface indicates that the initial roughness values deteriorated to an approximate value of 1.8 after two years and has remained fairly constant over the following three years. These IRI values are in the comfortable range of the ride categories. The ride quality levels (smooth, comfortable, uncomfortable) indicated on the graph are converted based on the established ride comfort index (RCI). RCI between 8 to 10 is smooth (IRI = 1.60 to 0.76); 6 to 8 is comfortable (IRI = 3.36 to 1.60); and below 6 (IRI > 3.36) is considered to be uncomfortable ride (Chong et al. 1995).

The IRI values between 1996 to 2000 appear elevated probably as a result of an erroneous transfer function used in converting PURD measurements into IRI values. The conversion was based on limited correlation data.

The ARAN surveys from 2001 to 2004 indicates the roughness remained constant over these years, with an average IRI of 2.3 and 1.8 for the driving and passing lane respectively. From 2005 to 2007, the driving lane roughness data shows a very mild trend of deterioration with an average IRI of 2.6. The roughness data for the passing lane are still fairly constant between 2005 to 2007, with an average IRI of 1.9.

Overall, the full CPR techniques used on the NBLs are still performing well within the comfortable category after 18 years of service.

**Figure 1.** Summary of Roughness (IRI) in Northbound Lanes

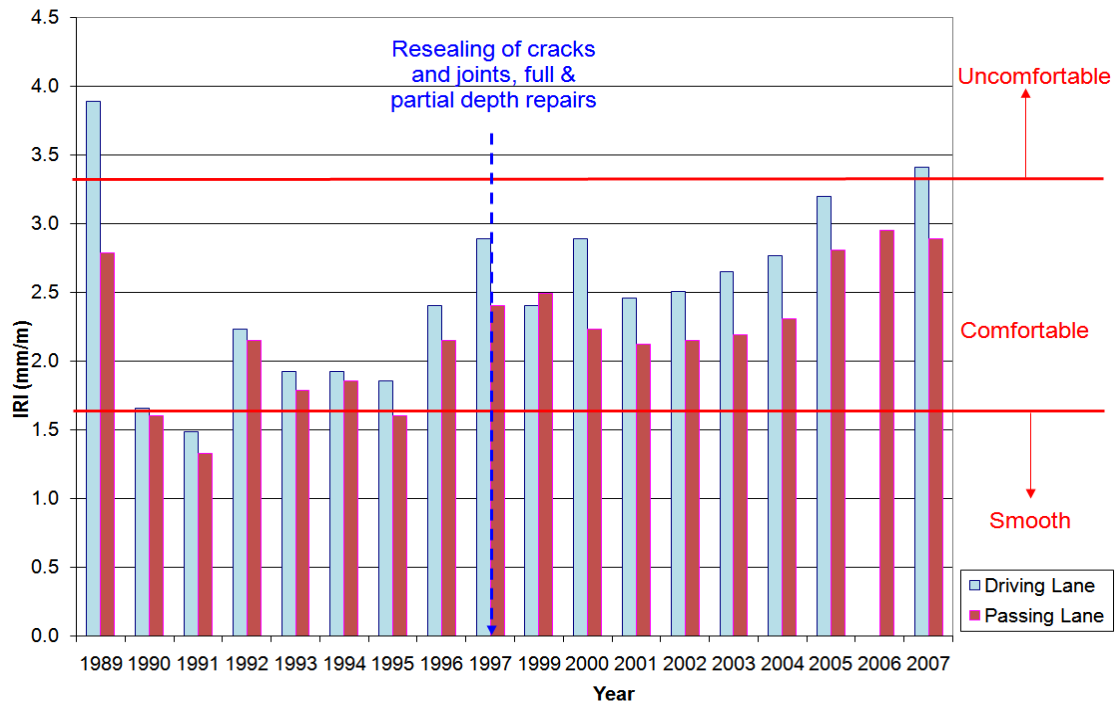
**3.3.2 Roughness Measurement Southbound Lanes.** The unbonded overlay rehabilitation on the SBLs in 1989 resulted in an improvement in roughness (IRI) from 3.9 to 1.7 and 2.8 to 1.6 in the driving and passing lanes respectively; see Figure 2.

The newly tined surface texture on the unbonded overlay was very aggressive and had contributed to some of the initial roughness. The roughness in both the passing and driving lanes in the southbound direction demonstrate fairly constant IRI values from 1990 to 1995, with an average IRI of 1.8 and 1.7 in the driving and passing lane respectively.

Again, due to the incorrectly correlated transfer function used to convert PURD data to RCI coupled with several additional cycles of remedial work, this resulted in the survey data from 1996 to 2000 being out of trend.

The surveys from 2001 to 2004 indicate the roughness has slowly deteriorated over these years. From year 2005 to 2007, the roughness starts to deteriorate at a faster rate; with the passing lane still within the comfortable range, and the driving lane just bordering into the uncomfortable range.

Overall, the unbonded concrete overlay on the southbound lanes is performing at an acceptable level of ride quality after 18 years of service, and it is well within the anticipated life cycle parameters.

**Figure 2.** Summary of Roughness (IRI) in Southbound Lanes

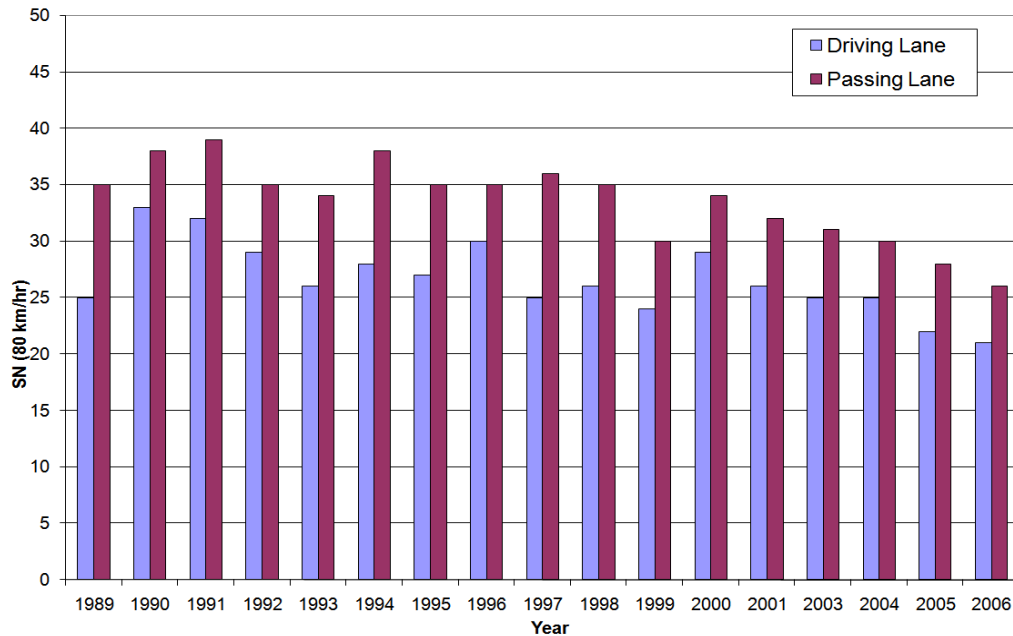
**3.4.1. Skid Testing on Northbound Lanes.** For the diamond ground surface on the NBLs, the skid numbers improved immediately after construction in 1989, from an average of 25 to 33 and 35 to 38 for the driving and passing lanes respectively. Skid numbers of this magnitude indicate a good friction factor and are similar to numbers obtained on premium hot mix surface courses in Ontario (Ryell et al. 1978).

As shown in Figure 3, the skid resistance has stayed fairly constant since 1990 to 2000, with the driving lane ranging from 24 to 33 (average of 28) and the passing lane ranging from 30 to 39 (average of 35). From 2001 to 2006, the skid resistance starts to decline slowly, from 26 to 21 in the driving lane; and from 32 to 26 in the passing lane.

**Figure 3.** Summary of SN<sub>80</sub> in Northbound Lanes

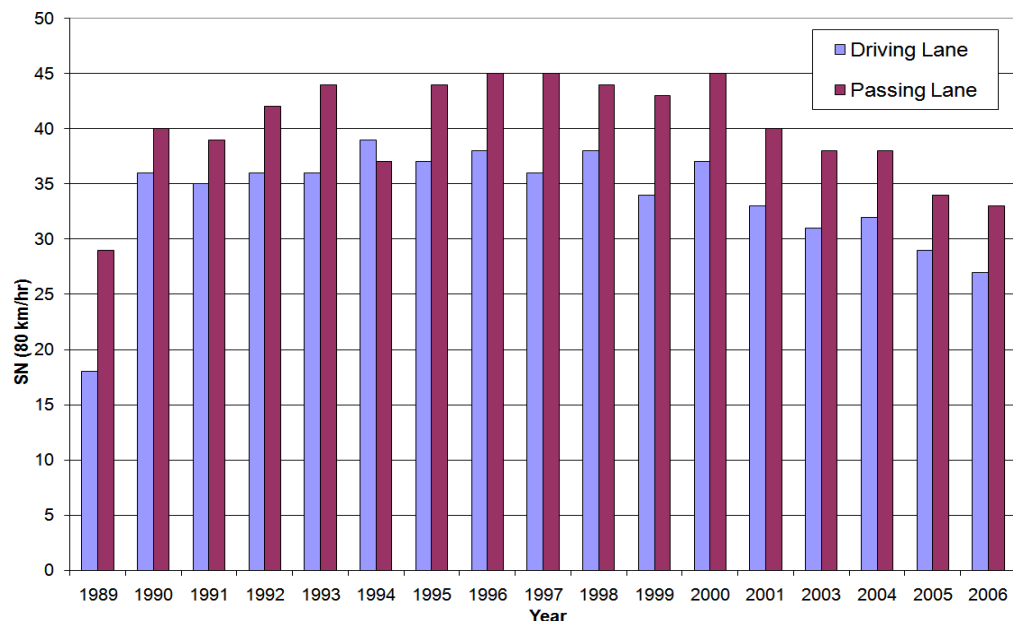
**3.4.2. Skid Testing on Southbound Lanes.** The skid numbers in the SBLs increased from SN<sub>80</sub> of 18 to 36 (driving lane) and 29 to 40 (passing lane) immediately after the overlay in 1989. See Figure 4 for an annual summary of the skid resistance in the SBLs.

The skid resistance has stayed fairly constant since 1990 to 2000, with the driving lane ranging from 34 to 39 (average of 37) and the passing lane ranging from 39 to 45 (average of 43). From 2001 to 2006, the skid resistance starts to decline slowly, from 33 to 27 in the driving lanes and from 40 to 33 in the passing lane.

**Figure 4.** Summary of SN<sub>80</sub> in Southbound Lanes
