# Experiences with Dowel Bar Retrofit in California

E. Kohler<sup>\*</sup>, J.T. Harvey<sup>†</sup>, and B. Steven<sup>‡</sup>

## Abstract

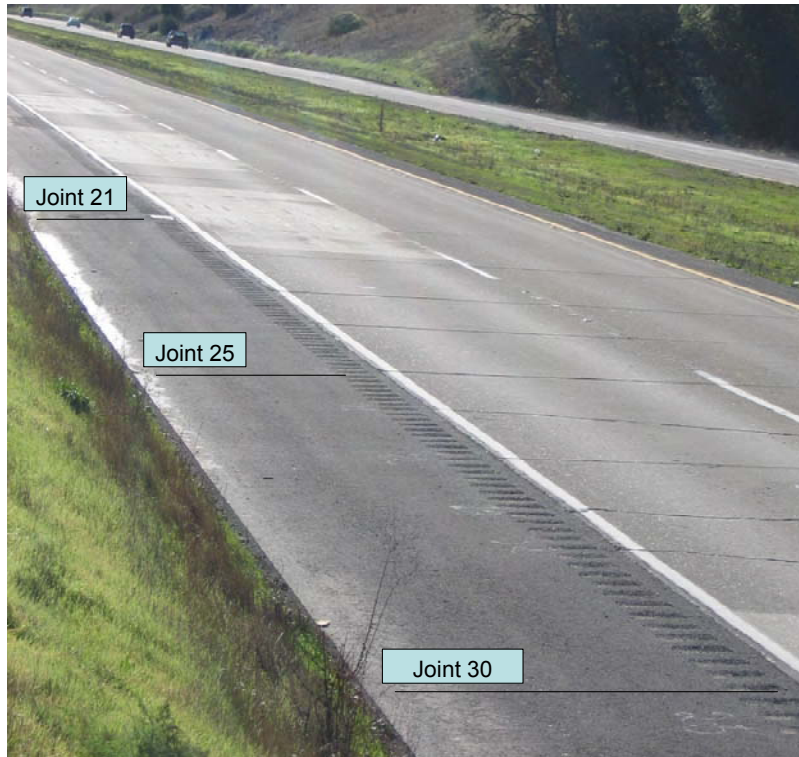
**Visual condition.** The live traffic performance of the Ukiah sites was assessed in December 2006. The DBR backfill material was found to be in good condition, with no cracks or loose pieces, indicating adequate bonding with the surrounding concrete. Faulting was evident in most of the non-DBR joints (see slab layout in Figure 1). In particular, severe faulting was observed at Joints 22 to 29 and Joints 36 to 43, as shown in Figure 3 and Figure 4.

**Figure 3. General overview of faulting between Joints 21 and 30, Ukiah.**

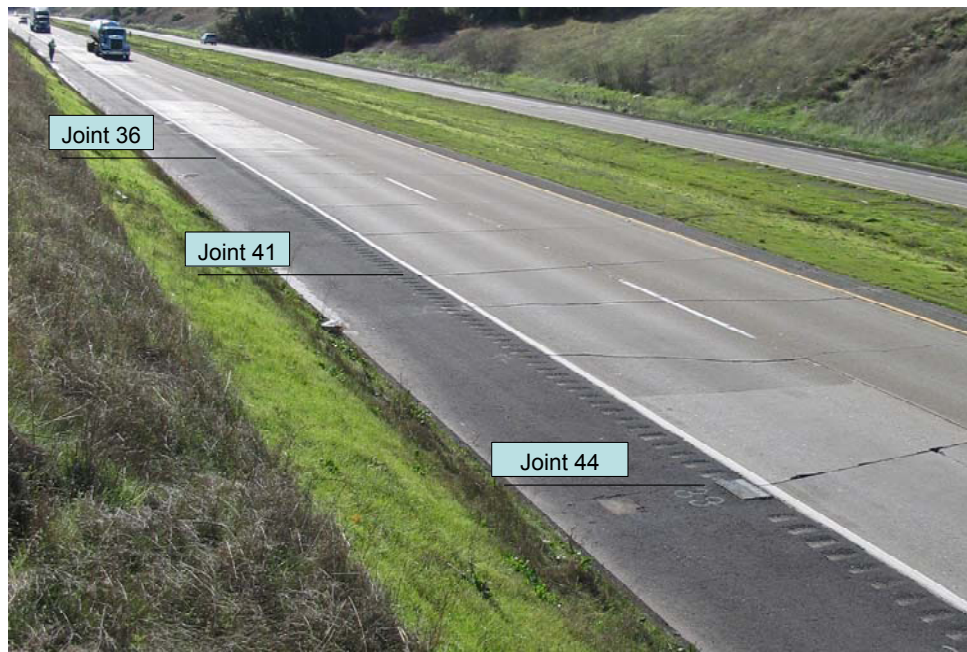
**Figure 4. General overview of faulting between Joints 36 and 44 , Ukiah.**

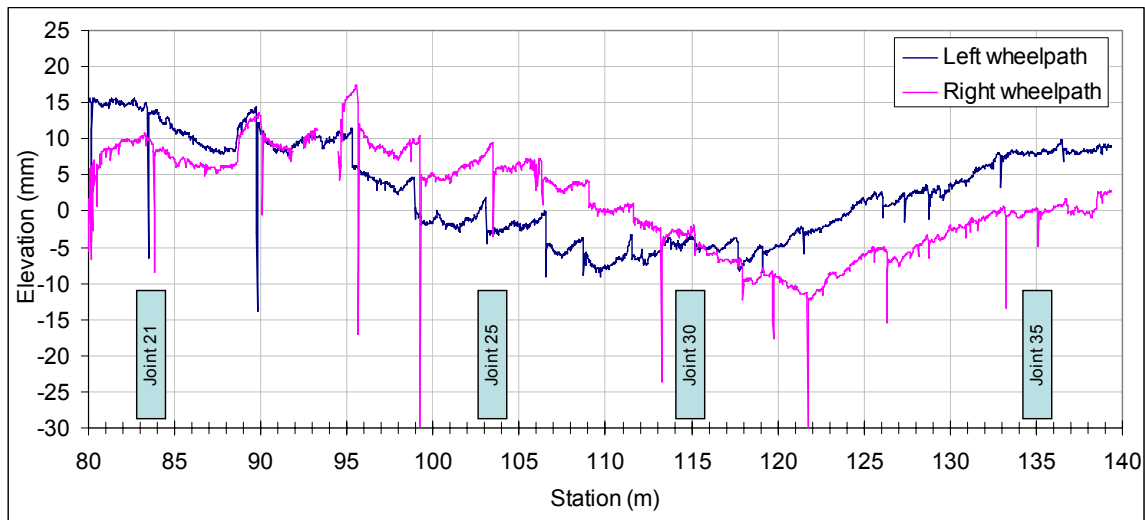
used to calculate the faulting. The reason for the offset in faulting locations between the wheelpaths is due to the skewed transverse joints at this site. The amount of faulting was determined using an automatic faulting algorithm in the Dynatest profilometer software which is based on *AASHTO method R 36-04*. Detailed profiles, including regression lines for two representative joints (21 and 25), are presented in Figure 5 and Figure 6. The overall assessment suggests that there is faulting in the order of two to eight millimeters in all of the nonretrofitted, nonground joints. A negligible faulting level of 0.8 mm was calculated for Joint 21, but the photographs in Figure 7 show that this DBR joint does not show any visible faulting. A close examination of the left chart on Figure 6 confirms that there is no faulting at this joint, and that the value obtained is just a mathematical construction.

**Figure 5. Wheelpath profiles indicating step faulting at some joints, Ukiah.**

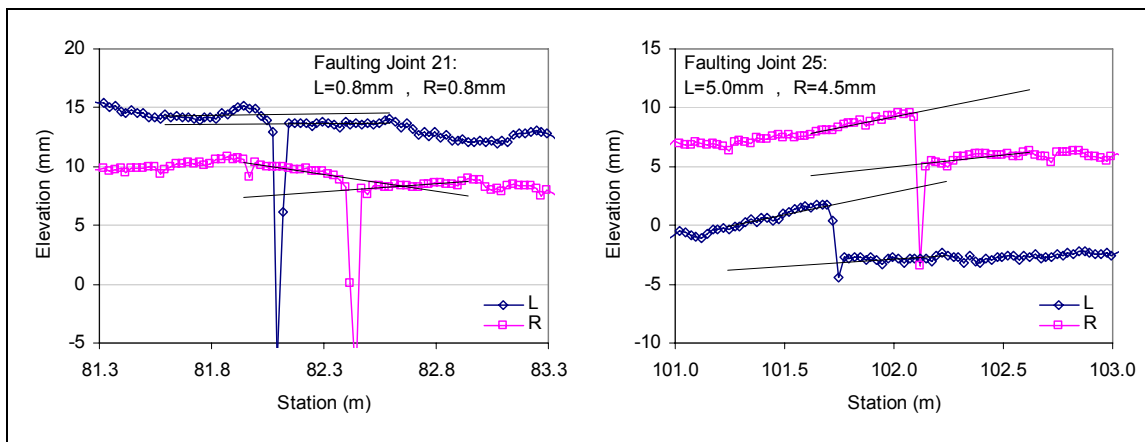
**Figure 6. Detailed profile and faulting determination at Joints 21 and 25, Ukiah.**

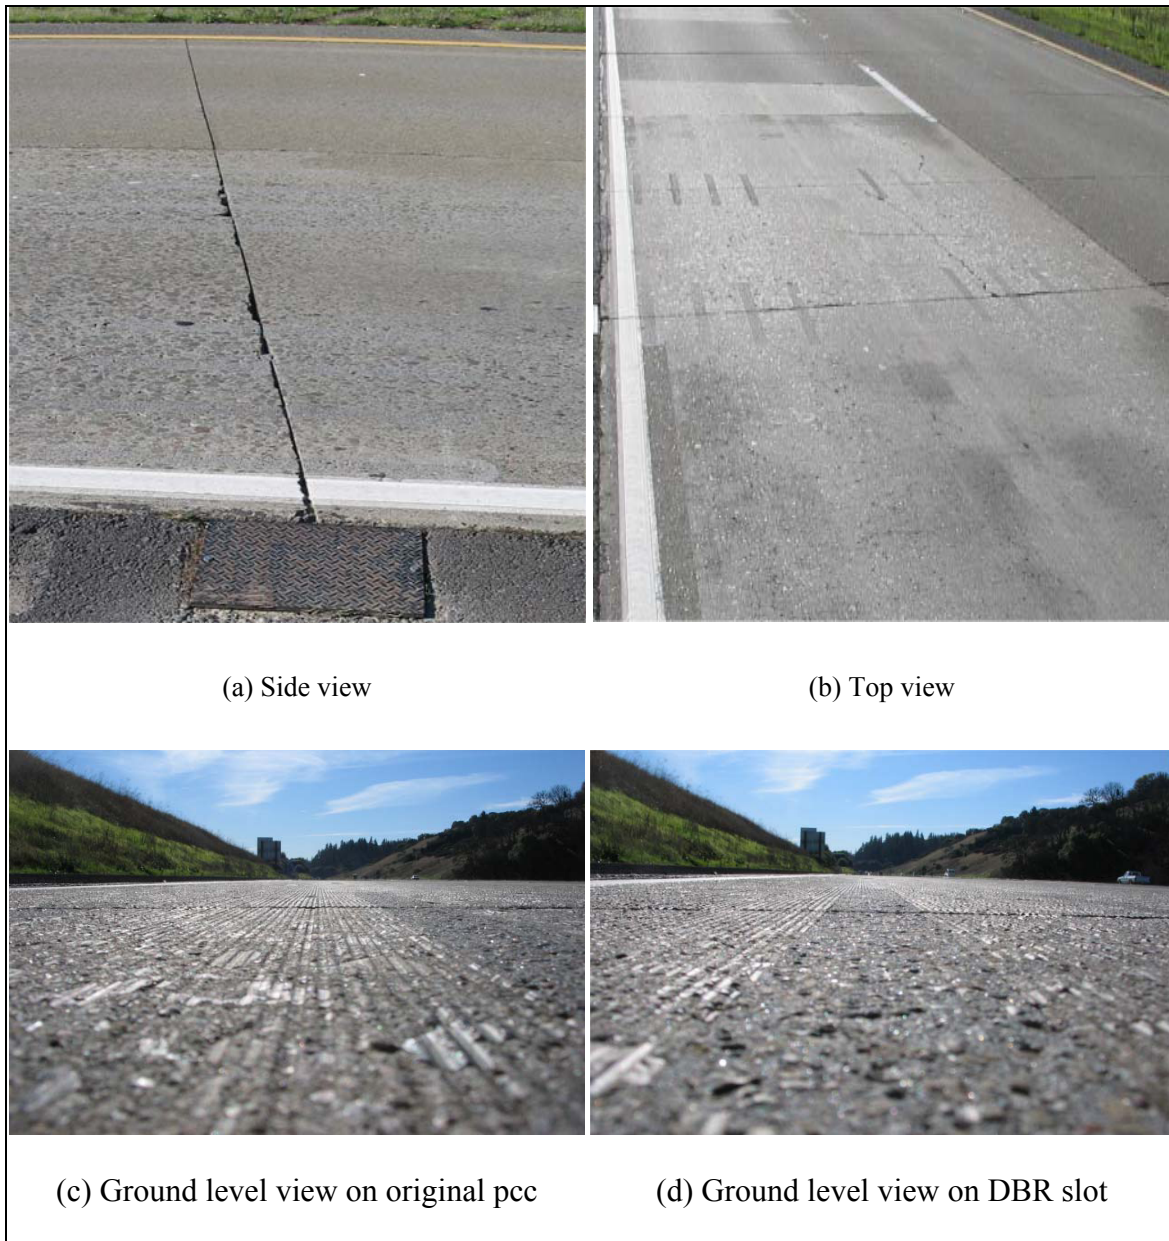
**Figure 7. Joint 21 (dowelled), Ukiah.**

The level of faulting measured by the vertical sensors (Figure 10) matches the observed faulting on the surface (Figure 11b). The photograph, as well as the general view presented in Figure 11b, was taken in December 2006. The absence of faulting for Joint 21 was confirmed in Figure 6 and Figure 7. Additional pictures of the Ukiah test sections and other California DBR sections are included elsewhere (Kohler and Santero 2008).

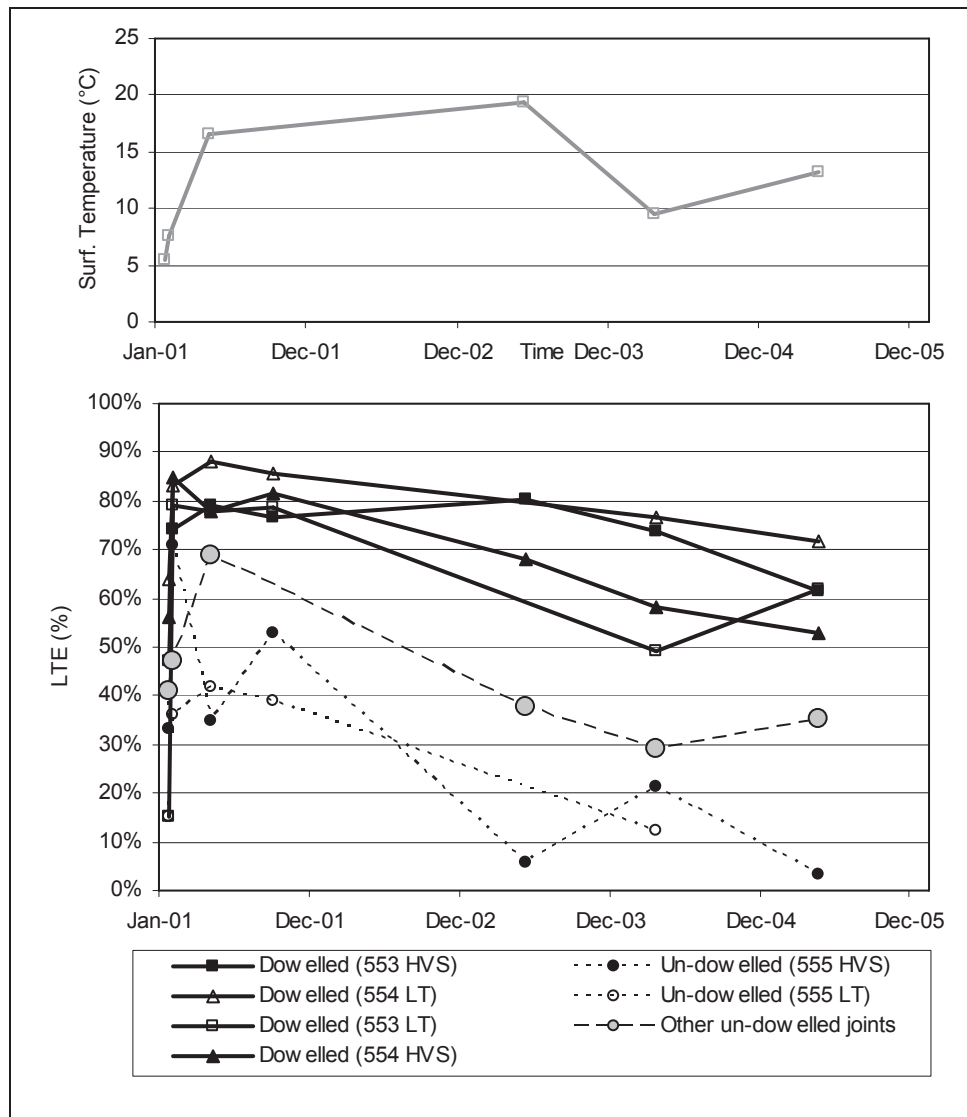
***LTE Measurements.*** The LTE was measured with a Dynatest Heavy Weight Deflectometer (HWD) on six separate occasions on these sections, once before the DBR and five times after. The results shown in Figure 8 indicate that the joints retrofitted with dowel bars (553HVS, 553LT, 554HVS & 554LT) showed a marked increase in LTE immediately after the installation of the dowel bars. Due to miscommunication with the HWD operators over time, the HWD measurements on the transverse joints were performed in the center of the joint between the wheelpaths rather than over the dowels which were placed only in the wheelpaths. This would help explain why the LTE of the dowelled joints was not greater than 90 percent. The improved performance of the DBR joints was sustained throughout the monitoring period, albeit with a gradual reduction in

**Figure 8. Load Transfer Efficiency over time at the Ukiah test site.**

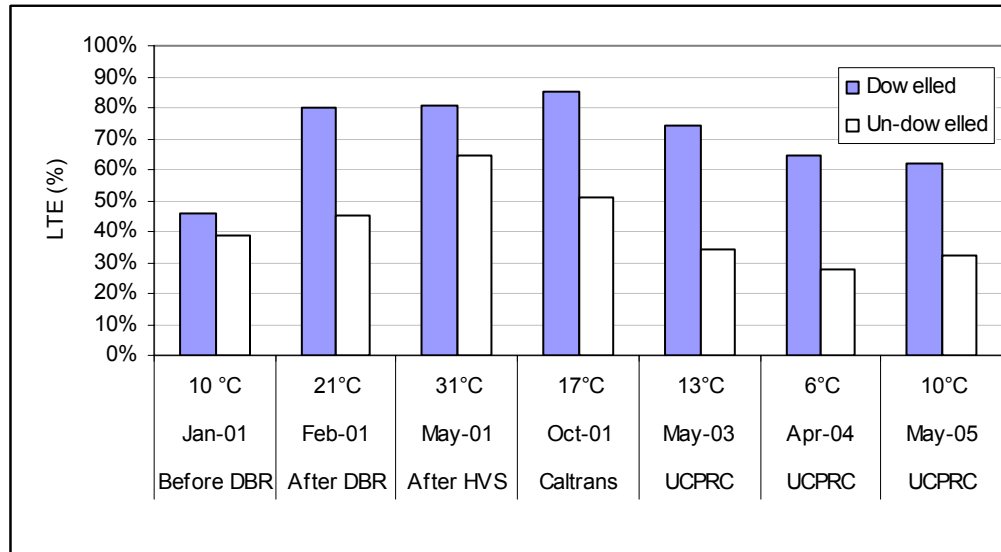
LTE over time. Figure 9 shows that retrofitted joints/cracks presented higher LTE than the undowelled joints, and that as expected they were much higher than before DBR, even after trafficking with the HVS.

**Figure 9. Comparison of Load Transfer Efficiency on dowelled versus undowelled joints at the Ukiah test site.**

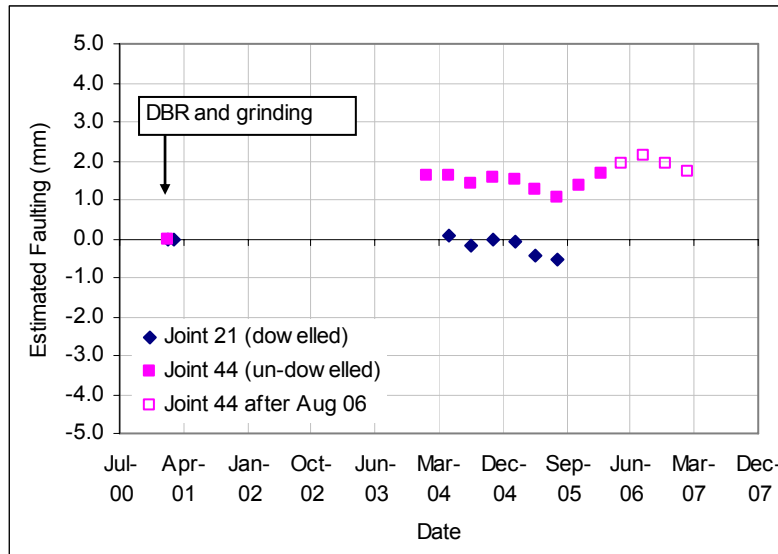
**Figure 10. Estimated faulting from vertical displacement sensors at Ukiah.**

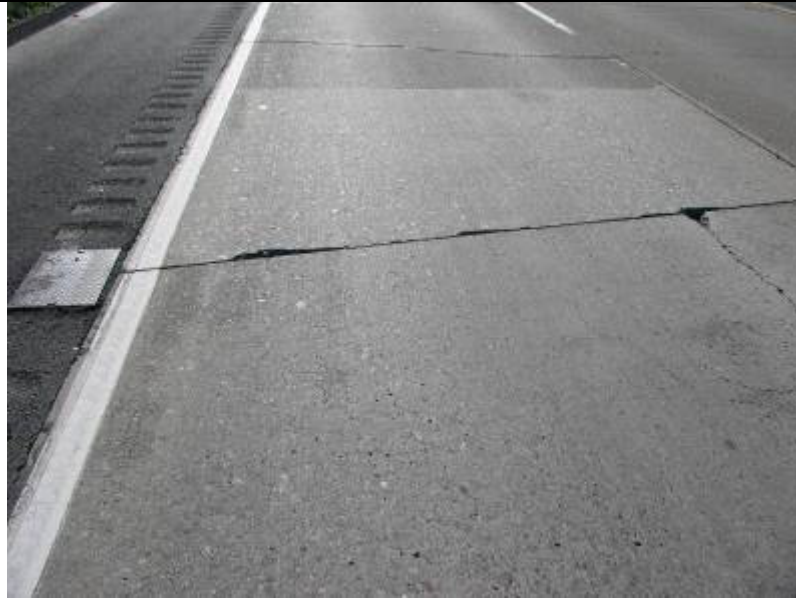
(a) General view

**Figure 11. Photographic set at Joint 44 (undowelled), Ukiah.**

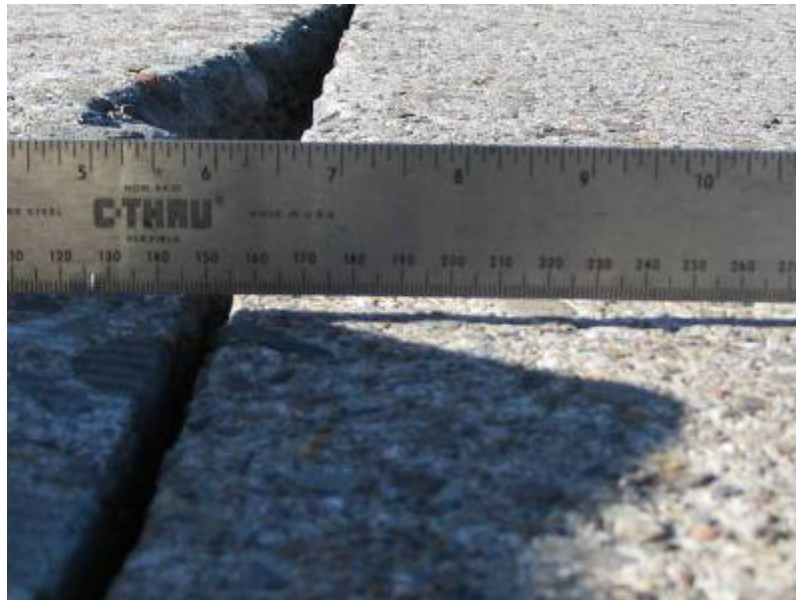
(b) Faulting

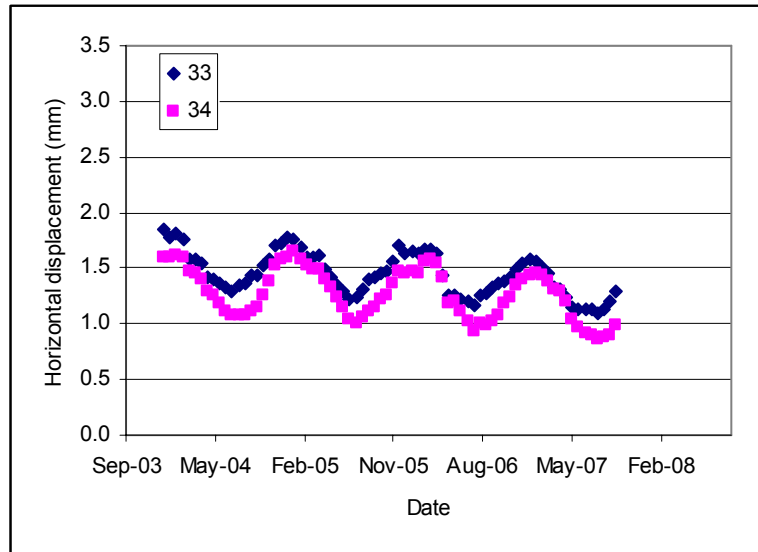
With regard to horizontal displacements, Figure 12 presents data from Joints 33 and 34, which show that they opened during periods of cold temperatures and closed during the summer months. This finding is important, as it indicates that the dowels are not preventing natural thermal movement and the joints are not locked. The seasonal opening/closing amounted to approximately 0.75 mm for an average joint opening of 1.5 mm, with a general trend toward closing for both joints.

**Figure 12. Long-term responses from the horizontal sensors in Joints 33 and 44, Ukiah.**

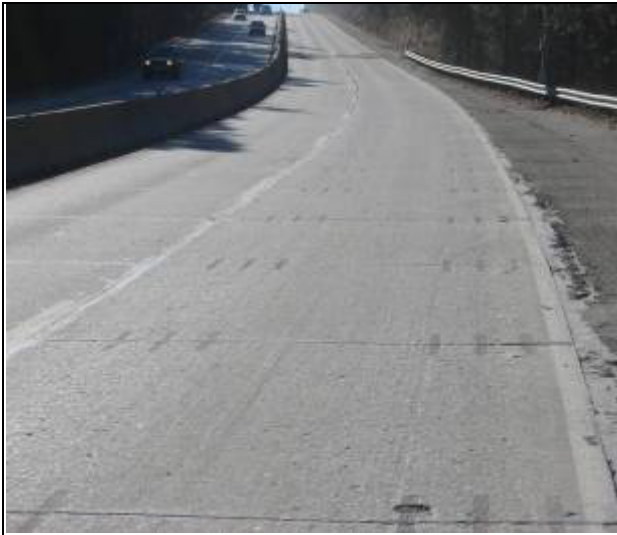
(a) General view

The site was visited again in January 2007 (eight years after DBR). The backfill material was still in good condition, with some higher levels of wear on the surface of the slots relative to the surrounding concrete, but without signs of debonding or the presence of loose material. Figure 14a shows a general view of the DBR area, clearly showing the three slots per wheelpath. Figure 14b and Figure 14c present the typical condition of the surface, the original texture from diamond grinding has been abraded.

**Figure 14. General and detailed pictures of the Colfax DBR site.**

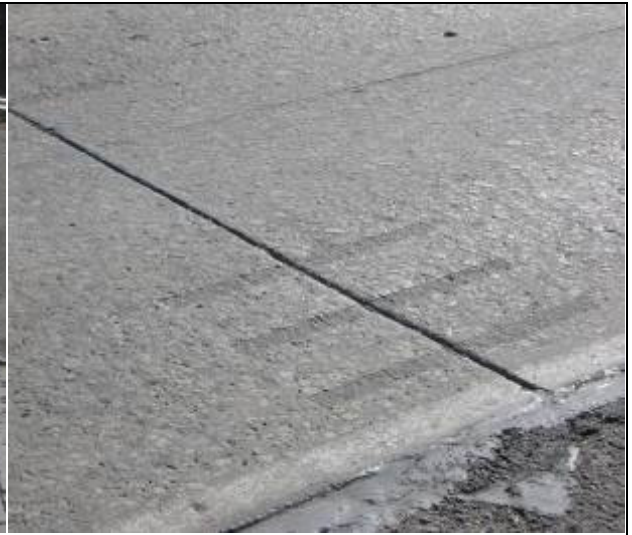
(b) Typical condition of backfill

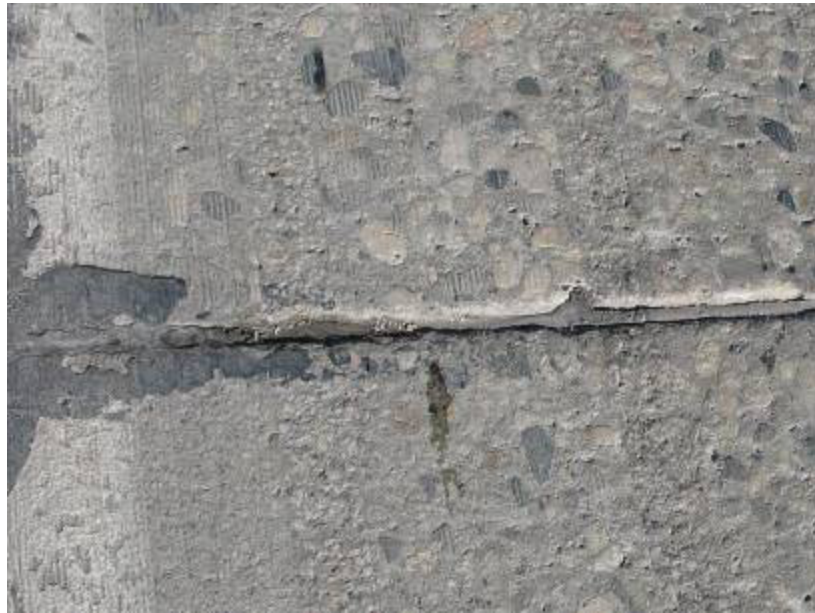
(c) Detailed view of surface condition

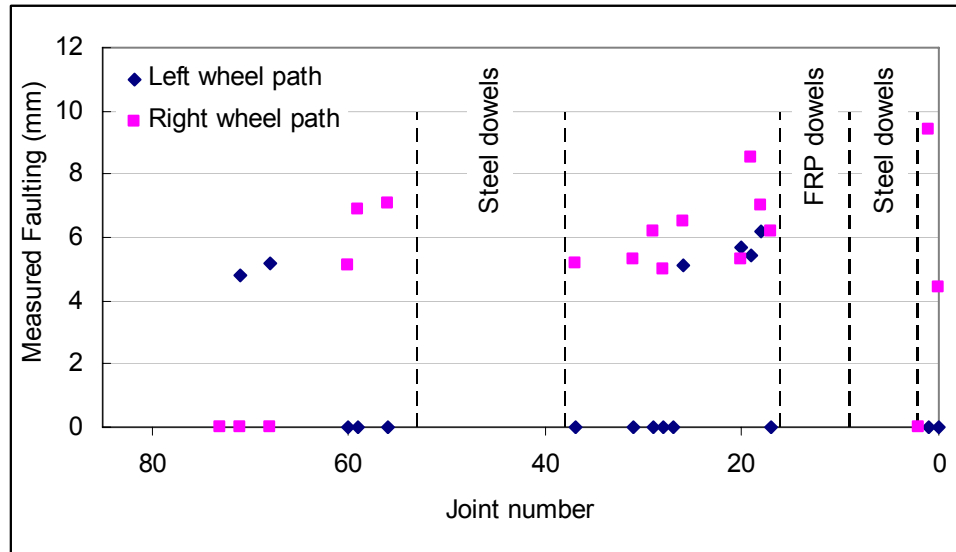
**Profile Measurements.** Longitudinal profile measurements were taken in January 2007. The automatic faulting detection feature in the profilometer software was used to calculate faulting and no faulting was reported for the retrofitted sections and up to nine millimeters of faulting was reported at the undowelled joints (Figure 15). Similarly, the roughness was lower on the retrofitted sections. The length of the various sections is insufficient to draw specific conclusions about roughness with respect to the different dowel bars used at the site.

**Figure 15. Faulting in Colfax DBR.**
