# **Fifteen Years Performance of a Concrete Pavement Rehabilitation Project in Canada**

Tom Kazmierowski<sup>1</sup> and Susanne Chan<sup>2</sup>

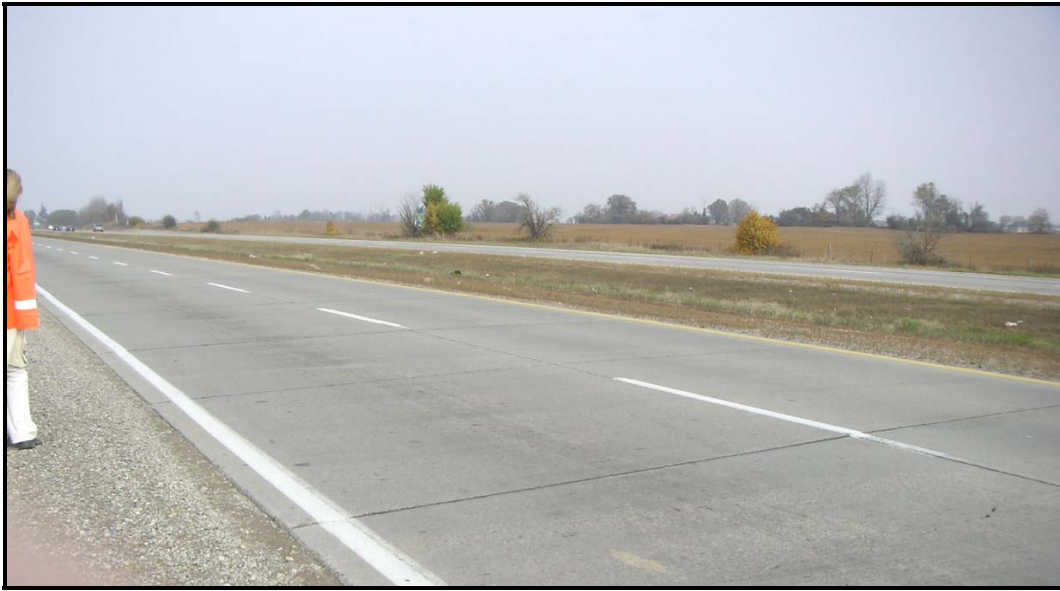
A recent survey of the southbound lanes in Fall 2004, after fifteen years, indicates the pavement is in good condition with a PCR of 70 in the driving lane, and 78 in the passing lane. Maintenance activities in southbound lanes consisting of routing and sealing of cracks and joints, as well as full depth and partial depth concrete repairs were carried out in 1997. There were a few moderate joint and crack spalling, localized slight faulting at the joints, and intermittent very severe pavement edge drop off. The longitudinal cracks identified earlier are now of moderate severity. In addition, a few severe reflection diagonal cracking and frequent moderate transverse cracks were identified. See Photo 1 below for the typical southbound lanes condition showing localized slight faulting at the joint.

**Photo 1.** Typical Unbonded Concrete Overlay Condition

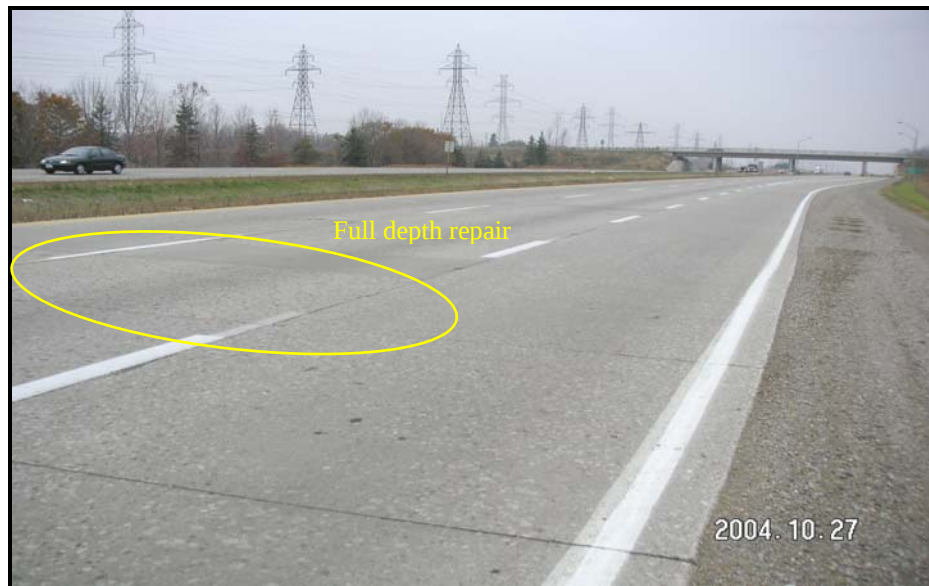
A recent survey of the northbound lanes in Fall 2004, after fifteen years, indicates the pavement is in fair to good condition, with a Pavement Condition Rating (PCR) of 63 in the driving lane, and 70 in the passing lane. Routing and sealing of cracks and joints, plus additional full depth and partial depth concrete repair was carried out in 1995 and early 2000. Most of the joints and cracks are performing well. There were a few moderate faulted joints and intermittent moderate joint and crack spalling. In addition, extensive severe pavement edge drop off was identified. See Photo 2 below showing the typical northbound lanes performance in 2004 adjacent to full depth repair.

**Photo 2.** Typical Northbound Lanes Pavement Condition

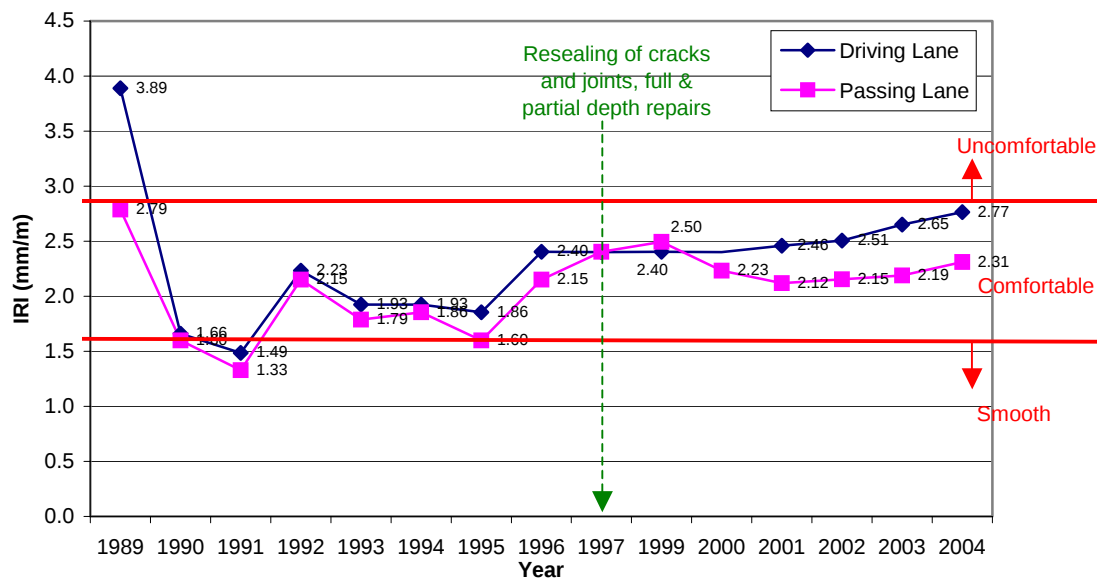
The IRI values between 1996 to 2000 appear elevated probably as a result of an erroneous transfer function used in converting PURD measurements into IRI values. The conversion was based on limited correlation data. The surveys from 2001 to 2004 indicates the roughness remained fairly constant over these years, with an average IRI of 2.60 and 2.19 for the driving and passing lane respectively. Overall, the southbound lanes are in the comfortable category, indicating that after 15 years, the unbonded concrete overlay is performing at an acceptable level, well within anticipated life cycle parameters.

**Figure 1.** Summary of IRI Values in Southbound Lanes.

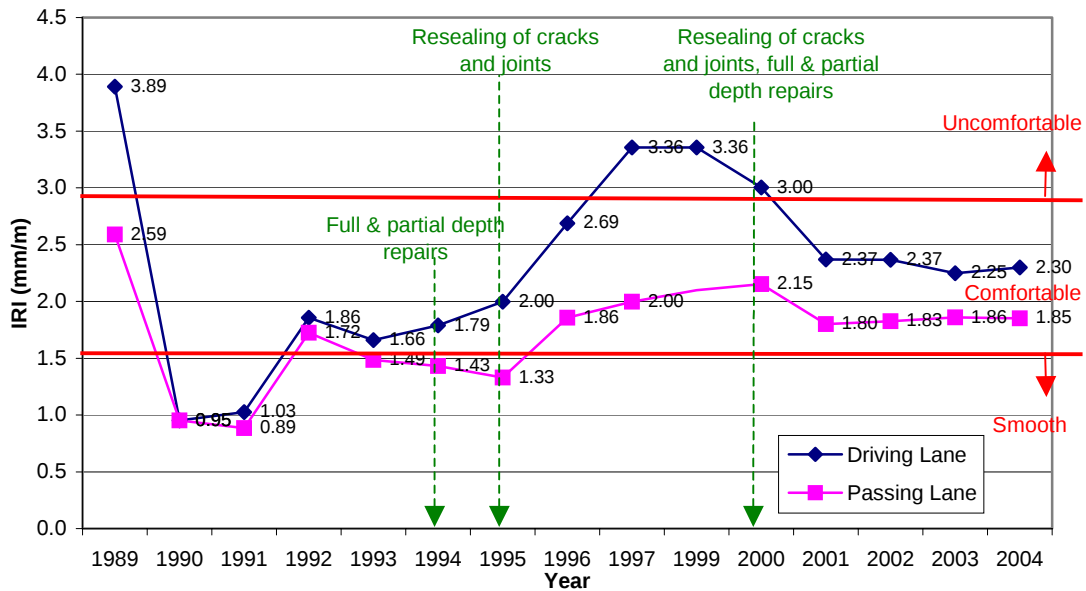
The ARAN surveys from 2001 to 2004 indicates the roughness remained constant over these years, with an average IRI of 2.32 and 1.83 for the driving and passing lane respectively. Overall, the northbound lanes rehabilitated using full CPR techniques are still performing within the comfortable category after 15 years of service.

**Figure 2.** Summary of IRI Values in Northbound Lanes.

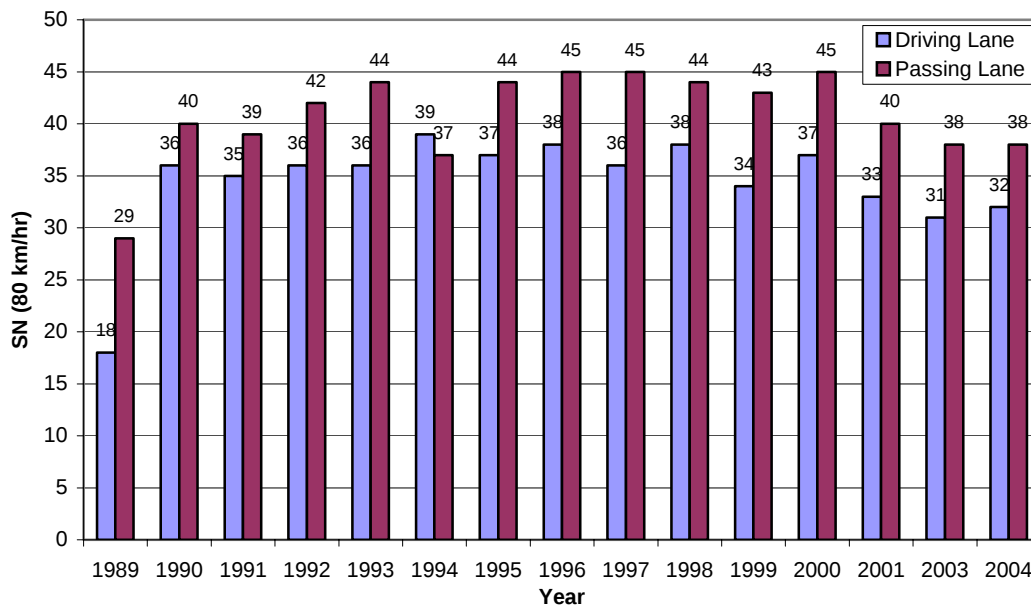
**Skid Testing on Southbound Lanes.** The skid numbers in the southbound lanes increased from SN 80 of 18 (driving lane) and 29 (passing lane) to an average SN 80 of 55 for both lanes immediately after the overlay in 1989. See Figure 3 for an annual summary of the skid resistance in the southbound lanes. The skid resistance has stayed fairly constant since construction with the driving lanes ranging from 31 to 39 (average of 34) and the passing lanes ranging from 37 to 45 (average of 41).

**Figure 3.** Annual Summary of Skid Resistance in Southbound Lanes.

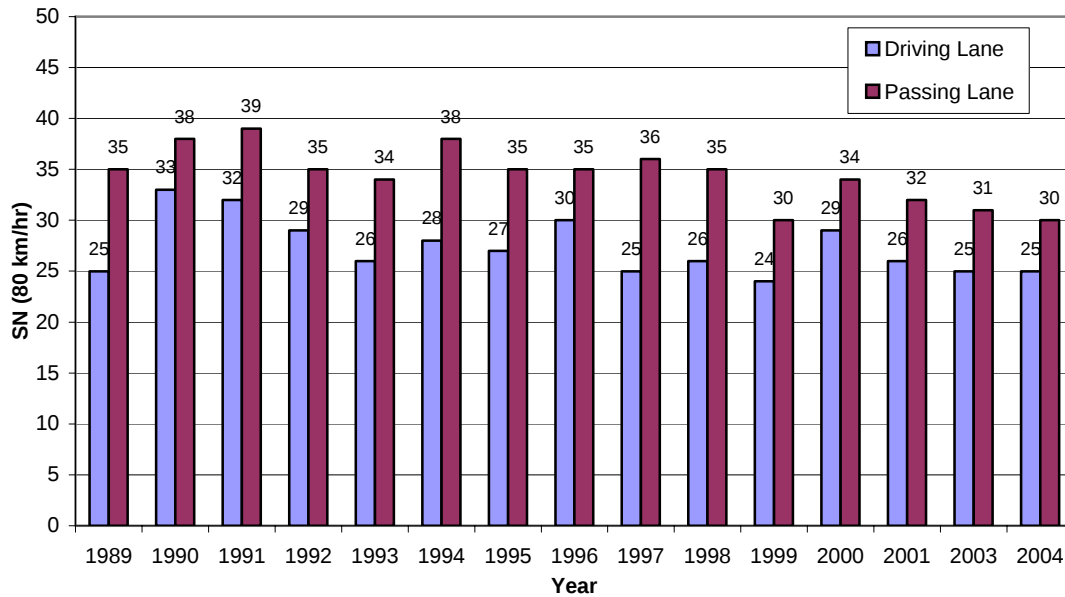
**Skid Testing on Northbound Lanes.** For the diamond ground surface on the northbound lanes, the skid numbers improved immediately after construction in 1989, from an average of 25 to 48 and 35 to 49 for the driving and passing lanes respectively. Skid numbers of this magnitude indicate a good friction factor and are similar to numbers obtained on premium hot mix surface courses in Ontario (Ryell et al. 1978). Over the last fifteen years, the skid resistance appears to be consistent in the range of 24 to 33 (average of 27) for driving lane, range of 30 to 39 (average of 35) for the passing lane, see Figure 4.

**Figure 4.** Summary of Skid Resistance in Northbound Lanes
