# **AN EVALUATION OF RETROFIT LOAD TRANSFER MATERIALS AND DOWEL BAR CONFIGURATIONS**

## **ABSTRACT**

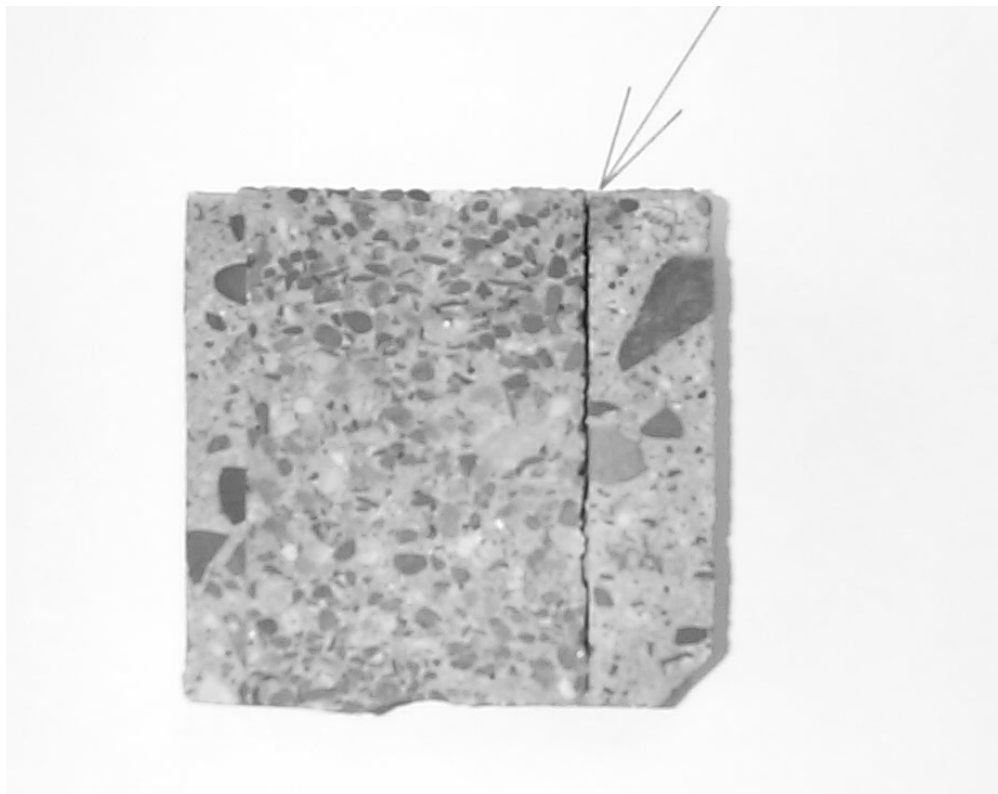
Subsequent coring of several of the slots and analyses of the cores showed that many of the slots suffered from a lack of bond between the repair material and either one or both vertical faces of the slots (see figure 5). The cores also showed that the repair materials were mainly bonding to the rough surface at the bottom of the slot that had been fractured off by the jackhammer. Both repair materials also exhibited a substantial amount of plastic shrinkage cracking, although it was more pronounced in the 3U18. Both materials also exhibited significant voids beneath the dowel bars. Several of the repairs also exhibited hairline cracks radiating from the caps on the ends of the dowel bars that appeared to be caused by shear forces. [4]

It was hypothesized that the lack of bond between the repair material and the slots was caused by excess water in the patching material, causing excessive shrinkage of the patches. The voids beneath the dowel bars and chairs also appeared to be caused by the presence of excess water that coalesced under the bars instead of bleeding to the surface of the patch. This theory is supported by a lack of aggregate in the repair material adjacent to these voids, indicating a high water content (see figure 6).

It was also thought there might have been insufficient sandblasting of the slots to completely remove the slurry left behind by the wet saws during the removal process. It was also possible that the smooth vertical face that results from using saws didn't provide an adequate surface for

the repair material to bond to, suggesting that much more aggressive sandblasting would be useful in any future work of this type.

Figure 5. Typical Debonded Vertical Face

- 2) Extraordinary effort should be made in to insure that all faces of the removal area are thoroughly cleaned and abraded (by sandblasting or other effective means) to assure the best possible bond between the repair material and the pavement.

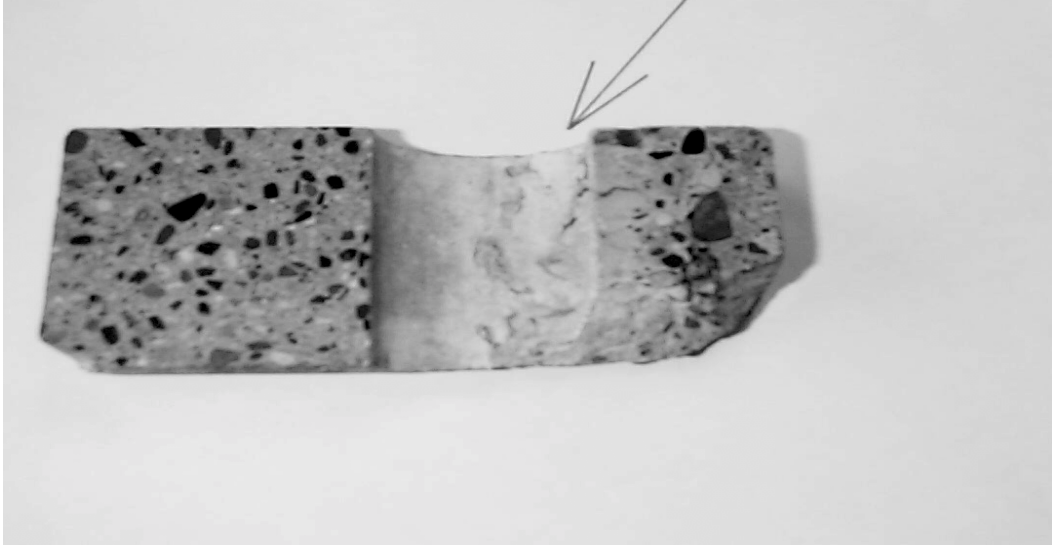
Figure 6. Example of Voids in Mortar Around Dowel Bar

- 1) The water content of any repair material used to backfill retrofit dowel bar slots should be carefully controlled and the amount used should be the minimum necessary to allow for the proper placement of the material in order to reduce the probability of shrinkage cracks and debonding.

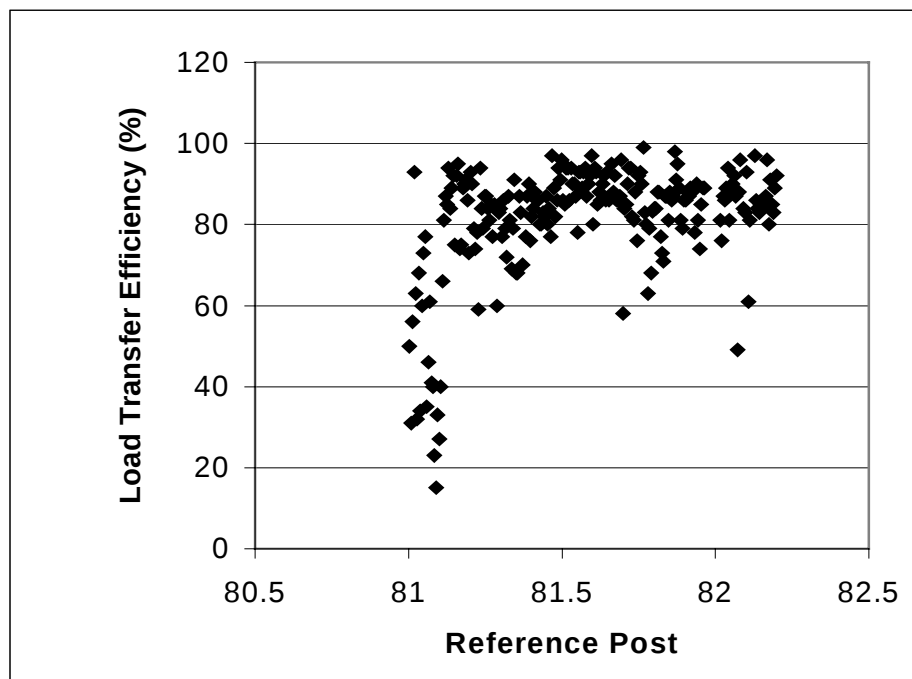
The LTE of the right lane test sections was measured again in October of 2000 using an FWD (see figure 9); the average had remained 85% with few crack LTE values below 80%. The majority of the cracks with LTE values below 80% were formed after the time the retrofit

installation was performed and therefore had no dowels inserted. The pavement surface temperature at the time of testing was between 3°C and 16°C.

The most noteworthy difference is the change with time in the LTE of the control section. The control section had an LTE of 88% in September 1994 with a few crack LTE values measured below 50%. By October 2000 the average LTE of the control section had dropped to 48% with only one crack remaining above 80% and half the cracks being below 50%.

Figure 9. Retrofit Dowel Load Transfer Efficiency, 10/30/2000 (Right Lane, Right Wheel Path)

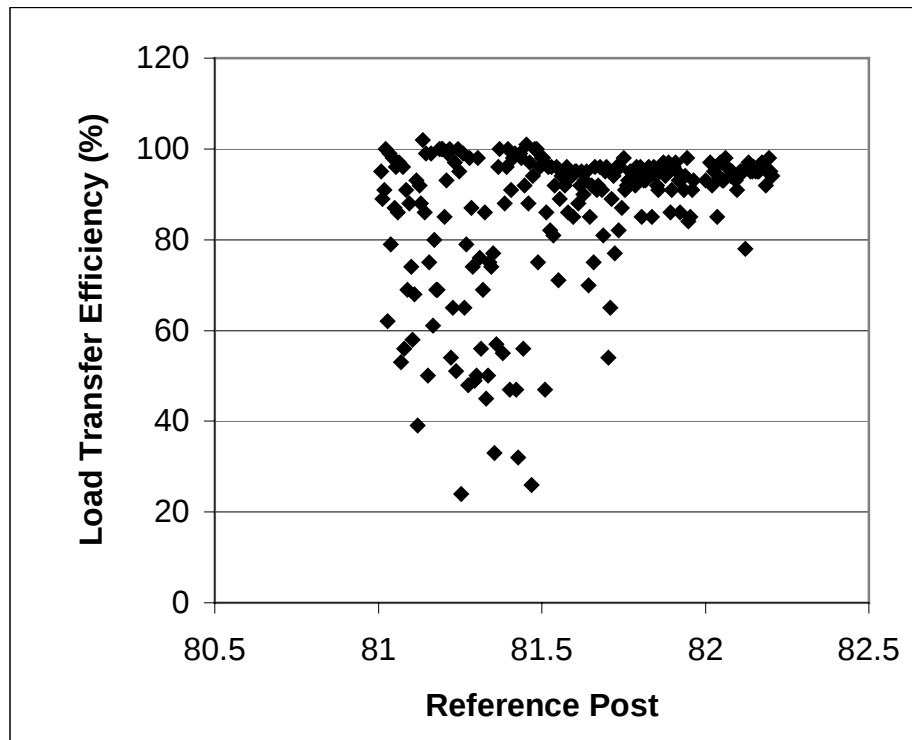
Load transfer efficiencies were measured on the cracks in the left lane on May 23, 2001 (see figure 10). The measurements were taken during a mild rainstorm that kept the pavement temperature between 10°C and 15°C. A comparison of the retrofit dowel test sections 4A, 4B, 5A and 5B shows that there is no significant difference in the LTE of any of the sections (see figure 11). All of the dowel configurations show LTEs between 92 and 95%, or slightly higher LTEs than the comparable test sections in the right lane, as could be expected due to the significantly lower traffic the left lane has seen.

Also noteworthy is the relatively high LTE of the undoweled sections, control and 1A-3B. The LTEs of these sections range between 73-91%, which is significantly higher than the undoweled right lane control section value of 48%. The LTEs in the left lane are comparable to or higher than the LTEs measured in the right lane in 1994, prior to the dowel retrofitting procedure. This supports the work of Vandenbossche [6], which showed that the load-induced fatigue was a primary contributor to the failure of the temperature steel in JRC.

Figure 10. Retrofit Dowel Load Transfer Efficiency, 5/23/2001 (Right Lane, Right Wheel Path)

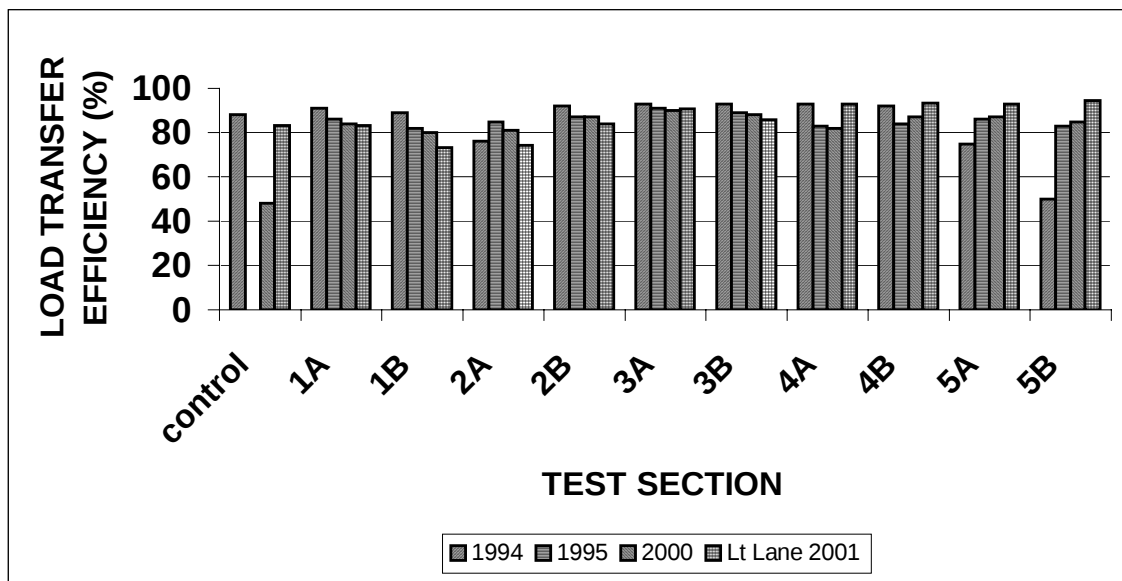
A comparison of the different dowel bar configurations shows no significant difference exists in the LTE of any of the test sections after 6 years of traffic (Figure 11). All of the test sections had average LTE's above 80% and 6 of the 10 were at 85% or above and are summarized in Table 2. The average LTE of the right lane, right wheel path dropped from 85.6% to 85.1% during this time period. All of the test sections had approximately the same loss in LTE with time, losing only an average of 0.5% in 5 years. Test section 2A had the greatest loss of 4%. This test section also had one of poorest LTE's prior to the dowel bar retrofits being installed. Test section 4B showed a gain in LTE of 3% between 1995 and 2000. This increase may be due to the higher pavement temperature during testing in 2000 relative to 1995.

A comparison of difference in performance between the 380mm and 457mm long dowel bars shows that the sections with the shorter bars lost an average of 1.4% LTE between 1995 and 2000, while the sections with the 457mm length bars gained 0.4% during that same period.

Figure 11. Retrofit Dowel Load Transfer Efficiency By Test Section

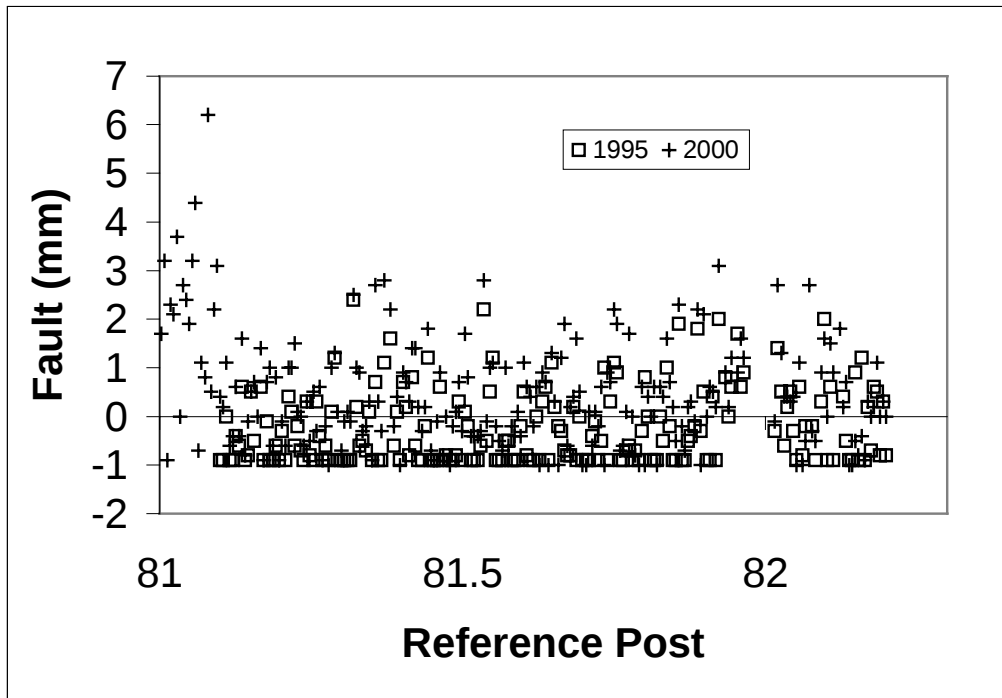
Faulting measurements were obtained from the outer wheel path of the right lane during September 1994, November 1995 and October 2000 using a Georgia Faultmeter (see figure 12). Unfortunately, it was not possible to accurately determine which measurement went with which crack for the 1994 data, so it was not used for this analysis.

Figure 12. Summary of Test Section Faulting Measurements

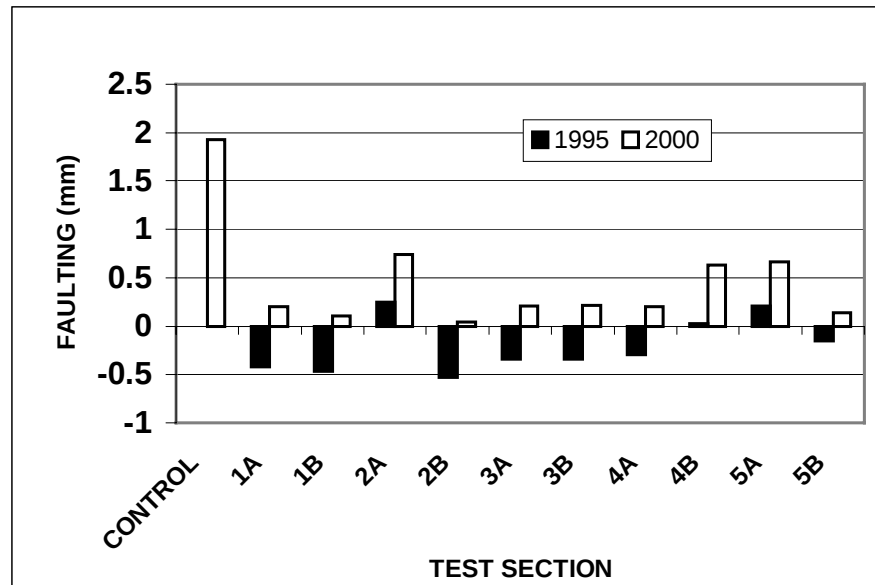
Figure 13 shows a summary of the average faulting measurements for each test section and the difference between the averages measured in 1995 and 2000. It can be seen that several of the test sections had negative faulting in 1995 and that none of the sections had an absolute average fault measurement greater than 0.53mm (test section 2B, -0.53mm). By October 2000 all of the test sections had seen an increase in faulting, with an average increase for each test section of 0.52mm. Test section 2A showing the greatest average faulting measurement of 0.75mm, and test section 5B had the lowest with 0.30mm. The control section had an average faulting measurement of 1.92 mm in 2000. The control section faulting was not measured in 1995 so a comparison cannot be made. However, the faulting in the control section is significantly greater than that of all of the test sections, which indicates that the retrofit dowels do reduce faulting.

Figure 13. Change in Test Section Faulting Averages over Time

- 7) Retrofit load transfer reduced the increase in faulting by a substantial amount over doing nothing. However, the poor ride that existed prior to the retrofit was maintained afterwards, which strongly suggests that poor riding pavements should be diamond ground after the load transfer is established.

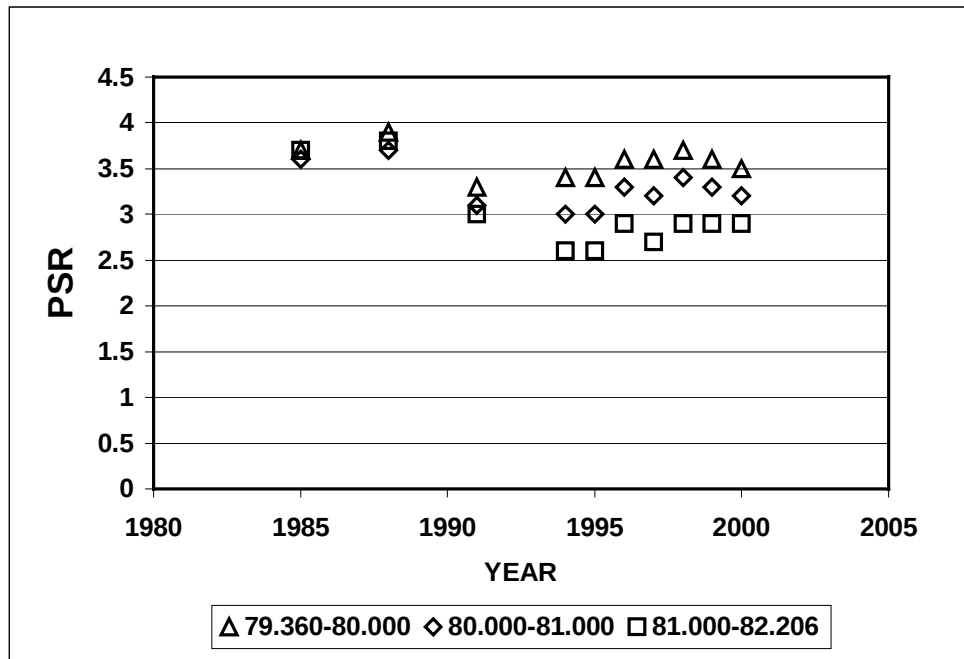
When this section of US 52 was originally constructed in 1994, it had a PSR of 3.7 which was typical for a new concrete pavement built in Minnesota at that time. Figure 14 shows the PSR for the pavement from 1985 through 2000, broken down into three segments. By 1994 the ride for the first two segments, RP 79.360 and 80.000 and RP 80.000 and 81.000, was substantially better than that of the segment between RP 81.000 and 82.206. This was due in large part to the relatively low number of uncracked panels in the first two segments, less than 10%, compared to the third segment which had over 95% cracked panels. The ride was measured again in 1995, after the retrofit load transfer was installed, and every year thereafter. The figure shows that the ride for all sections increased in 1996, most likely due to changes in the measuring equipment, and has remained relatively constant in each segment since then. It is unlikely that the 0.2km between RP 81.030 and 81.110, which was undoweled and had a larger amount of faulting, contributed negatively to the overall ride measurement of the third segment because of its short length relative to the entire segment.

Figure 14. US52 Retrofit Dowel Test Sections Control Section Ride by Mile
