# Performance of Bonded CRCP Overlay in Texas

Pangil Choi, Ph.D.<sup>1</sup> and Moon Won, P.E., Ph.D.<sup>2</sup>

In this paper, three BCO projects that have significance in terms of performance and technical development are presented. They are 4-in BCO on Loop 610 North in the Houston District, 7-in CRCP BCO on US 75 in the Paris District, and 4-in CRCP BCO on US 287 in the Wichita Falls District.

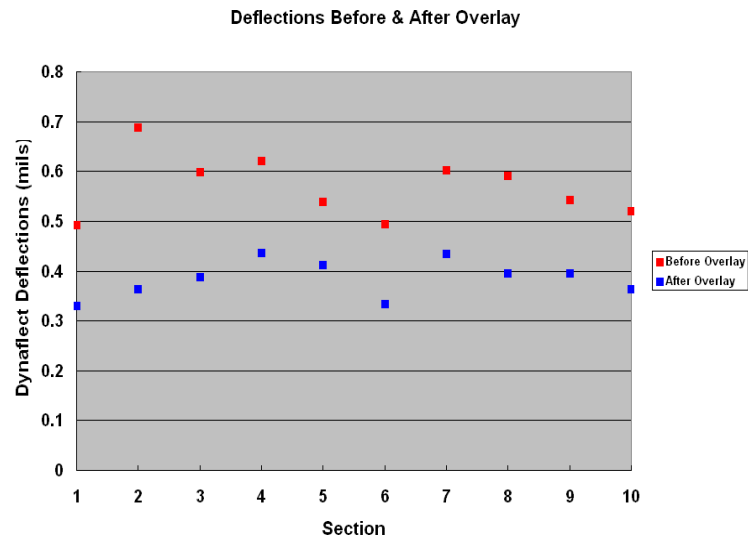
Figure 1 Deflections before and after overlay

The structural condition of the pavement was evaluated by deflection measurements with a Dynaflect. Deflection testing was conducted before and after BCO. Figure 1 shows the testing results, which indicates 4-in BCO reduced deflections by about 40 percent. This information illustrates the capability of BCO in enhancing the structural capacity of the under-designed PCC pavement.

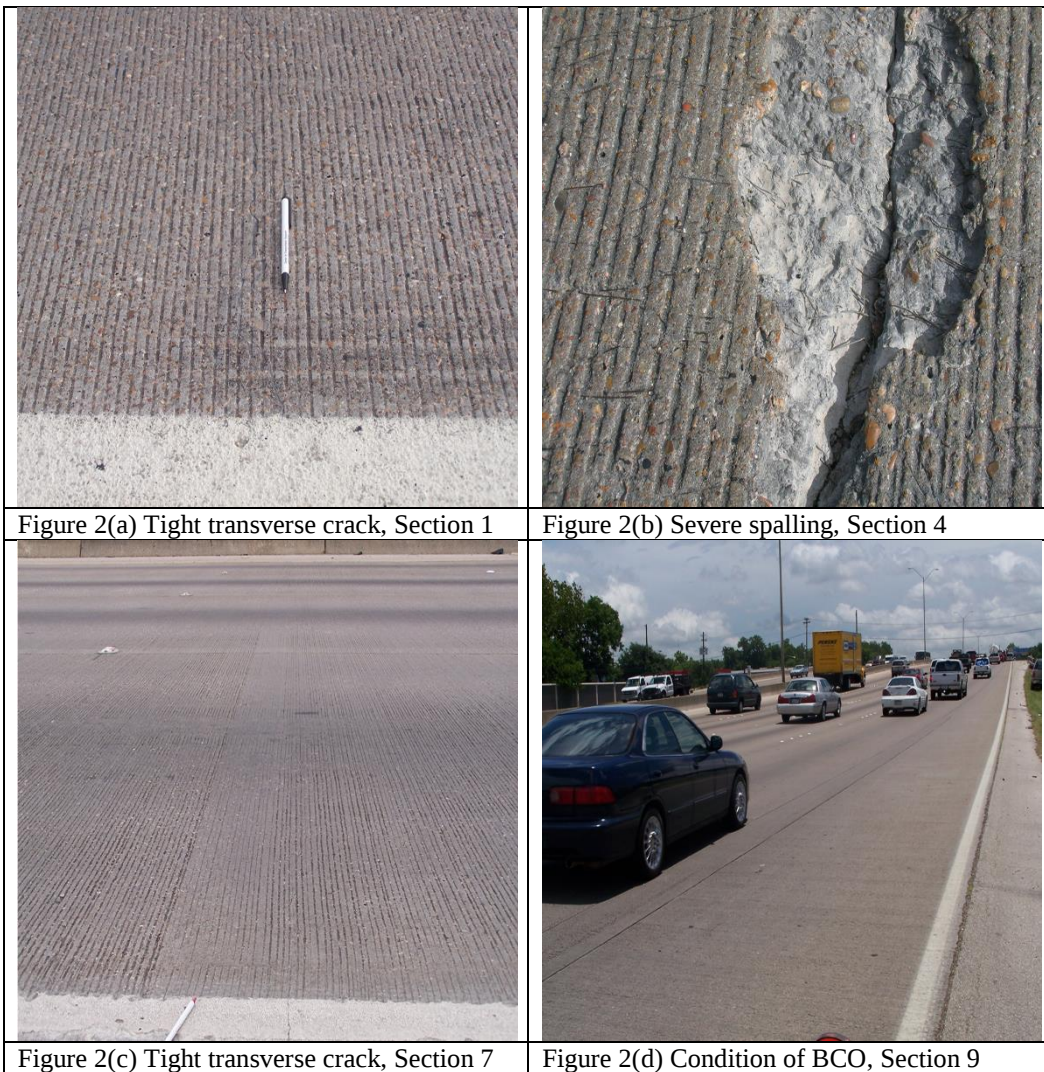
Figure 2(a) shows the condition of the pavement in Section 1, which shows quite tight transverse crack. As indicated in Table 1, WWF was used in this Section with SRG as coarse aggregate. Figure 2(b) illustrates severe spalling in Section 4, where fiber and SRG were used. It shows that fiber was not able to prevent severe spalling. Figure 2(c) shows excellent condition of BCO in Section 7, where WWF and LS were used. Both Sections 4 and 7 were in “severe” distress level prior to BCO; however, the selection of materials – as a reinforcement and coarse aggregate in concrete – appears to have substantial effects on BCO performance. Figure 2(d) shows a typical condition of Section 9. The combination of SRG and WWF provided excellent performance even when the existing condition was in “severe” distress level.

Overall, the performance of this section has been excellent, with very few distresses observed after more than 20 years of service. The section was removed

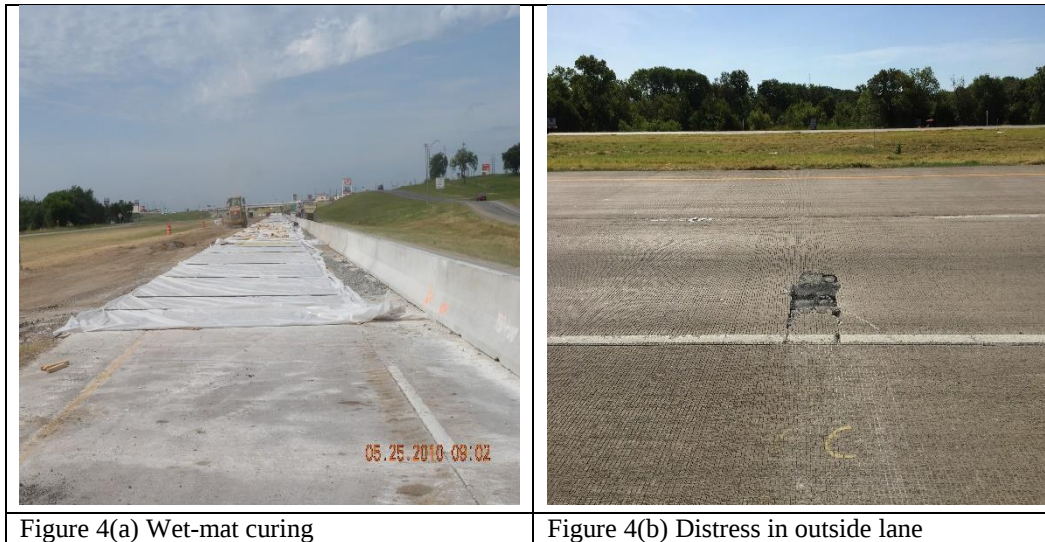
The performance of this project varied. The performance of inside lane has been perfect, with no single distress. However, distresses developed in the outside lane, at the locations of transverse joints, as shown in Figure 4(b). As of August 13, 2015, distresses occurred at a total 24 locations, all in transverse contraction joints

in the existing JCP. Truck traffic in this section is quite heavy, and it appears that heavy truck traffic caused large deflections in the BCO system, inducing separations of overlay from JCP, and resulting distresses. 24 distresses out of 140 total joints in this section represent 17 percent of joints. In other words, BCO at 83 percent of joints survived under heavy truck traffic loading for more than 5 years. It appears that the CRCP BCO system on deteriorated JCP could work with minor adjustments in design, as long as joint deflections in the existing JCP are not excessive. Further performance evaluations in this section need to be conducted to establish a threshold value for joint deflections for CRCP BCO on JCP.

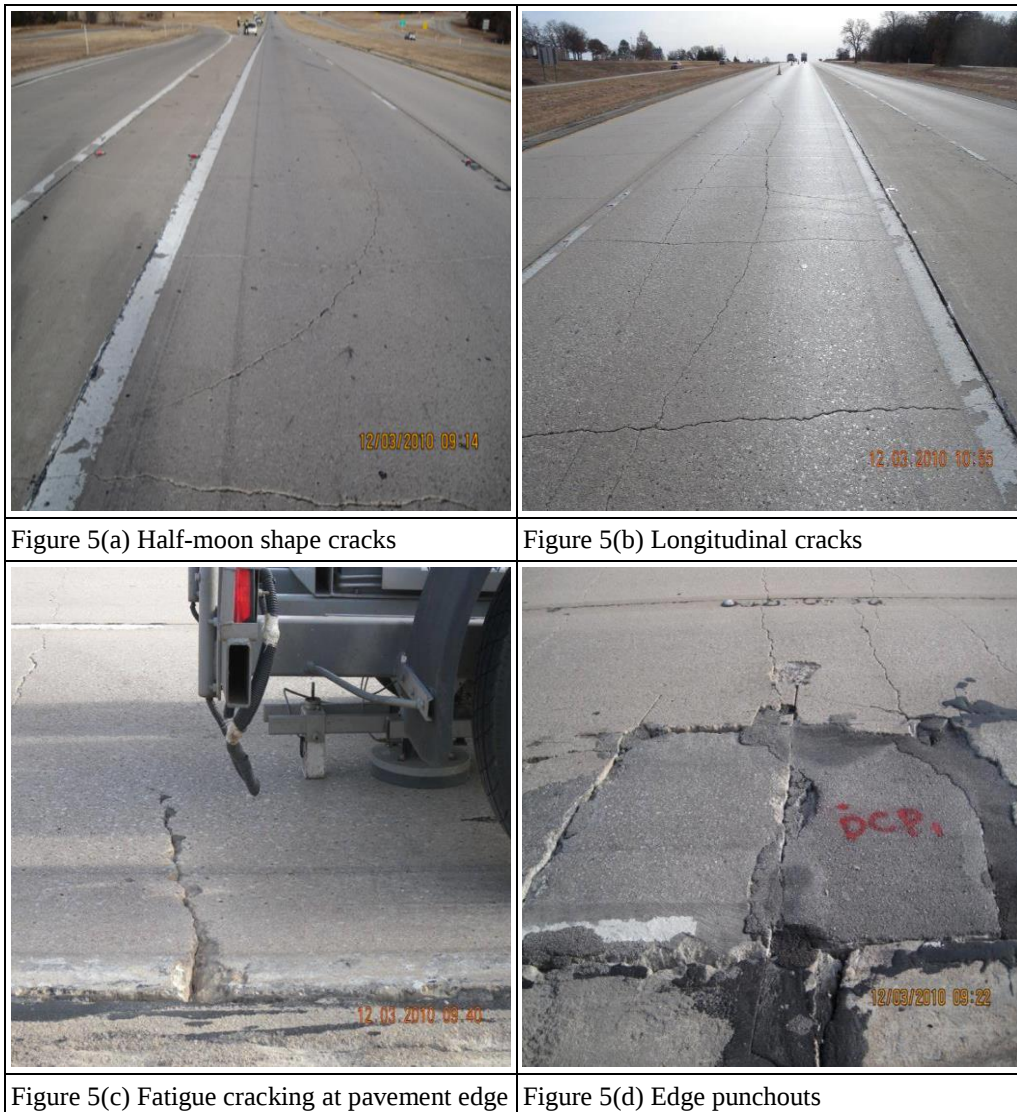
8-in CRCP was constructed in 1972 on US 287 in the Wichita Falls District. By late 2000s, distresses were observed in the form of punchouts. Figure 5 shows a condition of the existing CRCP in this section. Evidence for poor pavement support, as shown in Figure 5(a), (b), and (c) and resulting edge punchout as shown in Figure 5(d), was observed in a number of places. In 2012, a decision was made to rehabilitate this section. Two alternatives were considered: one was asphalt overlay and the other CRCP BCO. Life cycle cost analysis was conducted, and based on the analysis result, CRCP BCO was selected. The thickness design was performed in accordance with the AASHTO method. Based on the design inputs, 4-in slab thickness was selected. For the evaluation of the condition of existing CRCP, FWD testing was conducted at a selected 1000-ft long section.

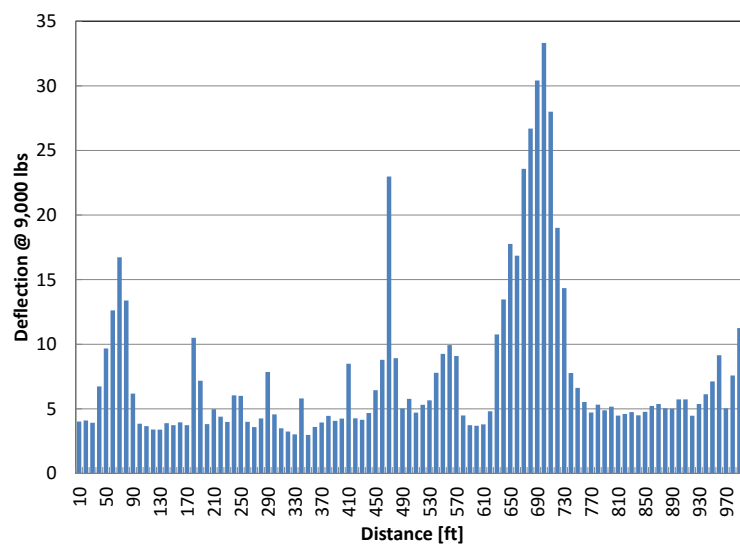
Figure 6 Deflection at 9,000 lbs

Figure 6 shows deflections at 9,000 lbs from FWD testing. Localized large deflections were observed at several locations due to poor slab support condition. Evidence for pumping was also observed during the field survey, which indicated possible loss of base materials. Texas statewide average deflection for 8-in CRCP is 3.6 mils according to the TxDOT rigid pavement database project (Choi et al. 2013). However, in the section evaluated with FWD, there are a number of locations with much larger than the average deflection of 3.6 mils, an indication of poor slab support at those locations.

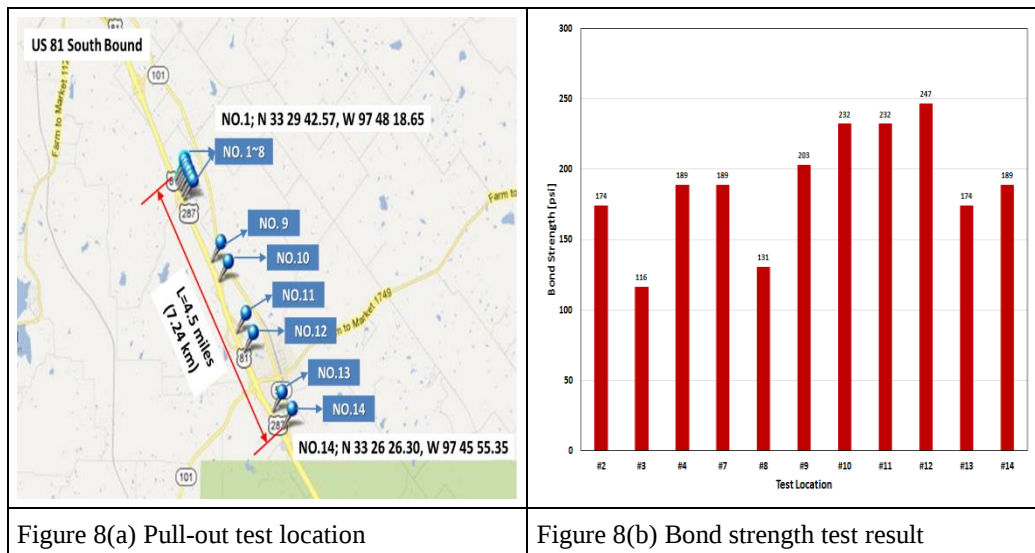
Figure 8(a) shows the test locations for the bond strength test. Figure 8(b) illustrates the bond strength test result. Among the testing at 14 locations, concrete was broken at 2 locations and concrete was broken at the interface at one location during coring. Test results illustrate that the bond strengths are larger than 150 psi at 9 out of 11 locations, which is an indication of quality construction.

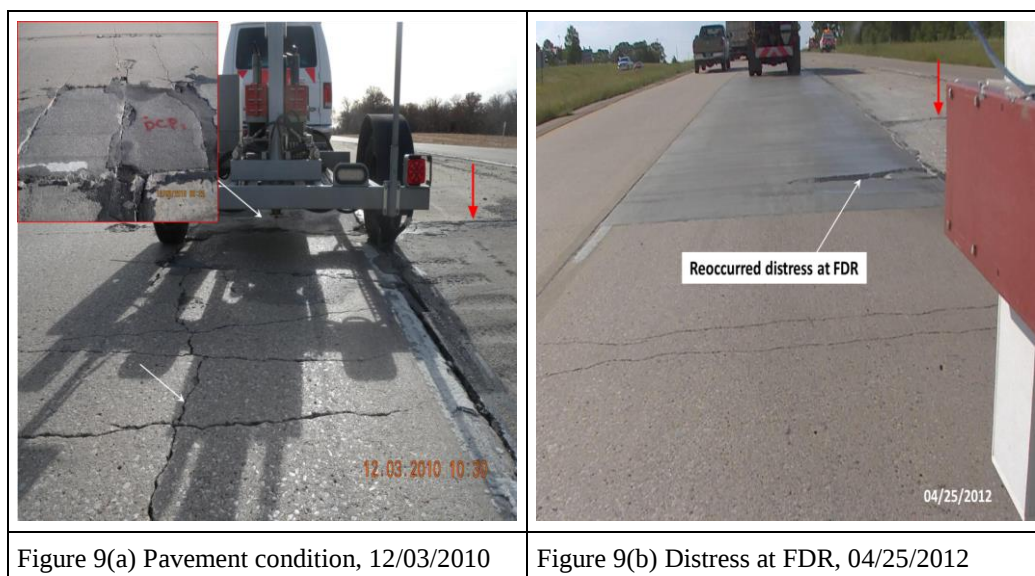
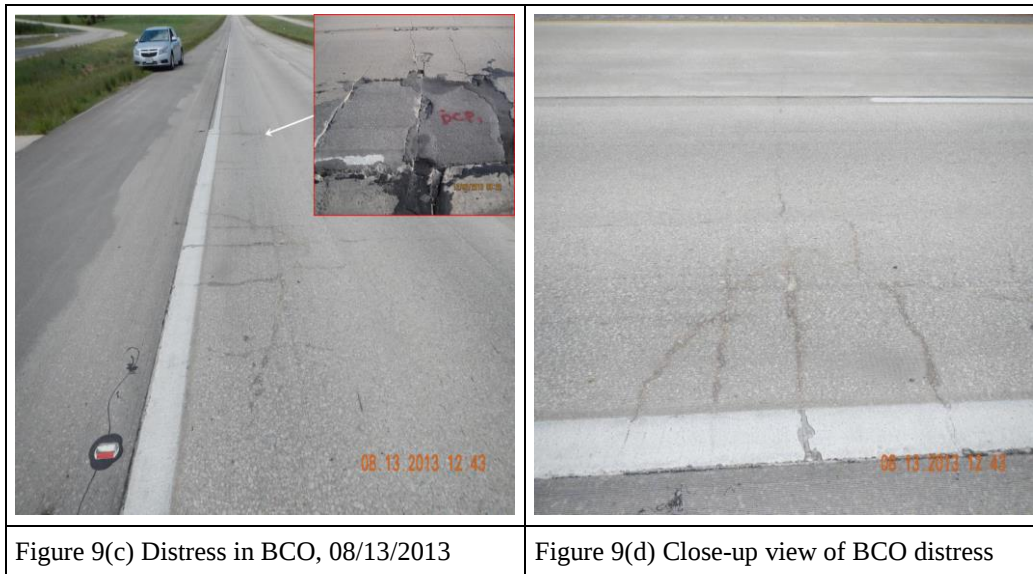
Figure 9(c) Distress in BCO, 08/13/2013

Figure 9 shows an example of pavement condition before and after the BCO in the full-depth repair (FDR) area. The FDR was done prior to BCO as shown in Figure 9(b) to address longitudinal cracks and large deflections in the location shown in Figure 9(a). However, distress occurred again in the FDR section before the BCO construction as shown in Figure 9(b). This location includes all types of distress and mechanism in CRCP - edge punchouts, longitudinal crack due to a poor base support, and pumping at the longitudinal joint. Figure 9(c) shows reflected cracks in BCO at the location of distresses in the existing pavement. Figure 9(d) is a close-up view of distress in the BCO. The edge punchouts in the old CRCP seem to be reflected through in the newly constructed BCO slab. This strongly indicates the need for sound repairs of CRCP distresses prior to BCO placement.

Figure 9(d) Close-up view of BCO distress

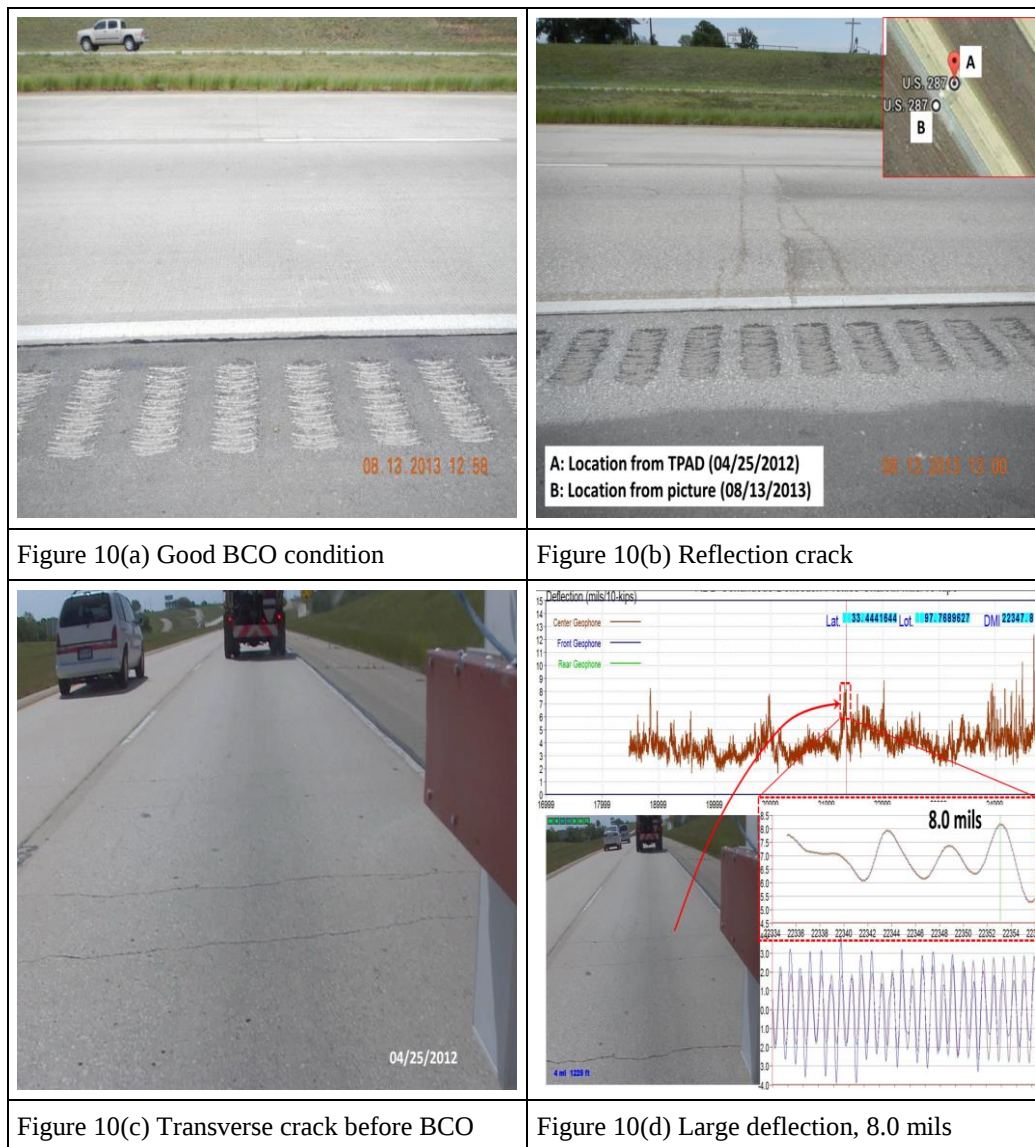
Figure 10(a) illustrates well performing BCO area, with no wide or meandering cracks. Figure 10(b) shows reflected cracking from the existing CRCP. In this area, the overall deflection was measured at lower than 7.0 mils at 10,000 lbs and resulting in good BCO. However, at a location of the reflection cracking, deflection measured prior to BCO was larger than other nearby areas, with about 8 mils at 10,000 lbs. Figures 10(c) and (d) show captured picture from TPAD video image and the measured TPAD deflection. Both GPS coordinates in TPAD image and surveyed picture were nearly identical, which means the reflective cracking was at the location of the larger deflection. Although the pavement condition shown in Figure 10(b) is not classified as a distress at the time the picture was taken, there is a high potential for further deterioration. The fundamental mechanisms leading to the development of reflective cracking are differential movements from the supporting pavement structure in asphalt concrete overlay over JCP (Chen et al. 2007). On the other hand, movement of transverse crack in CRCP is negligible when the base support condition is adequate. Accordingly, the transverse crack behavior in CRCP is completely different from that of contraction joint in JCP. However, the pavement survey result shows that once the base support condition is degraded, reflection cracks might develop in BCO. The condition of this BCO project deteriorated at a number of locations. There was a good correlation between deflection level in the existing CRCP and distresses in BCO. Unfortunately, the area and the rate of deterioration in BCO became excessive and a decision was made to overlay with asphalt for entire 5-mile project. Even though bond strength was quite adequate in this project with good quality construction, poor slab support in the existing pavement resulted in larger deflections and distresses in BCO. The performance of BCO in this section indicates that a threshold value for deflections should be developed and applied when BCO is considered as a rehabilitation method of CRCP.
