# **Failure Modes in Unbonded Concrete Overlays**

Kevin Alland, Julie Vandenbossche, Steven Sachs, John DeSantis, Thomas Burnham and Lev Khazanovich

## **Abstract**

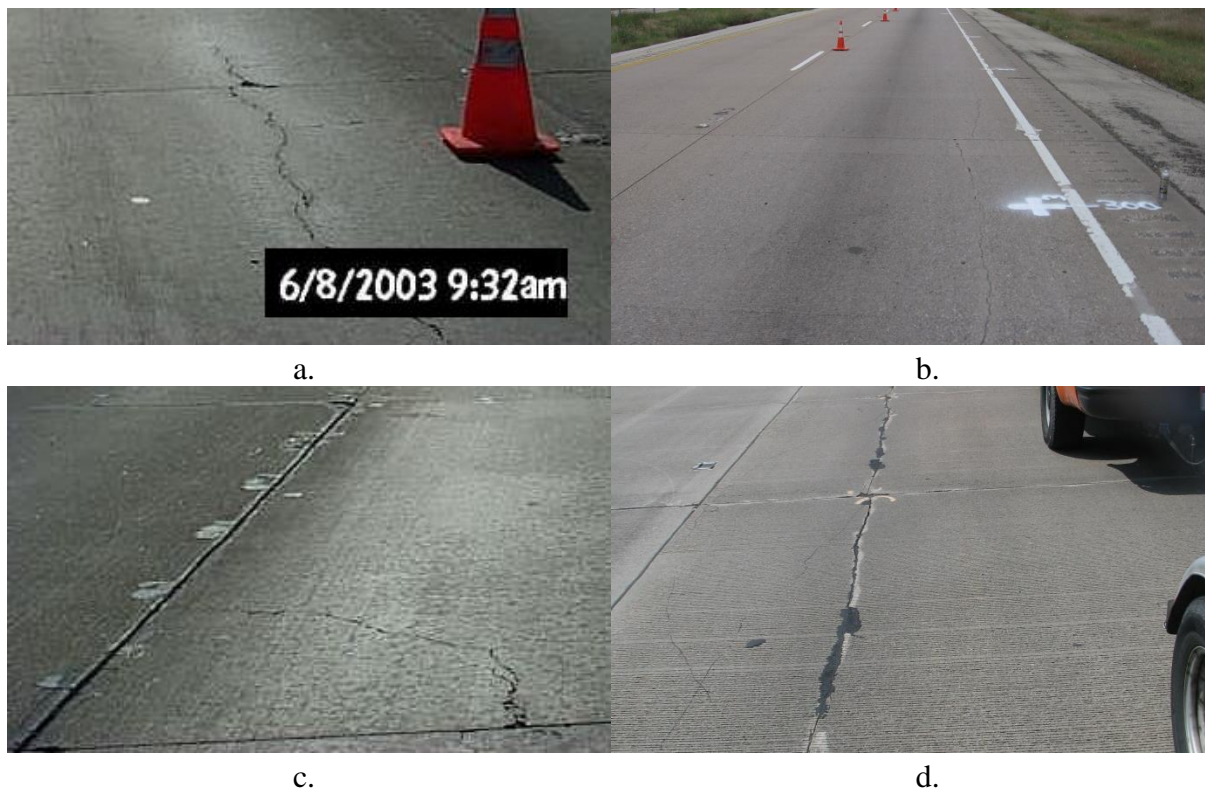
The high stress contributing to the initiation of this crack can be the result of a void or gap in the interlayer beneath the overlay. A void can form beneath the slab in the wheelpath in several ways. Consolidation in the HMA interlayer may occur in the wheelpath at the joint. Also, a portion of the interlayer may be pumped from beneath the joint resulting in faulting on the approach side of the joint and a void on the leave side of the joint. Finally, less stable interlayer systems, such as an open graded asphalt mix or a dense graded HMA where localized stripping has occurred in the vicinity of the transverse joint, may also fatigue and breakdown in the wheelpath. These can all lead to loss of support in the wheelpath starting at the joint, and eventually propagating the full length of the slab. When a wheel load is applied over this area, the slab must bridge this loss of support region, creating stress at the bottom of the slab and eventually bottom-up cracking in the wheelpath. This mechanism can be seen in Figure 1. Bonded Concrete Overlays of Asphalt (BCOA) with 1.8x1.8 m panels experience a similar distress mechanism (Li and Vandenbossche 2013).

Longitudinal cracks were the primary distress mechanism observed in the UBOLs included in the LTPP database and in Michigan. They occur in 11 of the 13 JPCP LTPP sections, and in all of the Michigan sections reviewed. The undoweled sections in the LTPP database, which experience significant faulting of the transverse joints have developed more longitudinal cracks in the wheelpath than the doweled sections where faulting did not develop. However, it is worth noting the doweled sections in the LTPP GPS-9 were thicker than the

**Figure 2: a. Longitudinal Crack in Inside Wheelpath LTPP Section 06-9049, CA (Photo from Infopave.com), b. Longitudinal Crack in Outside Wheelpath LTPP Section 48-9167, TX (Photo from Infopave.com), c. Diagonal Crack Propagating to Adjacent Longitudinal Joint LTPP Section 06-9049, CA (Photo from Infopave.com), d. Longitudinal Cracks In Inside Wheelpath I-96 Near Walker, Michigan (Photo Courtesy of Andrew Bennett, Michigan Department of Transportation)**

There are several ways to mitigate this distress mechanism. Increasing the thickness of the concrete overlay will decrease the stress on the interlayer, and therefore decrease the risk of degradation and/or consolidation. Reducing differential deflections and minimize pumping by using load transfer devices will also be helpful. Finally, using an interlayer system which is not prone to consolidation or stripping, will help minimize this distress as well.

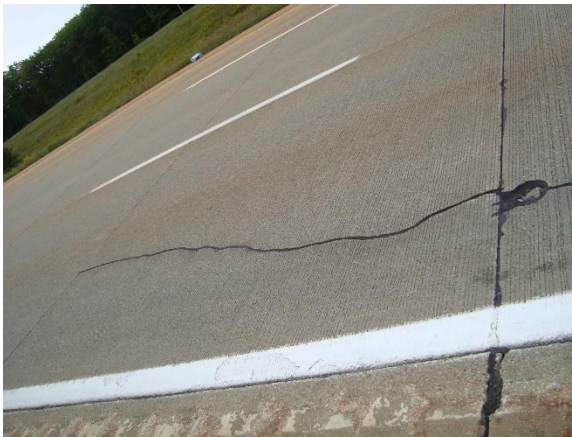
A survey of Michigan UBOLs found these cracks often occurred in clusters, when proper drainage was not provided. MDOT has identified proper drainage as a crucial aspect necessary for good performing UBOLs. Without a means of escaping, water can become trapped along the interlayer. Figure 4 shows a random longitudinal crack on I-75 near West Branch, Michigan.

**Figure 4: Random Longitudinal Crack, I-75 West Branch, Michigan**

Careful attention to pavement drainage details are important for preventing random longitudinal cracking. A clear path must exist for any water entering the pavement to reach the drainage system. Proper maintenance of the drains and outlets is extremely important for these structures as well. The backup of water from a clogged drain can quickly strip and erode the interlayer. Drainable interlayers such as open graded asphalt or non-woven geotextile fabric will only improve drainage characteristics if there is a suitable method for removing the water from away from the pavement structure.

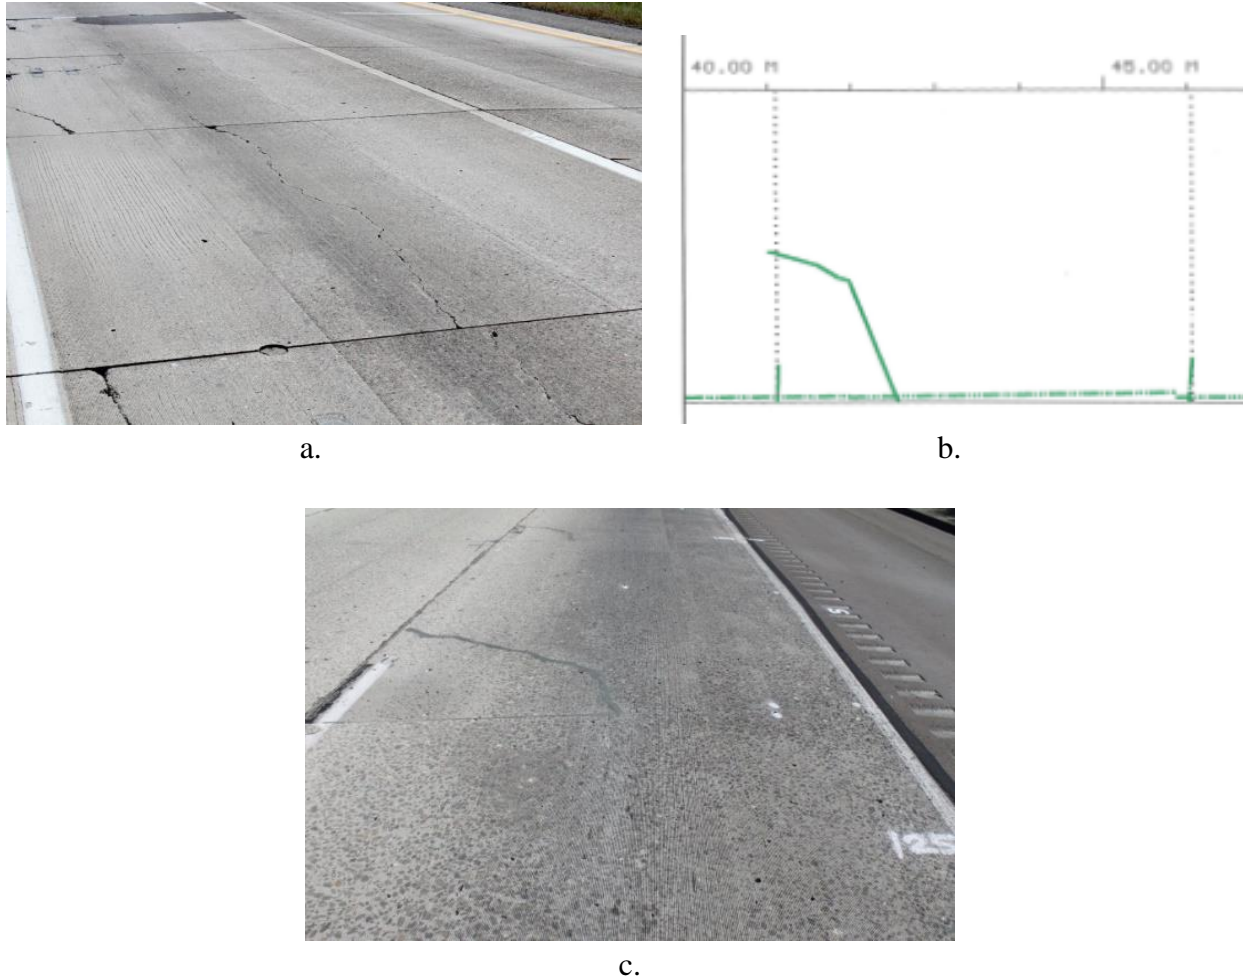
Mid-slab longitudinal cracks developed in MnROAD Cells 305 and 405, LTPP Sections 06-9048 and 06-9049 in California, 20-9037 in Kansas, and 89-9018 in Quebec. At MnROAD and LTPP Section 20-9037, the longitudinal cracks occurred only at mid-lane. It should be noted that LTPP Section 20-9037 experienced a significant amount of material related distress. In the other sections, the cracking at mid-lane was secondary to cracking in the wheelpath.

**Figure 6: Longitudinal Crack at Mid-Lane at a. MnROAD Cell 305, b. LTPP Section 89-9018 Quebec (Automated Distress Survey From Infopave.com) c. LTPP Section 06-9048 California (Photo From Infopave.com)**

An effective way to decrease the stresses due curling and warping in the slab coupled with wheel loads is to increase the thickness of overlay. A thicker pavement will experience lower flexural stresses from wheel loads, and smaller effective temperature and moisture gradients. A less stiff interlayer, such as a non-woven geotextile fabric or open graded asphalt should allow the pavement to sink into the interlayer more under its own self weight. This will decrease the portion of the slab which is unsupported when the slab is curled upward and thereby decrease curling stresses. Stress reductions can also be achieved by using smaller slab sizes, such as 1.8 x 1.8 m. This will both decrease the curling and warping stress, and eliminate the negative moment due to wheel loading, as the slabs would only be loaded by half the axle at a time.

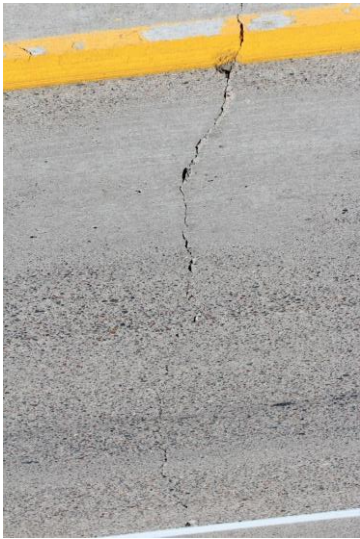
At MnROAD, two mid-slab transverse cracks formed in the passing lane of Sub-Cell 305. These cracks both occurred when joints in the existing pavement aligned at mid-slab in the overlay. One of these transverse cracks can be seen in Figure 8. From the pre-overlay distress survey, these joints were not distressed and were not exhibiting faulting but FWD testing was not performed on either of the existing joints which reflected up to establish if a void was actually present. FWD testing was performed on a joint between the two reflective cracks. The LTE at the tested joint had been measured as low as 60%. This indicates that the existing joints may have been at risk for developing voids. No reflective cracks occurred in Sub-Cell 405, where the

joints were distressed by a “Road Warrior” hammer prior to overlay construction. It is possible that the hammer drove the existing pavement into any voids that had developed, and actually helped provide uniform pavement support.

**Figure 8: Reflective Transverse Crack at MnROAD Sub-Cell 405**

When selecting a rehabilitation alternative it is important to consider the support conditions of the existing pavement. UBOLs are a good rehabilitation alternative for pavements which are distressed, but uniformly supported. If voids are present, uniform support should be restored by subsealing prior to the construction of the overlay.

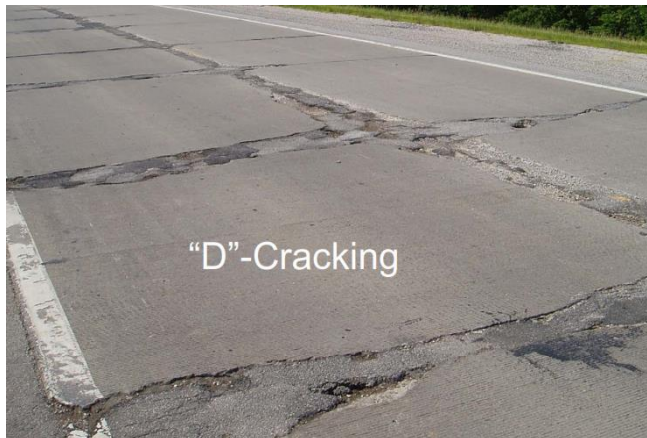
Reflective distress does not always occur above deteriorated joints. In Missouri, a UBOL was placed in 2008 on a rural road with severe joint deterioration. Deteriorated joints were filled with grout or asphalt but were not repaired. The pre-overlay pavement can be seen in Figure 9. No reflective distress has occurred in the seven years since construction (John Donahue, Personal

**Figure 9: Condition of Route D in Missouri Prior To Overlay (Photo Courtesy of Todd LaTorella, ACPA)**

Deteriorated sections of the existing pavement should be checked for uniform support. If any voids occur, uniform support should be restored by subsealing. Any large gaps in the existing pavement should also be filled.

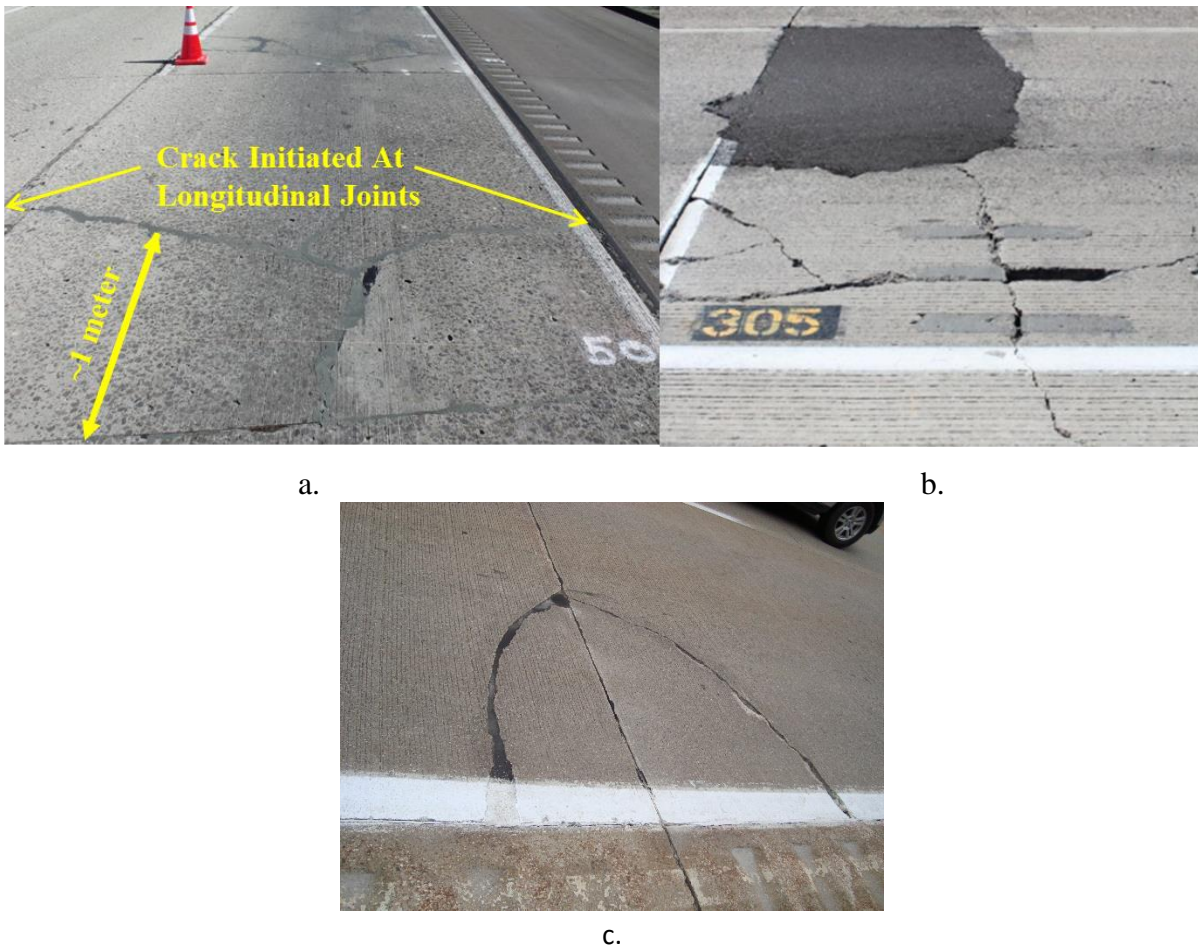
***Erosion Along the Transverse Joint*** Transverse cracks also form on the leave third of the overlay slabs, 0.5-1.5 m from the transverse joint. This is most likely due to the interlayer washing out due to water entering the transverse joint. Often a longitudinal crack will form between the crack and the adjacent joint and will look similar to that of a punch out in CRCP. Water entering the transverse joint due to lack of sealant or damaged sealant will drain slowly from the pavement structure, even when an open graded mixture is used. During periods of upward curling, water may even pool in the gap between the interlayer and the existing slab. If water only enters on part of the lane, a corner break may develop. This water will cause an asphalt interlayer to strip and ravel, leading to a loss of support. Images of this distress can be seen in Figure 10.

**Figure 10: Transverse Crack Due to Erosion at a. LTPP Section 06-9048, California, b. MnROAD Cell 305, and c. a corner break on an UBOL in Michigan.**

The LTPP Section 06-9048 seen in Figure 10 is experiencing spalling along the joint, which is likely compromising the effectiveness of the joint sealant. The joints at MnROAD in Sub-Cell 305, also shown in Figure 10, were not sealed, allowing water to enter (Watson and Burnham 2010). Preventing water from entering the joint with well-maintained joint sealant may prevent interlayer erosion along the longitudinal joint.

To prevent cracks from forming on the leave side of the joint, it appears to be important to keep joints properly sealed. Using a non-erodible interlayer, such as a non-woven geotextile fabric will also help mitigate this distress.

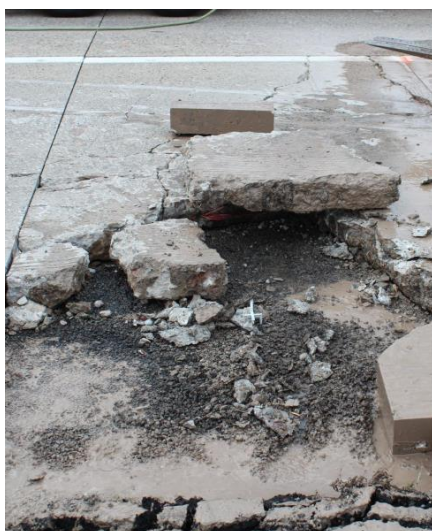
a. MnROAD Cell 305

Deterioration of the interlayer between a transverse joint and an adjacent transverse crack have been observed in several locations. Repairs in Cell 305 at MnROAD revealed that the open graded HMA interlayer had broken down into gravel at these distress locations. Cores taken from the thin UBOL constructed on TH-53 near Duluth, MN (229 mm overlay on a 25-mm dense graded HMA interlayer) revealed deterioration of the dense graded HMA interlayer as well. The deteriorated interlayers from these sections can be seen in Figure 11. The Missouri Department of Transportation has also taken cores in similarly distressed locations, which again revealed the HMA interlayer had broken down (John Donahue, Personal Correspondence, August 2015).

**Figure 11: Deteriorated Interlayers Between the Transverse Joint and and Adjacent Transverse Crack**

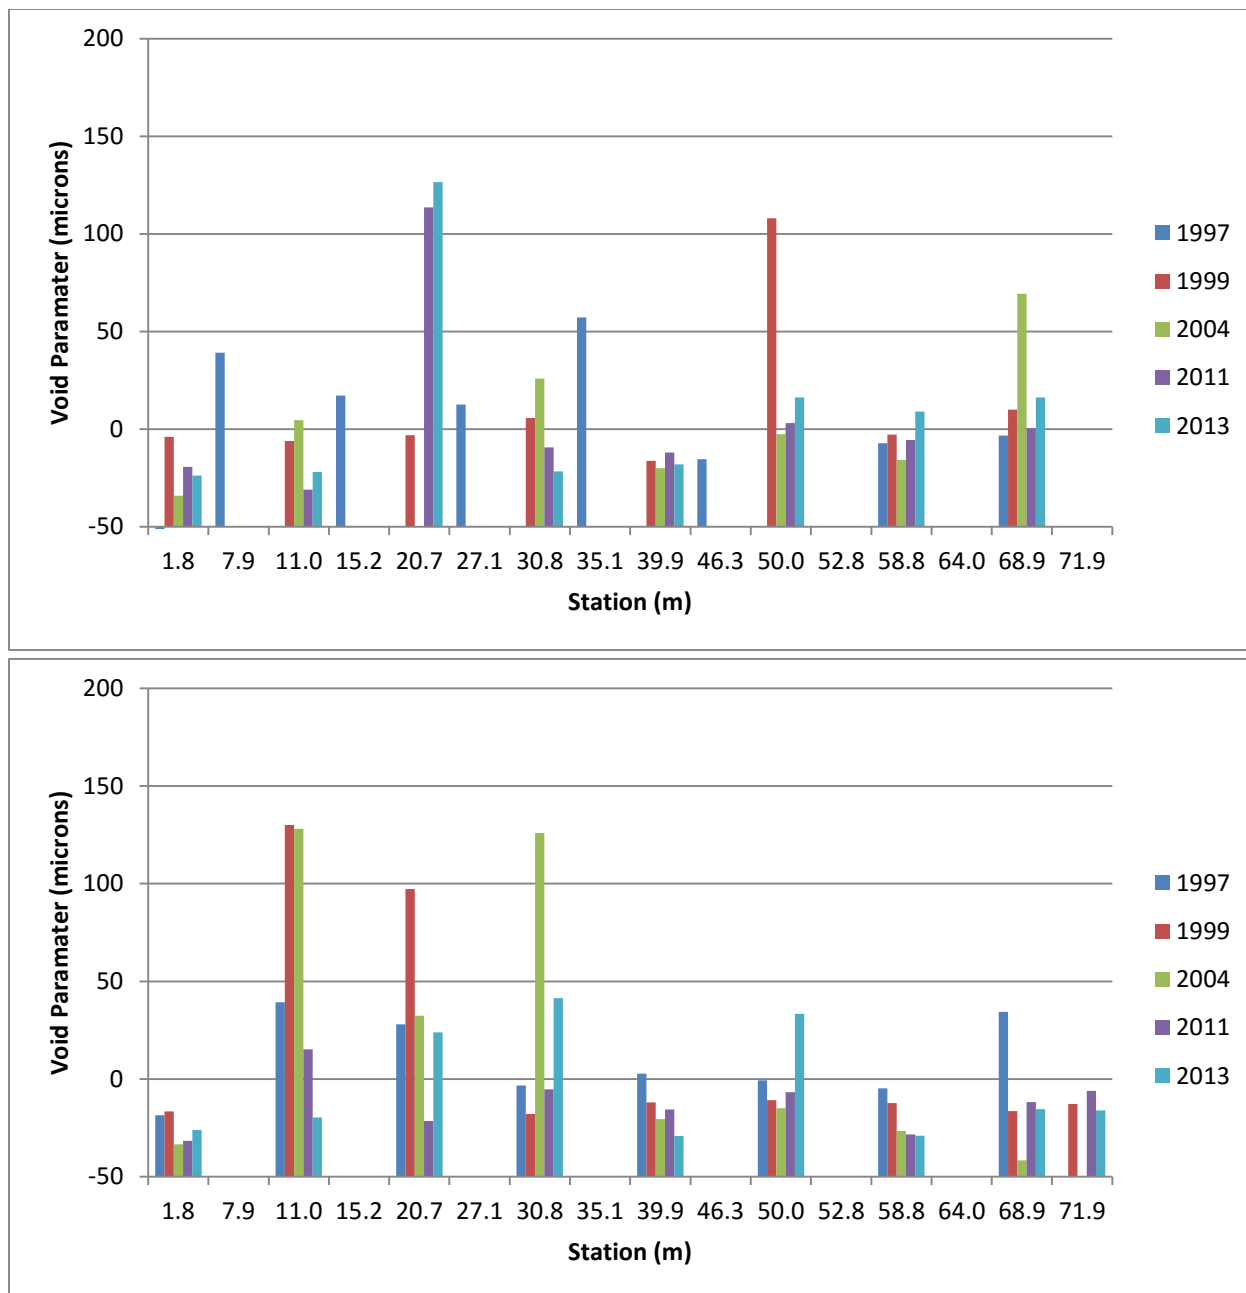
FWD testing was performed on LTPP Section 06-9048, where several of these voids developed. At each joint, deflection testing was performed near the 40 kN, 53 kN, and 71kN load levels, at the corner of the slab. The void parameter is calculated as the deflection intercept of a linear regression line drawn through the load vs. deflection data. The results can be seen in Figure 12. Of the seven joints which exhibit a void parameter greater than 50 microns, a transverse crack formed on the leave side of the joint four times, and a corner break formed three times. Transverse cracks or corner breaks did not occur at any location where a void was not detected. This confirms that the transverse cracks 0.5-1.5 m on the leave side of the joint are likely caused by a loss of support. .

**Figure 12 Deflection Intercept Corner Void Detection for LTPP Section 06-9048 in California**
