# Concrete pavement Falkenberg, Sweden – a 20 year review

Ellen Dolk<sup>1</sup>, Johan Silfwerbrand<sup>2</sup>, Sigurdur Erlingsson<sup>3</sup>

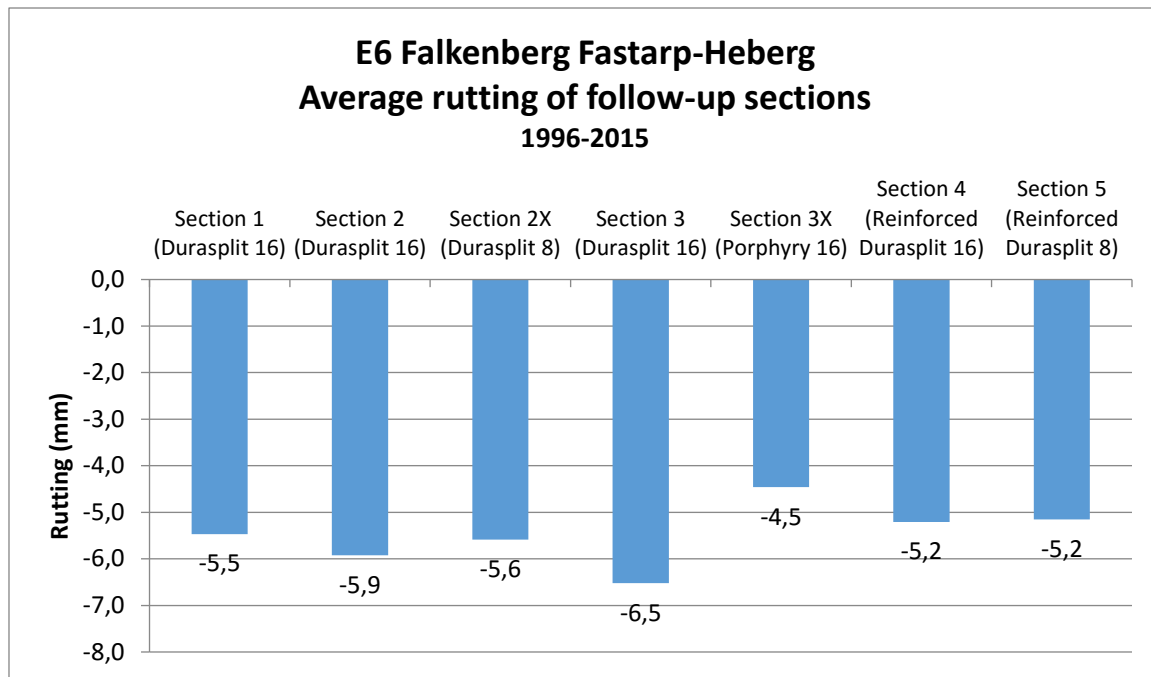
**The condition survey** showed that the rutting after 19 years is still minimal with an average of around 5 mm. Figure 3 shows the average of ten profiles from each test section measured with a Primal profile tester. The RST measurement of the whole road stretch showed an average of 5 mm rutting in the slow lane and 2.5 mm rutting in the fast lane.

Figure 3 – Test sections measured with Primal profile tester 2015.

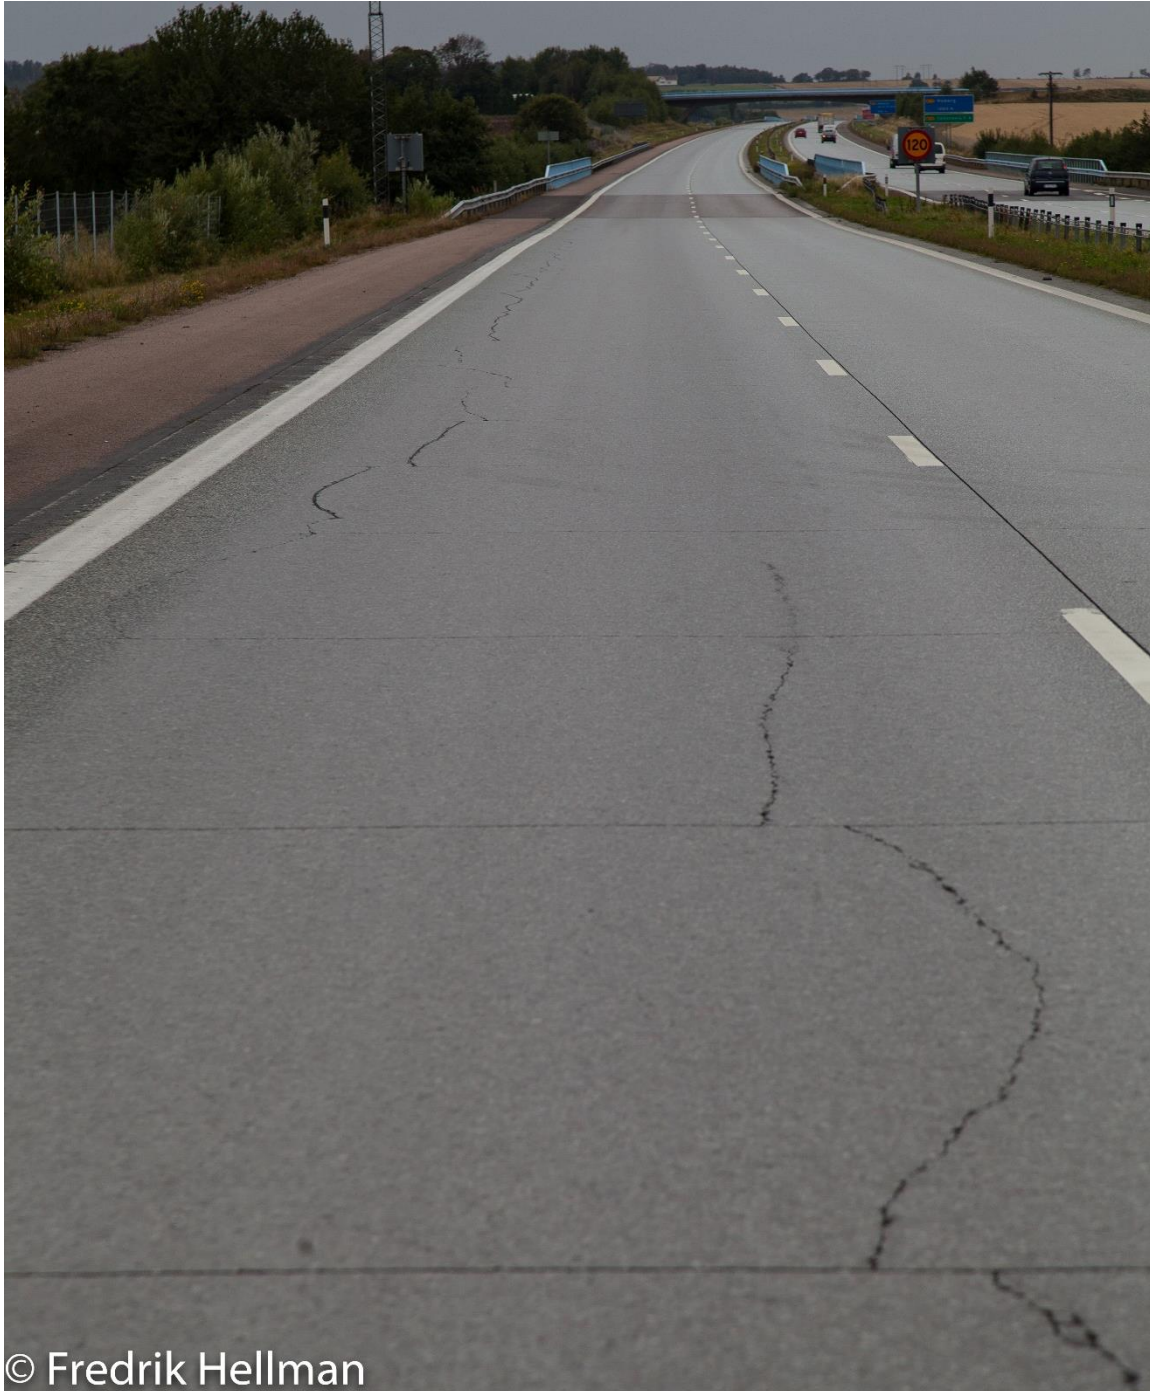
The main problem with Falkenberg stage two during the last decade has been the longitudinal cracking. An unpublished crack survey made by the local administration shows an average of around 500 meters of new cracks each year since 2006. Most of the cracks occur in the right wheel track in the right hand lane, some in the left wheel track and very few in the left hand lane. One observation has been made that the cracks are more likely to be found in the left wheel track on stretches where the inclination of the road is to the left, suggesting that topography and water play a role in causing the cracking. It is also noticeable that the cracks are travelling through the dowel placements, sometimes jumping sideways the 250 mm presumably from one dowel to the next one, from one slab to the other (see Figure 4). Sometimes the crack starts in the wheel track at the edge of the slab, then curves outward towards the edge of the slab, sometimes meeting a crack from the other edge of the slab and resulting in a wave pattern of cracks along the road (also seen in Figure 4).

*Figure 4 – Longitudinal cracking in wheel track (photo taken against traffic direction).*

There has been a three year program in 2012-2015 of replacing concrete slabs where the cracking has led to vertical shifts in the slab, and a total of around 50 slabs have been replaced. Simultaneously the joint sealing was redone for the first time, that is at the age of 17-19 years. While old, cracked slabs were lifted there was a good opportunity to study the condition of the cement-treated base. A beam was taken from a sound corner of a cracked slab for flexural testing that gave a result of 7.8 MPa.

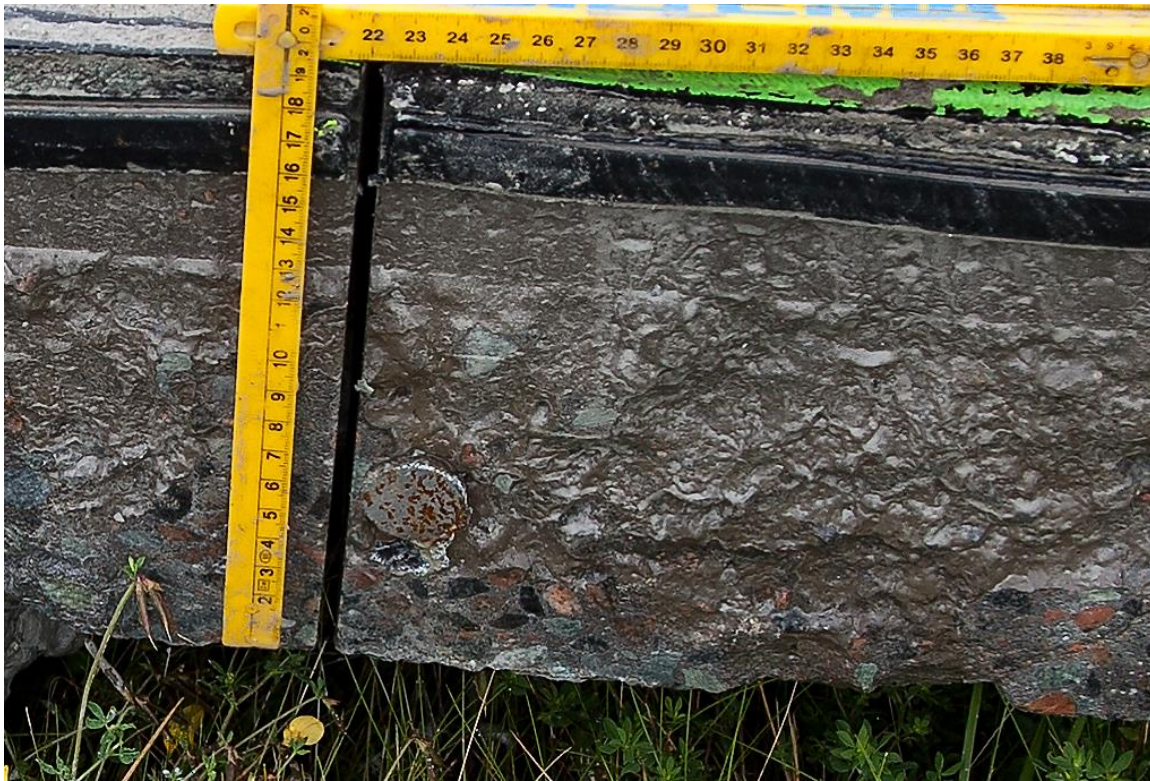
After ten years of use the longitudinal cracking of stage two accelerated in an unexpected way. An investigation into the damage concluded that the dowels had been placed 120-150 mm below the pavement surface instead of the planned placement in the middle of the pavement at 100 mm below the pavement surface, and that many cracks started at the place of a dowel and then continued along the concrete slab. An investigation was also made looking at the effect of the road base on the amount of cracking, comparing the part of stage one with its asphalt base and stage two with its cement-treated base, and finding the stretch with asphalt base to be in much better condition (Hultqvist & Carlsson, 2006).

**Identified causes of damage.** Stage one has after 22 years still not needed any major repairs while stage two has had several slabs replaced due to heavy cracking. During the replacing of these slabs two things were clear: some of the dowels were placed well below the middle of the pavement (see Figure 5) and the cement-treated base was eroded under the joints and cracks (see Figure 6).

*Figure 5 – Dowel placement in a removed slab, planned to be at 100 mm depth, instead being around 140 mm depth.*

***Erosion of the cement-treated base*** is one of the reasons for the extensive longitudinal cracking at Falkenberg stage two. Another is the misplacement of the dowels that sit too low in the pavement structure. One can theorize that the two facts work together, where the misplaced dowel acts as a crack inducer when the base has been eroded away and created a hollow space under the concrete slab. The erosion is probably caused in part by water trapped in the pavement structure. Both the mid-strip and the shoulders in Falkenberg stage two consist of dense soils/clay, which prevents water from draining from the road. The Swedish use of de-icing salts during the winter months can possibly also have added to the erosion of the base.

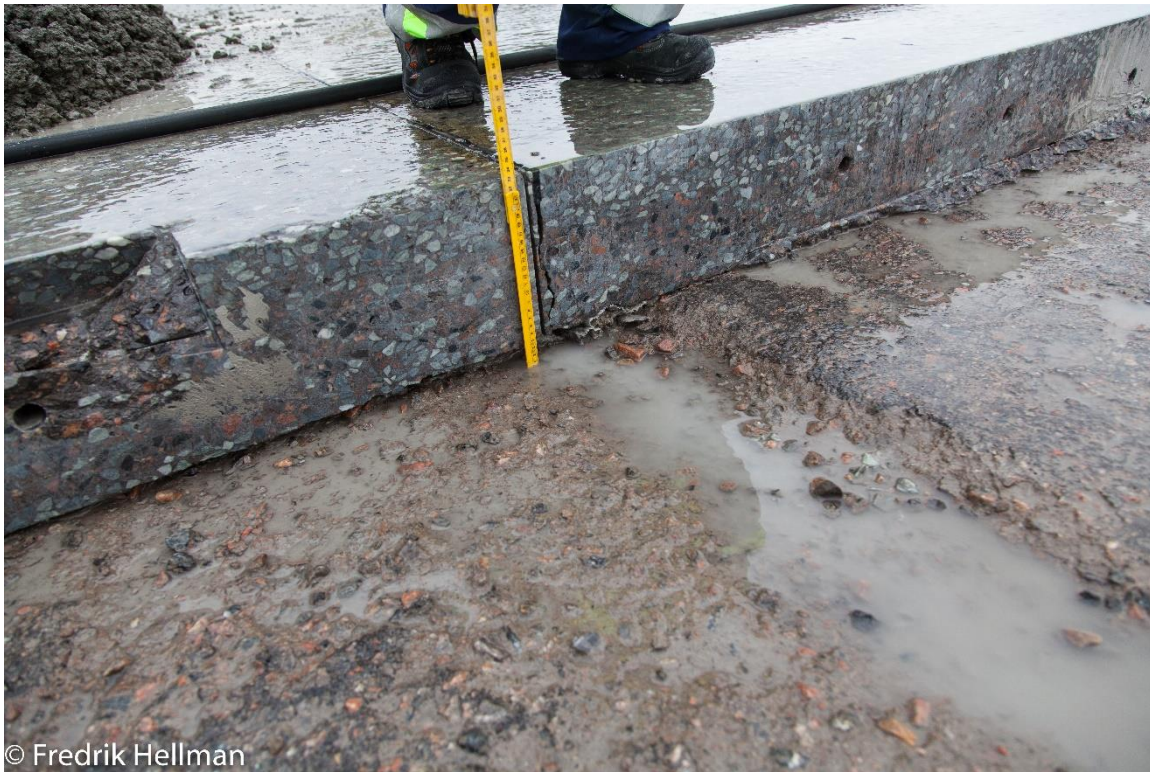
The soil next to the road was a dense clay and the drainage of the water from the pavement was very slow. At the same time as the slab replacement program, the clay from the roadsides was being replaced with a more permeable soil. After the removal of a slab there was a noticeable “ditch” where the joint had been that, in places, left a 10-20 mm gap between the pavement and the base.

*Figure 6 – Erosion of the cement treated base visible under a removed, cracked slab.*

The rehabilitation being done today consists of removing cracked slabs and casting new ones as needed. This will probably not work well in the long run as long as the old cement-treated base is still in place. Another measure that is being done is replacing the dense soils on the side of the road with more permeable soils which should reduce the speed of erosion on the base.
