# Performance of Roller Compacted Concrete Pavement in Arkansas

Stacy G. Williams<sup>1</sup>, Ph.D., P.E., Alan Meadors<sup>2</sup>, P.E., Sarah Tamayo<sup>3</sup>, P.E.

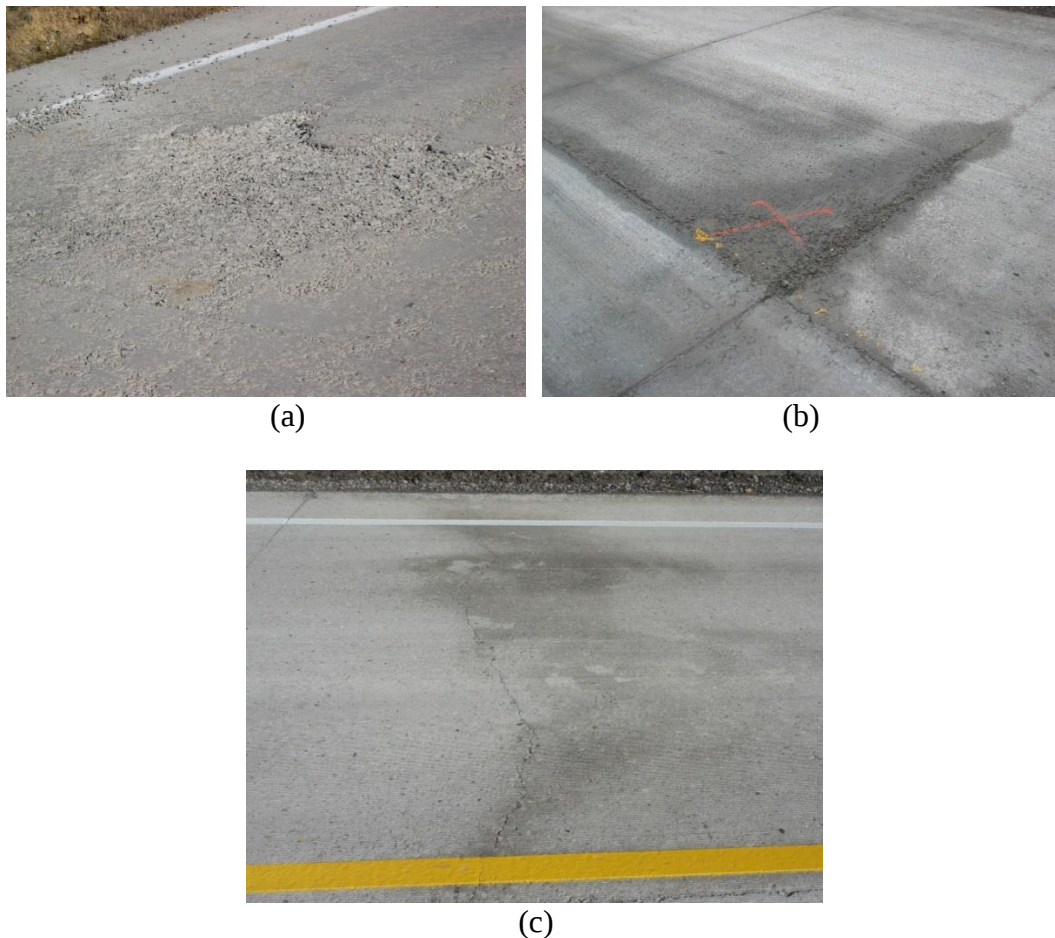
Immediately after the completion of paving, distresses began to appear in the original portion of Section 1, as shown in Figure 2. The most notable were localized areas of segregation and raveling. Minor raveling was later removed during diamond grinding, but deeper areas of raveling still visible after grinding were patched with an epoxy resin. Distresses were also evident at longitudinal and transverse construction joints, where roughness extended beyond the grinding depth. One crack, shown in the figure, formed almost immediately after construction. This crack was a transverse crack in the westbound lane that extended across the entire lane width. With the exception of roughness at the longitudinal joints and some low areas that were not removed during diamond grinding, no significant distresses were immediately evident in Section 2 or the reconstructed portion of Section 1. Smoothness was excellent after diamond grinding, with the pavement having an average International Roughness Index (IRI) of 70 inches/mile.

**Figure 2. Early distresses in the original portion of Section 1: raveling (a), joint deterioration (b), and transverse crack (c).**

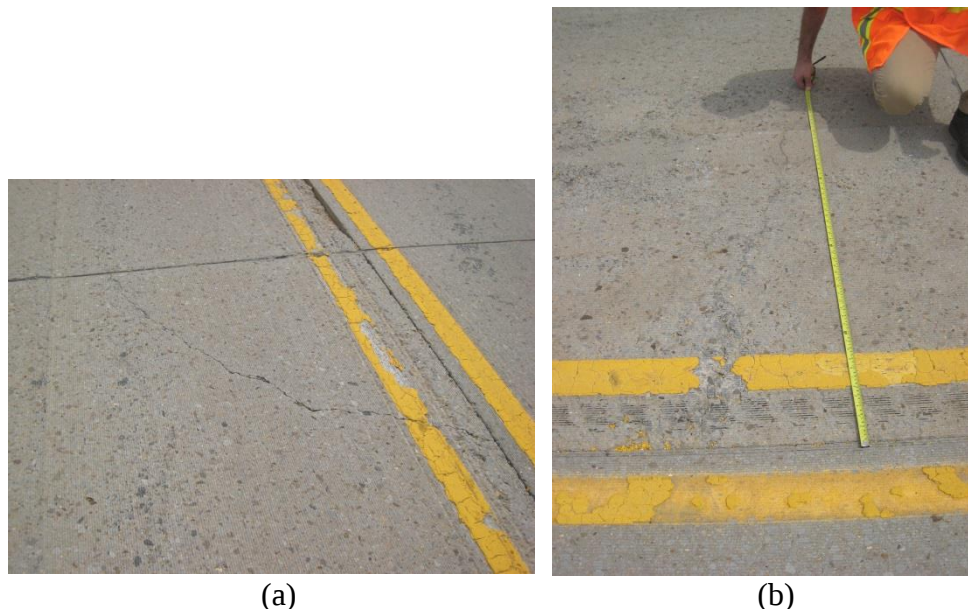
As previously stated, one full-width crack was immediately evident in the original westbound lane of Section 1. No specific cause was determined for this crack; however, this crack was in the same general location that areas of lower densities had previously been identified. After 6 months, a total of 4 cracks were identified in the original portion of Section 1, and that number grew to 9 cracks within 12 months. During the first year, only two cracks formed in Section 2 and the reconstructed portion of Section 1, and these cracks were corner breaks that were very small in width.

At 33 months, several more small cracks had formed. These cracks were mostly located in the original portion of Section 1, and were primarily corner breaks or minor surface cracking that had connected in areas of segregation (see Figure 3). One major longitudinal crack was identified in Section 2. This crack was near the middle of the lane and approximately 53 m (175 ft) in length (shown in Figure 4). Prior to placement of the RCC, this section had been a significantly rutted asphalt pavement. Although an asphalt leveling course was placed prior to the RCC, it was suspected that the prior distresses provided uneven support, allowing the underlying distresses to reflect through to the RCC layer. No cracks were noted in the eastbound lane of Section 2.

**Figure 3. Corner break (a) and transverse crack (b) in Section 1.**

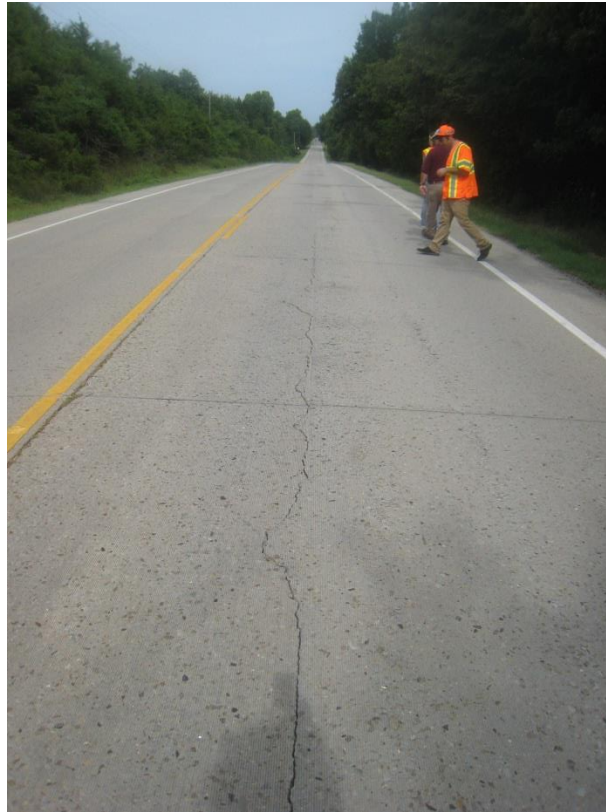
**Figure 4. Longitudinal crack in Section 2.**

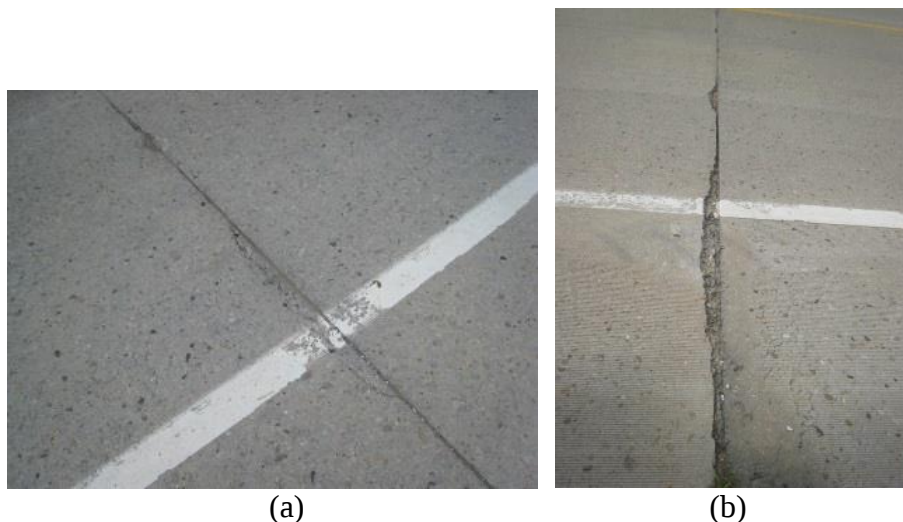
***Transverse Joint Deterioration.*** Transverse joints were cut as soon as was practical after paving using an early entry saw, and the joints were sealed. Transverse joint deterioration was noted in several locations shortly after construction, and the distress increased throughout the first year. In most cases, this distress was observed as a small crack along the edge of the joint, approximately 8 to 15 cm (3 to 6 in.) in length. Over time, the spalled appearance worsened, as shown in Figure 5. The original portion of Section 1 suffered the greatest percentage of these distresses, with some deterioration in all sections of the project. Although the percentage of affected joints increased slightly between the 12-month and the 33-month survey, the rate of deterioration appeared to have slowed.

**Figure 5. Transverse joint deterioration after 6 months (a) and 33 months (b).**

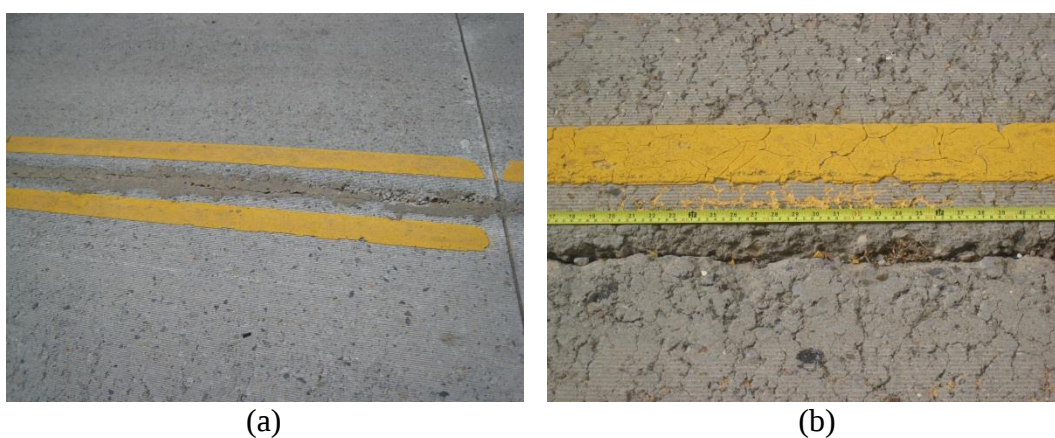
**Longitudinal Joint Deterioration.** Longitudinal joint deterioration was also a prevalent distress. Because two adjacent lanes of RCC could not be placed at the same time, the first paved lane hardened before the second lane was placed. This edge was unconfined, resulting in an area of low density. Thus, a minimum of 10 cm (4 in.) was sawed from the centerline area in order to form a solid vertical surface against which to compact the second lane. Forming a dense, smooth centerline joint proved to be one of the most difficult features of the RCC paving process. As a result, early signs of deterioration began to appear along the longitudinal joint. In some of the more severely distressed locations, an epoxy sealant was placed, though the seal material did not perform consistently (see Figure 6). The original portion of Section 1 exhibited the greatest level of deterioration. In this section, most of the deterioration appeared within the first 9 months of service, with deterioration slowing after that. In the other sections, longitudinal joint distresses appeared more slowly, but have continued to increase throughout the 33-month period.

**Figure 6. Longitudinal joint deterioration with (a) and without (b) sealant.**

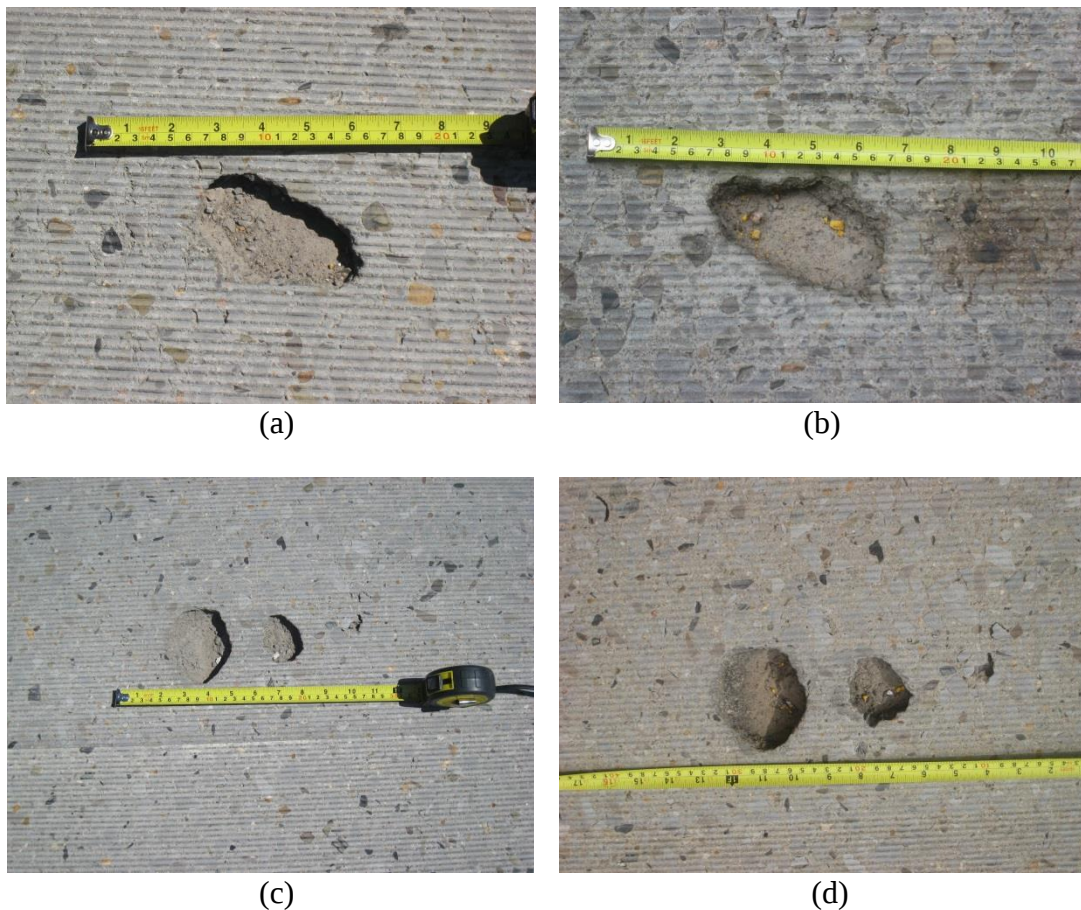
**Popouts.** Popouts were believed to be a function of the aggregate type and surface density, and did not significantly affect the structural integrity of the pavement. Popouts ranged from 25 mm (1 in.) in diameter to almost 150 mm (6 in.) after the first year of service. For the distress survey, only popouts having a diameter of 75 mm (3 in.) and greater were included in the distress count. While Section 2 and the reconstructed portion of Section 1 performed better than the original portion of Section 1 with regard to overall distress, this portion of Section 1 was a much better performer with respect to popouts. The majority of popouts appeared within the first 6 months of service, and while the size of some popouts increased after the first year, many generally retained their original shape, as shown in Figure 7. The appearance of popouts did not increase significantly after the first year.

**Figure 7. Popout after 6 months (a, c) and 33 months (b, d).**

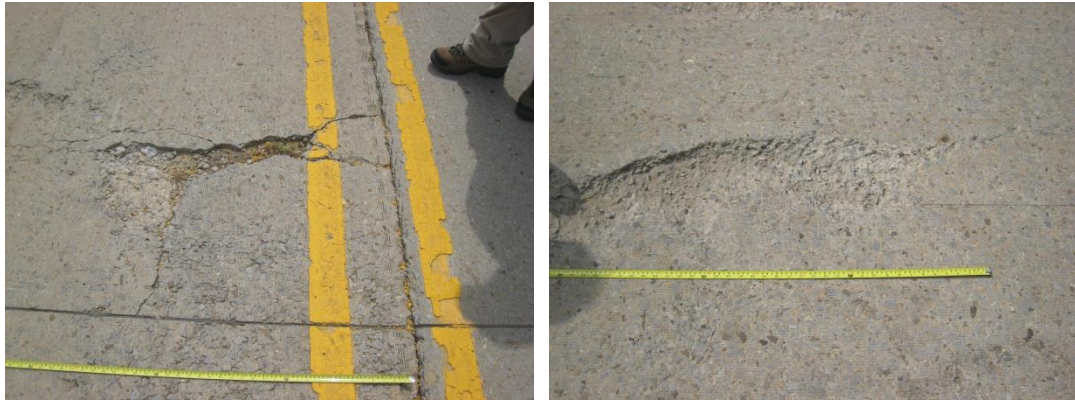
**Raveling.** Raveling was another surface distress noted in throughout the project. In some cases, raveling appeared to be the result of a deteriorated popout; and in others, it was generated by a segregated area of the mat with low surface integrity. Two of the more severe areas of raveling are shown in Figure 8. In Section 2 and the reconstructed portion of Section 1, the percent length affected by raveling was limited to approximately 2 percent, and has not changed significantly after the first year of

service. The original portion of Section 1, however, had approximately 3 percent of length affected by raveling at 12 months of service, and two-fold increase after 33 months.

**Figure 8. Examples of raveling.**
