# **CRCP on the N49 – How the repair of the longitudinal joint leads to a better view on the crack formation of CRCP**

## **Abstract**

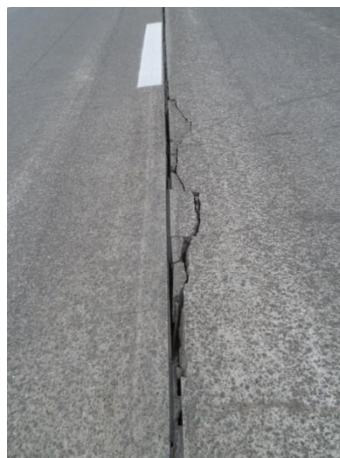
In spite of the use of tie bars, the two lanes were found to slip away from each other, leading to the opening of the longitudinal joint. Moreover, local spalling was observed at some places at the edges of the joint, as illustrated in Figure 2.

**Figure 2. Widening of the longitudinal joint and cracking over a width of 100 to 150 mm along the joint**

Some core samples were taken in a place where a longitudinal crack ran alongside the longitudinal joint, as shown in Figure 2. Figure 5 shows the core taken at the end of the tie bar, over the crack. Good adhesion between the bar and the concrete is visible. As this was an exception, the bar had not been able to hold the concrete pavement by itself and a crack had formed right next to the end of the bar.

**Local repairs.** The local repairs were made with a repair mortar. A rectangular zone was removed from the concrete. In most cases this was within a width of 150 mm, so no longitudinal bars were cut by this operation. The repairs were full-depth.

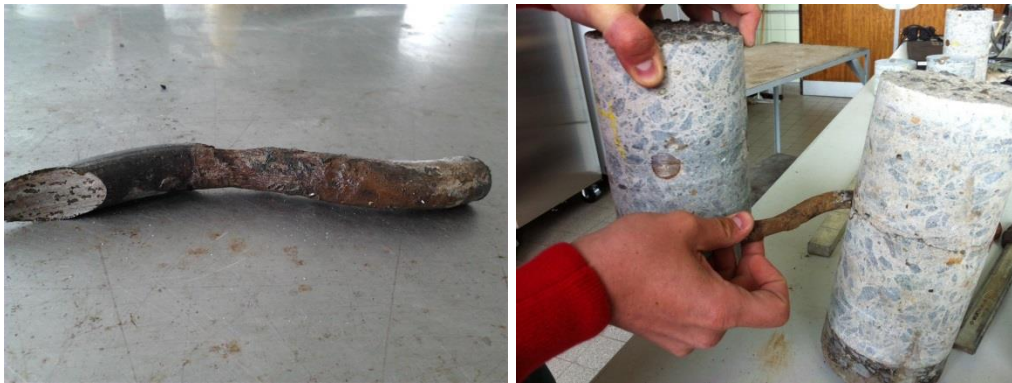
In the direction of Antwerp an elongation of the tie bars took place, as can be seen in Figure 3. In order to be able to straighten the tie bars, a steel quality BE 220S was used. The bars were smooth and had a diameter of 16 mm. A reduction in diameter from 16 mm to 13.13 mm was measured in the middle of the tie bar at the longitudinal joint. In this direction the bond with the concrete was very good, but the steel quality was too low to prevent the joint from opening.

**Figure 3. Elongation of a tie bar at the longitudinal joint**

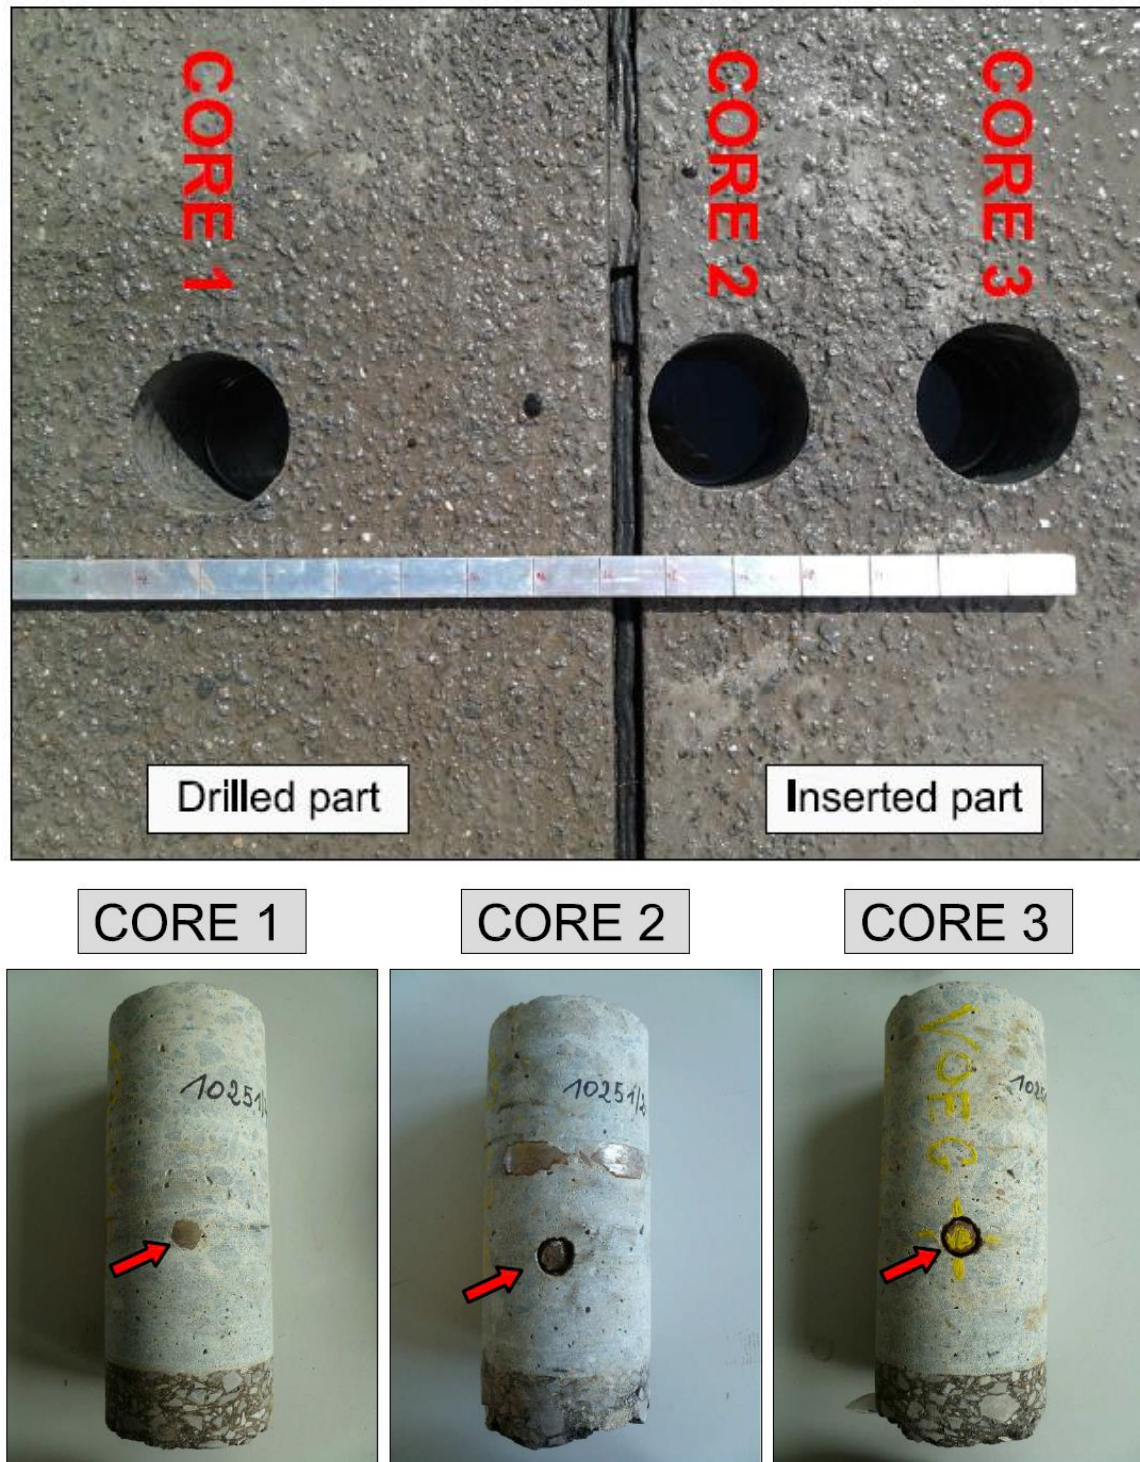
A different type of distress was found in the direction of Knokke. In this case the tie bars were not driven automatically into the concrete, but drilled and glued afterwards. The investigation showed that the glue had disappeared in a lot of places, resulting in no bond between the smooth bar and the concrete. Figure 4 shows the positions of three core samples drilled on one line perpendicular to the longitudinal joint. The tie bar was well anchored in the concrete of the second stage (core 1), but totally debonded in the other cases. This was due to the disappearance or lack of glue. The bars in cores 2 and 3 could be removed by hand.

**Figure 4. Positions of the core samples taken in the direction of Knokke: good bond in the core taken from concreting stage 2 (core 1), total debonding in the cores taken from concreting stage 1 (cores 2 and 3)**

In the fast lane, the bond between the asphalt interlayer and the base was still good. In the slow lane, delamination had occurred at the bottom of the asphalt interlayer. This binder course was damaged more severely along the joint (core 3), owing to the pumping effect of the water in the joint in the presence of heavy traffic.

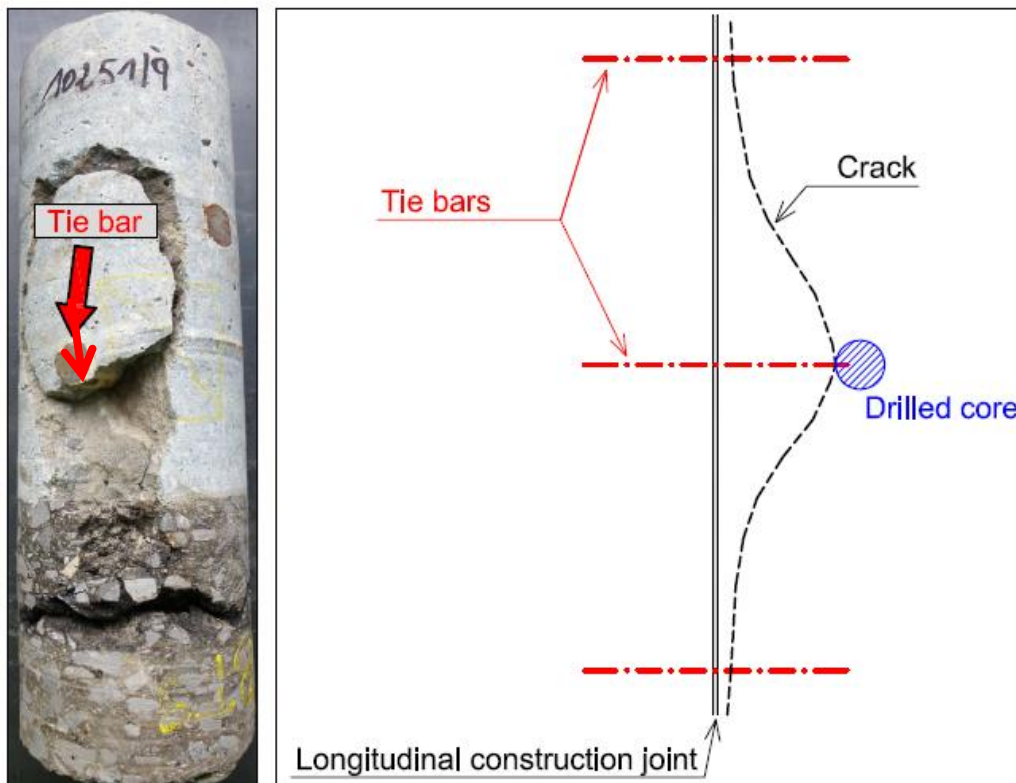
**Figure 5. Core sample taken at the end of a tie bar in the presence of a longitudinal crack**

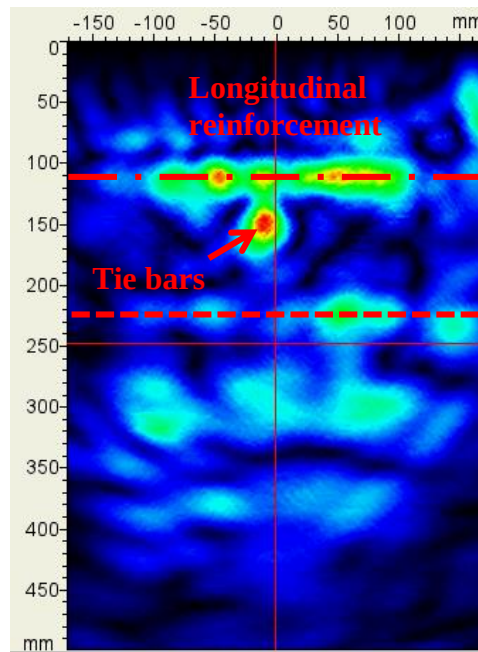
Besides core drillings, non-destructive measurements were made with an ultrasonic tomograph. These measurements allowed determining the positions of the tie bars accurately, as can be seen in Figure 6. Not only the tie bar but also the longitudinal reinforcement could be located, as well as the transition between the concrete and the asphalt interlayer at a depth of 220 mm. The tie bars are situated at a depth of 150 mm and the longitudinal reinforcement at a depth of 110 mm.

**Figure 6. Measurements with an ultrasonic tomograph accurately indicated the positions of the tie bars and the longitudinal reinforcing bars and of the transition between concrete and asphalt**

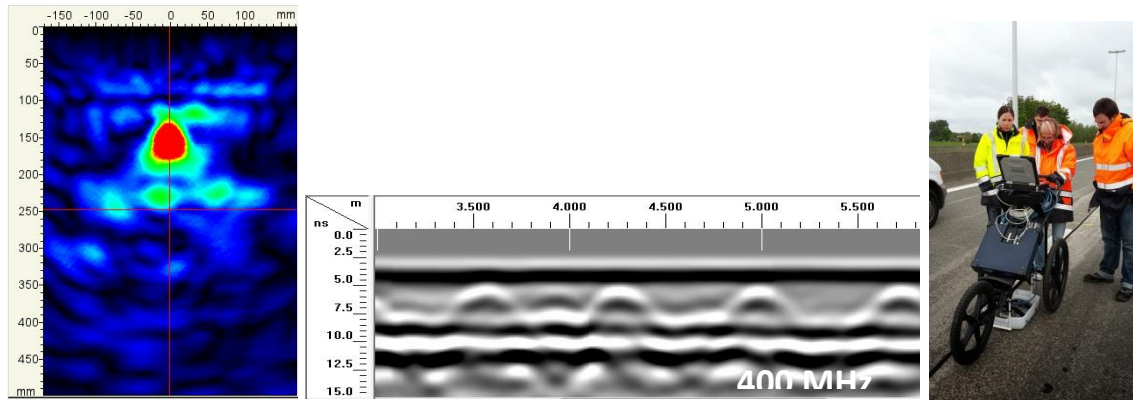
**Figure 8. Images of the tie bars obtained with an ultrasonic tomograph and with ground-penetrating radar, respectively**

- positioning of the existing tie bars with an ultrasonic tomograph and with ground-penetrating radar. The ultrasonic tomograph was used first. Although the positions of the tie bars could be detected very accurately, the method was time-consuming as there was often a lot of interference due to the presence of the metal lid that was used to obtain the keyed transition. Ground-penetrating radar was used subsequently. Two different antennae were used . Both measurements, one at 2.6

GHz and the other at 400 MHz gave good results. The tie bars were very visible on the image obtained and the measurement could be carried out at walking speed. Figure 8 presents the images obtained with the ultrasonic tomograph and with ground-penetrating radar;

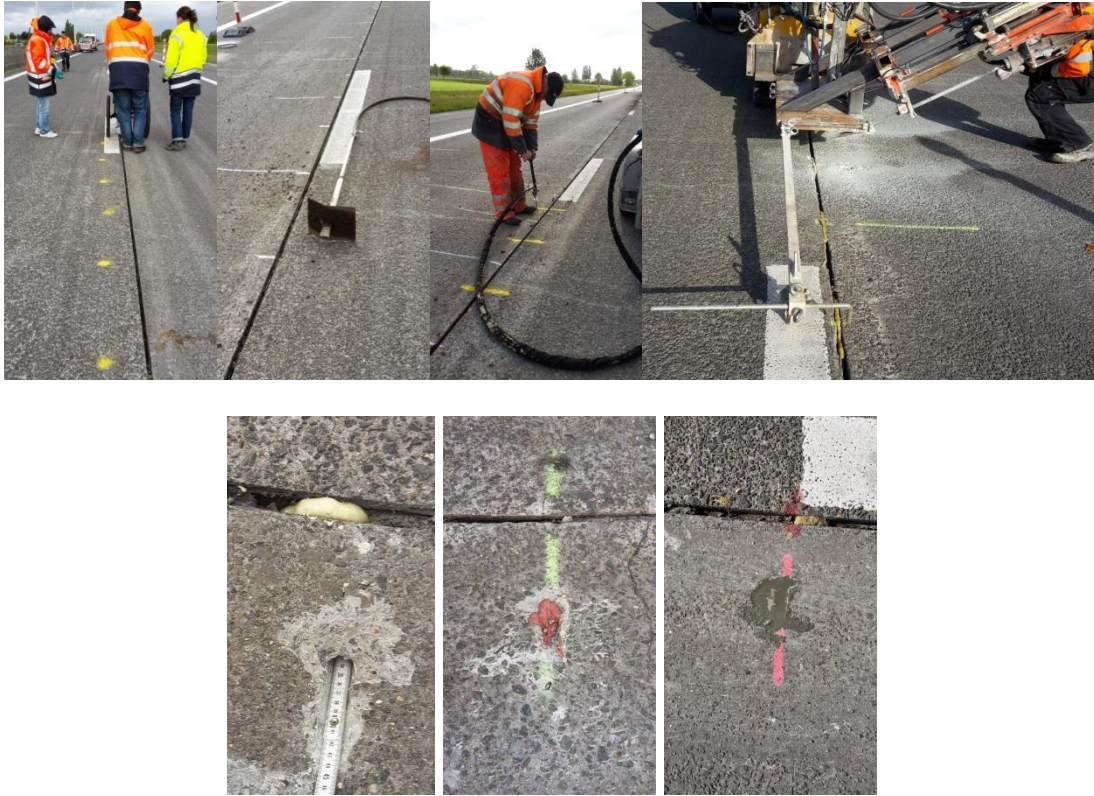
**Figure 9. Different steps of stitching: positioning of the existing tie bars; cleaning of the joint (and damming); drying of the joint; filling up the joint with polyurethane foam (no picture); drilling the holes (two at the time); insertion of the tie bars in the epoxy glue; filling up the surface with acrylic resin.**

- to avoid filling the joint with epoxy, small holes were drilled on top of the keyway and then injected with a two-component polyurethane foam. However, damage occurred during the drilling of the larger holes for inserting the tie bars, as the small cover between the joint and the first drilling hole delaminated. It was then decided to inject the joint itself with expanding polyurethane foam on the spot where the drilling was to take place, prior to the drilling of the hole;

- in order to be in the cadance of the existing tie bars, which are 800 mm apart, the interdistance was taken 1 600 mm in stead of 1800 mm per pair of stitches. The interdistance between the two tie bars was taken 500 mm and 1 100 mm was taken between the pairs;

- to avoid insufficient anchoring length, it was first decided to place the stitches at 190 mm centre to centre on the side of the key-and-keyway and at 220 mm distance on the other side. However, during the drilling of the holes it became clear that the longitudinal reinforcing bar was much closer to the joint than expected, which caused spalling of the concrete. Therefore it was decided to place the stitches on one side of the joint only in the first stage, which was also beneficial to the anchoring length;

- to avoid water interference, dams were made in the joint, which was then dried;
- the gluing was done with a thixotropic epoxy resin with high epoxy content;

- at the surface the hole was closed with a self-levelling epoxy resin. A cementitious grout was not possible here since no onset was present.

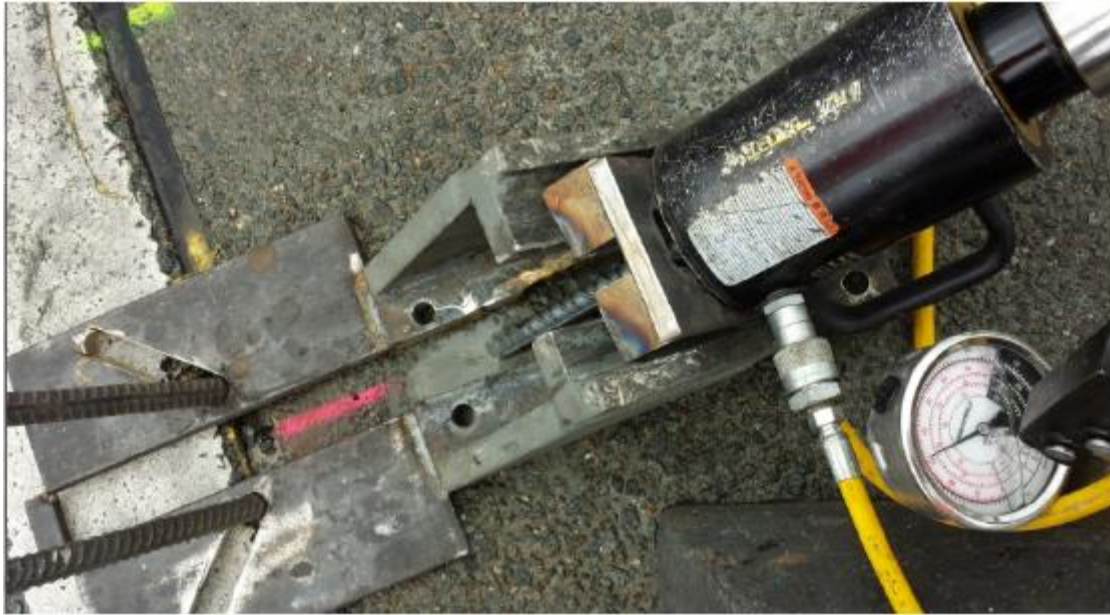
In order to test the stitching system, different tension tests were carried out on tie bars placed in the concrete as can be seen in figure 10. Each time, a tensile force up to 10 ton was applied, which was the double of the required tensile force of 5 ton.

**Figure 10. Tensile test on a elongated tie bar on site**

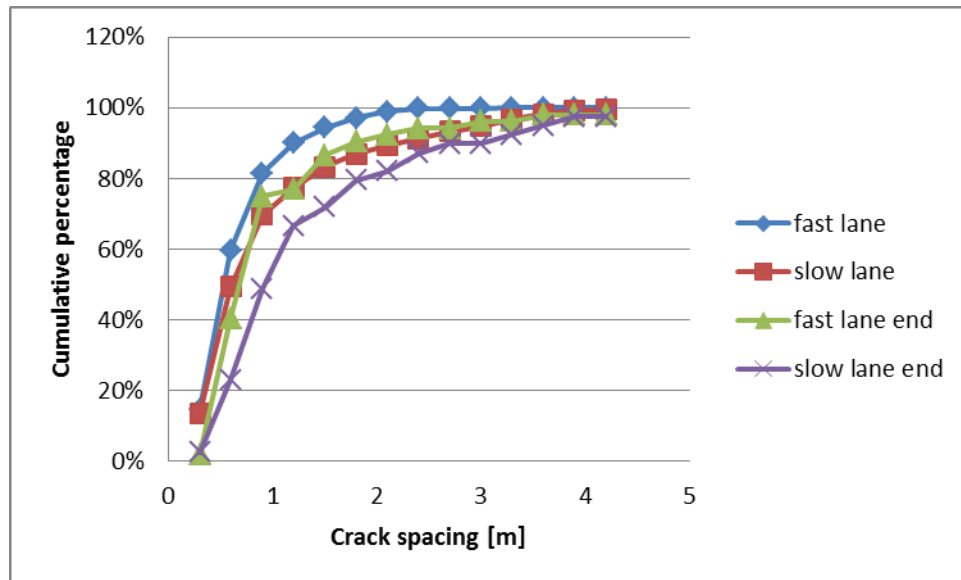
The results are shown in Figure 11. A similar crack spacing spectrum was taken as from the measurements on the E17 by Feys (Feys, 2010). The effect of adhesion between the CRCP and the asphalt binder course and the base is clearly visible. This is also visible in the average crack spacing, which is 0.89 m for the slow and 0.62 m for the fast lane. At the end locks, this average crack spacing increases to 1.28 and 0.97 m, respectively. A double effect is involved here. On the one hand, the higher rate of reinforcing steel (doubled at the transverse ribs) will result in more distribution of stresses and in fewer cracks appearing at the surface. On the other, the effect of the slow lane slipping is visible as well, since the poorer bond between the various layers will result in stresses building up less high.

**Figure 11. Crack spacing spectrum for the slow and the fast lane, with separate measurements at the end locks**
