## **Field and Laboratory Performance of Cementitious Partial Depth Repair Materials in Cold Climates**

Haithem Soliman, EIT<sup>1</sup> and Ahmed Shalaby, P.Eng.<sup>2</sup>

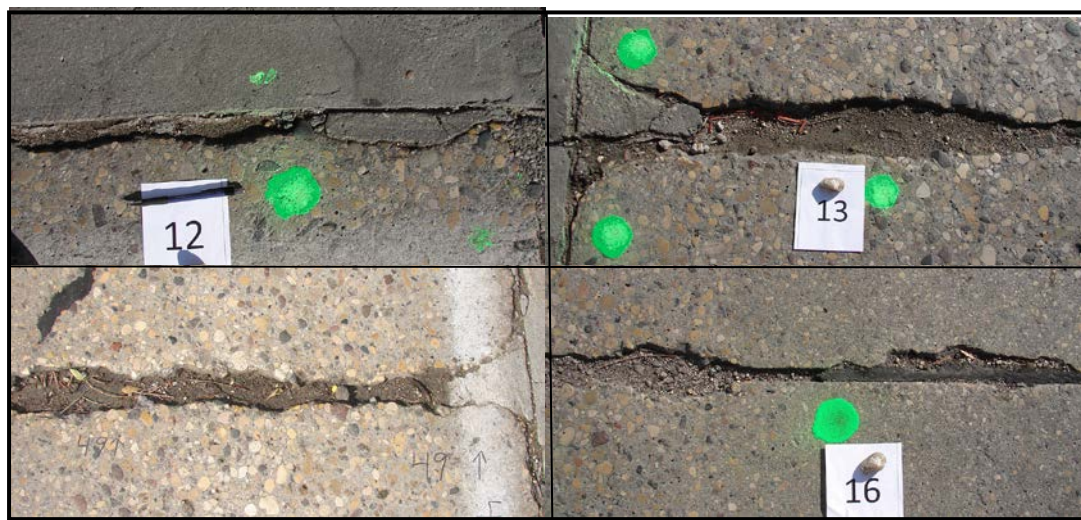
All repairs areas in both test sections were located along the longitudinal or transverse joints. The severity level of the spalls was more significant along transverse joints than longitudinal joints, as shown in Table 1. The severity level of the spalls along longitudinal joints was predominantly low for both test sections. On the other hand, the majority of transverse joints along test section 1 had low severity while test section 2 had predominantly moderate severity. Figure 2 shows some distressed joints before repairing.

**Figure 2: Distressed Joints before Repairing**

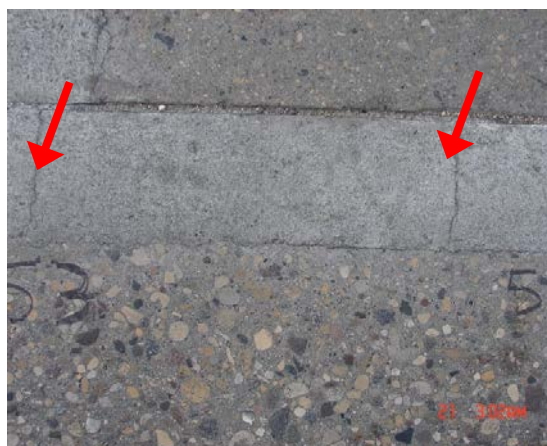
Transverse cracking, shown in Figure 4, are the cracks in the transverse direction of the repair area. The severity of the transverse cracking was categorized as low, medium, or high according to the spacing between cracks along the repair area. Longitudinal cracking, as shown in Figure 5, are the cracks in the longitudinal direction of the repair area. Cracking at the saw-cut surface, as shown in Figure 6, are the initiation of separation between the repair material and the original concrete. Surface finish, as shown in Figure 7, represents the regularity of the repair surface after installation of the repair material. Spalls, shown in Figure 8, are the chipping off of pavement in the repair area. Surface wear, as shown in Figure 9, represents the pop-out of aggregate and fines from the repair materials due to traffic and weathering.

a) Low severity cracking

**Figure 4: Transverse Cracking in the Repair Area**

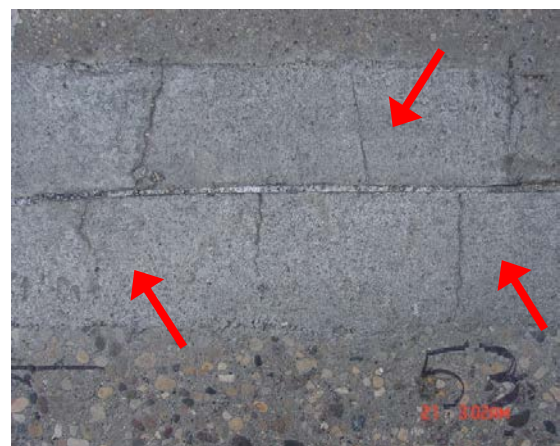
b) High severity cracking

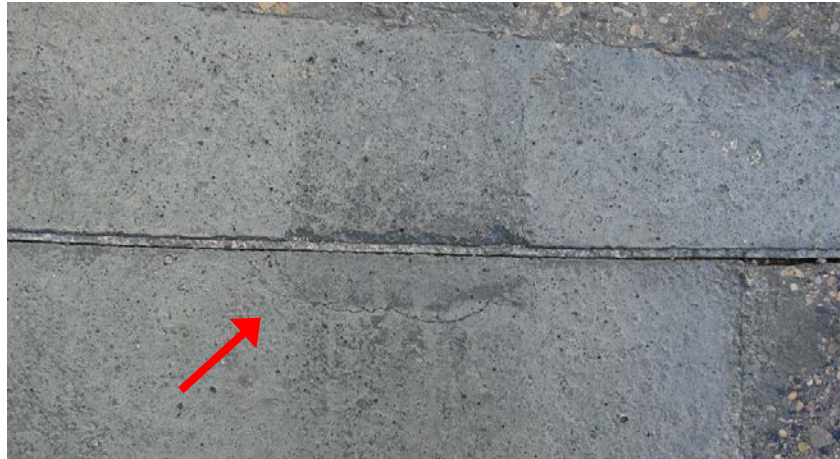
**Figure 5: Longitudinal Cracking in the Repair Area**

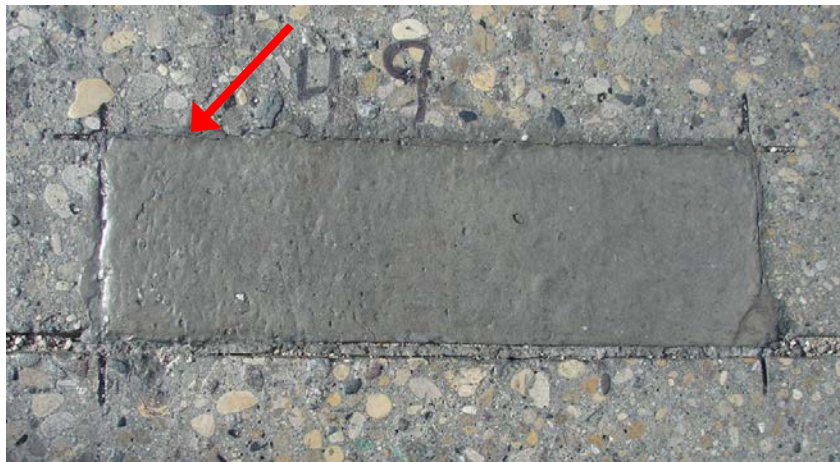
**Figure 6: Cracking at the Saw-Cut Surface in the Repair Area**

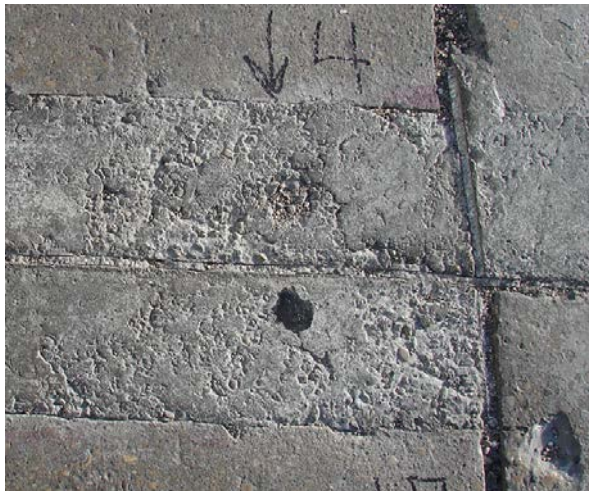
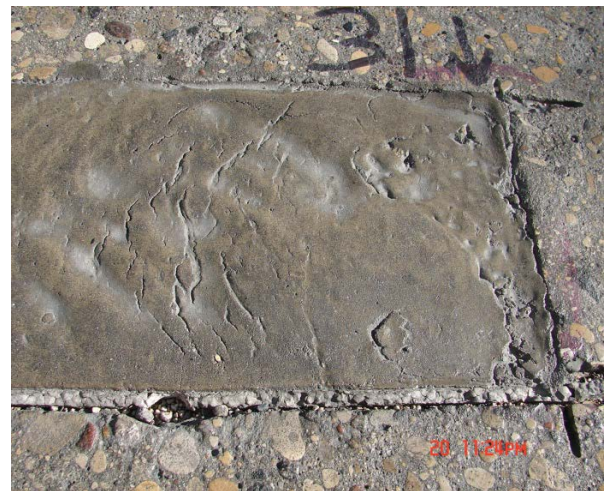
**Figure 7: Repair Areas with Poor Surface Finish**

Figures 10 to 15 show the frequency of the distresses for the repair materials one, six, nine, and thirteen months after installation. All the repair materials had good surface finish except material A, where 32% of these patches had a poor surface finish. Areas repaired with materials E and F had lower percentage of transverse cracking than the remaining materials. Almost all the transverse cracking was observed one month after installation. Repair materials that had high water content during mixing experienced higher percentage of transverse cracking. All the repair material had no, or very small percentage, of longitudinal cracking except for repair material B. The longitudinal cracking near the wheel path can be attributed to the structural instability of the patched area and are not related to the type of repair material.

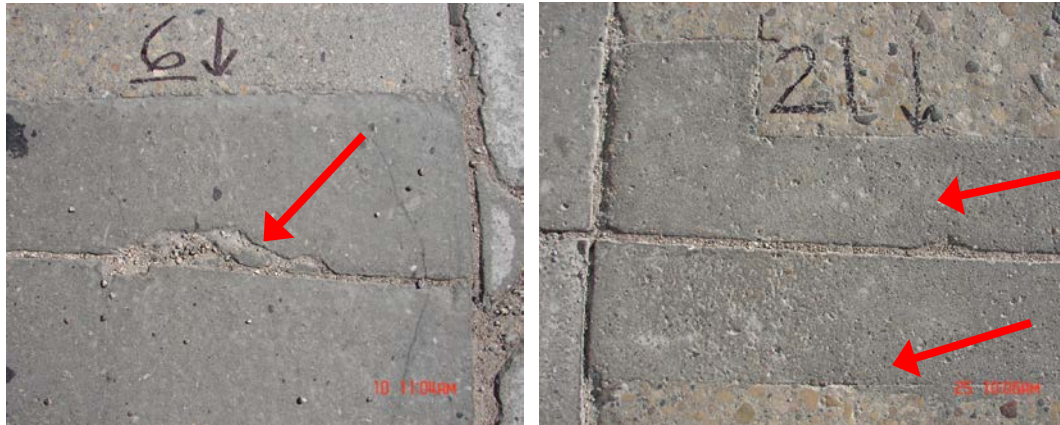
**Figure 8: Repair Areas with Spalls    Figure 9: Repair Areas with Surface Wear**

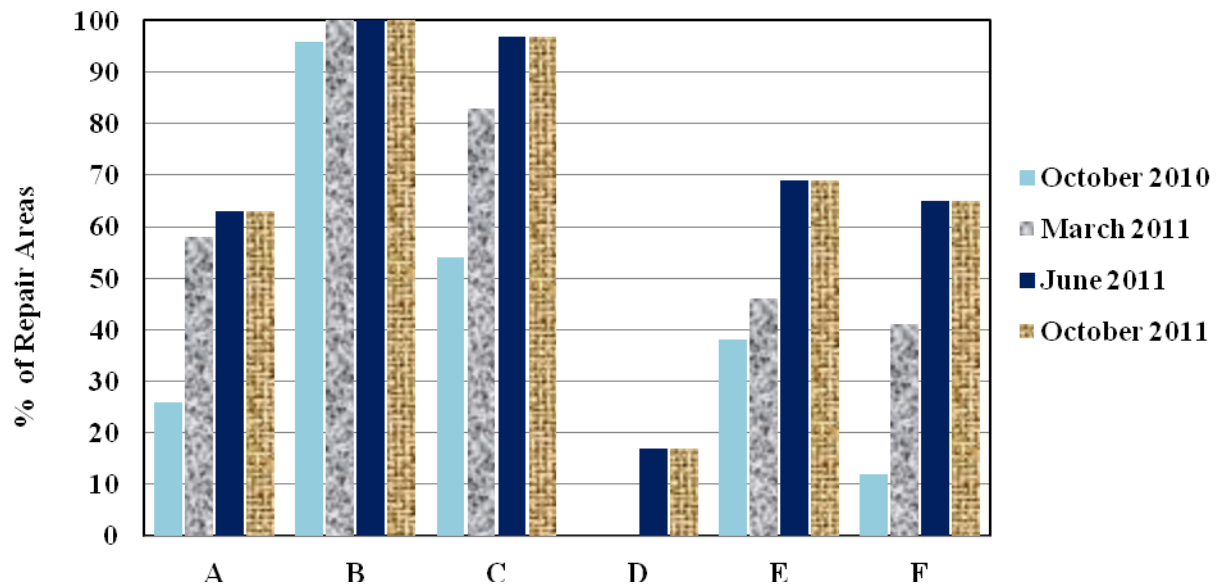
Figure 12: Percentage of Repair Areas with Cracking at Saw-Cut Surface

After one month, materials D and F had the lowest percentage of cracking at saw-cut surface, while material B had the highest percentage of cracking. After thirteen months, material D was the only material that maintained low percentage of cracking at saw-cut surface. For surface wear, 33% of the patches repaired with material D showed signs of surface wear after six months; this percentage ranged from 62% to 89% for the remaining repair materials. After thirteen months, all repaired areas showed signs of surface wear. The percentage of patches with spalls ranged from 2% to 16% after six months. After thirteen months, the percentage of patches with spalls ranged from 8% to 26%.
