## Implementation of Polyester Concrete Grout in Dowel-Bar Retrofit of Jointed Plain Concrete Pavements

Shakir Shatnawi<sup>1</sup>

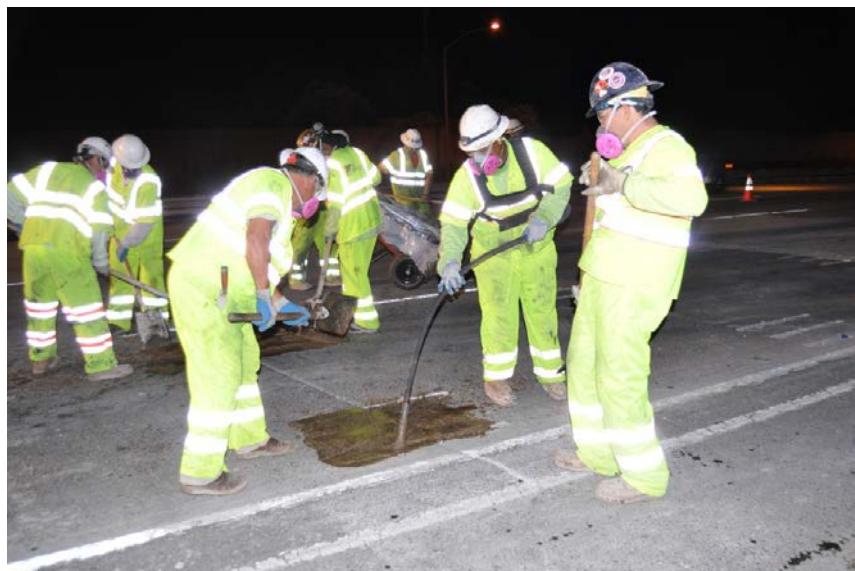
**Figure 2. Minimal vibration of the PPC material in the slots.**

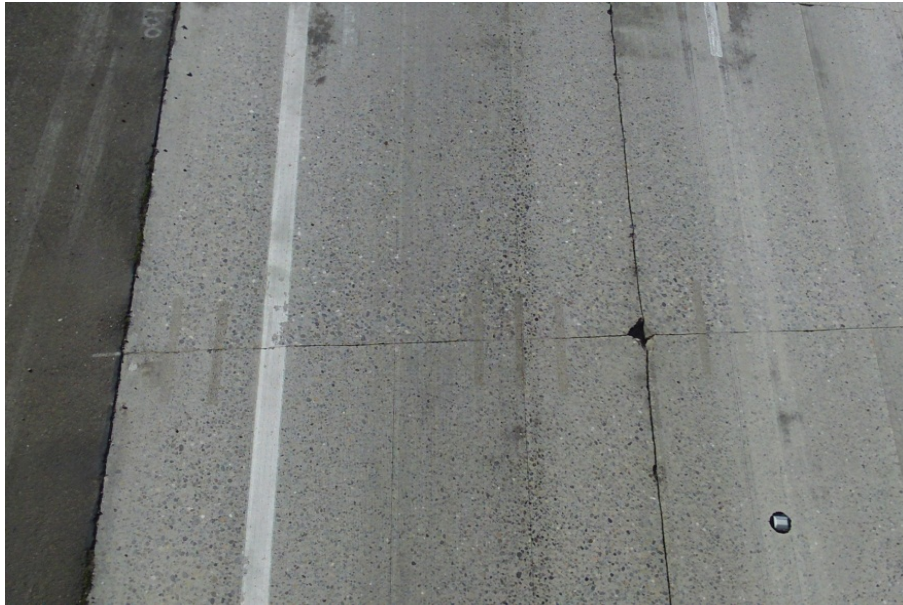
**Figure 3. US 50 DBR slots backfilled with polyester polymer concrete seven months after diamond grinding.**

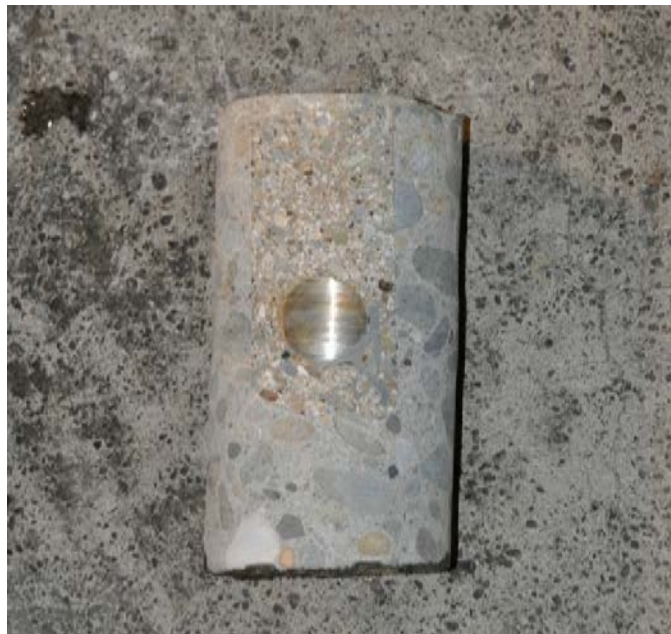
slot backfilled with polyester polymer concrete is shown in Figure 4. As can be seen, the polyester concrete completely surrounds the dowel bar and the no voids appear within the backfill material or at the interface with the Portland cement concrete.

**Figure 4. A core showing good consolidation from a DBR slot backfilled with polyester polymer concrete**

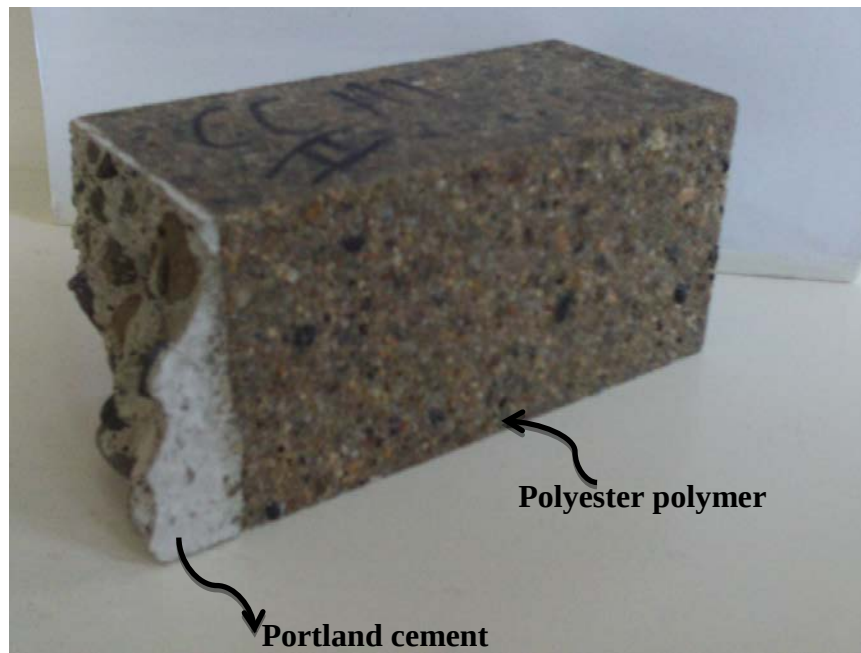
**Figure 5. Beam failure in the cement concrete not in the polyester concrete or at the bond.**

Testing using California Test 551 (bending beam) on both Portland cement concrete and polyester polymer concrete revealed 2.75-3.45 MPa for the cementitious mix and 8.28-12.41 MPa for polyester concrete. These results are to be compared with 2.75 MPa minimum (dry) and 2.07 MPa saturated surface dry (ssd) for conventional grouts and 3.45 MPa minimum (dry and ssd) for polyester backfill grout as specified for these two materials. The significantly higher bond strength values achieved with the use of polyester concrete over the specified minimum values indicate the great benefits of polyester in terms of bonding and its ability to bond well even under lower quality control construction practices and higher material variability. For example, if the bond strengths are 8.28 MPa and 3.45 MPa for PPC and conventional grouts, respectively and if the Coefficient of Variation (COV) is 40%, then the bond strength may drop from 8.28 MPa to 4.96 MPa for PPC which is still way above the minimum requirements, and will drop from 3.45 MPa to 2.07 MPa for conventional grouts which is below the minimum requirements. This example shows that PPC is more “forgiving” to construction variability.
