## **Field Investigation of Dowel Misalignment and Potential for Joint Lock-Up**

J. Mallela, S. Rao, and P. Littleton<sup>\*</sup>

### **Abstract**

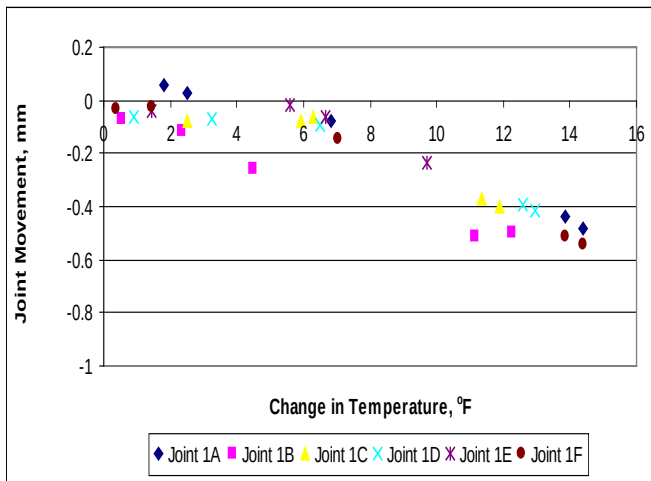
(a) Category 1 Joints.

Figure 3. Joint movements recorded at the various joints tested.

The following observations can be made from the figure 3:

- All the joints tested including those in category 5 (with the highest number and degree of dowel misalignment) experienced joint movements as a function of temperature change.
- The magnitudes of the joint movements in categories 2 through 5 appear to be relatively in the same order of magnitude when compared to the control category (category 1) which had perfectly aligned joints.
- Generally speaking, the trends in the joint movement as a function of the temperature are as expected for all joint categories, i.e., as the temperature rises, the joints close.
- There is a fair degree of variability in the movements experienced by joints within a given category. This appears to be true for all the joint categories.

This relatively small but practical study illustrates that unfavorable dowel misalignment measurements do not necessarily result in “locked” joints. While MIT Scan is a good screening test, joint movement measurement is a relatively straightforward technique that could be made a part of the overall evaluation of joints suspected to have poor dowel alignment. The results of this evaluation could be used to refine rejection criteria and to develop corrective measures. Based on the limited empirical evidence gathered from this study, those joints suspected to cause joint “lock-up” in fact did not show such behavior in the field. Hence removal and replacement of these slabs may be unwarranted, unnecessary, and expensive. Further work to evaluate the potential to use the results from this diagnostic test is recommended.
