# CRCP on the Ben Schoeman Freeway – No Alternative

Dr Anna-Carin Brink<sup>1</sup> and Mr Kevin Pickard<sup>2</sup>

## Abstract

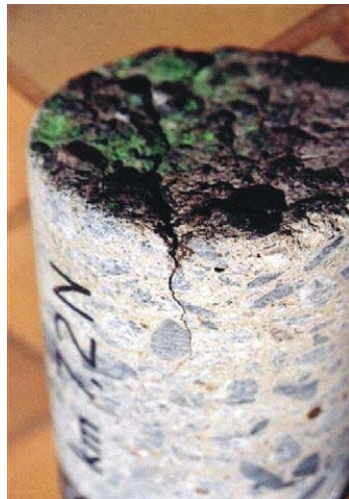
The first core was drilled at N1/21 km 7.2 on the northbound carriageway where the road surface had weathered considerably more than the rest of the road. During road construction, problems had been experienced along this section as the component of the ground granulated blast-furnace slag (ggbs) in the 70:30 – cement:ggbs in the concrete mix was exceeded. Although the core was drilled on a transverse crack, the concrete proved to be structurally sound, with the crack feathering out about two-thirds of the depth of the core (Photo 1).

**Photo 1: Surface weathering due to high ggbs content (left)**  
**Photo 2: Transverse crack showing no signs of pumping (right)**

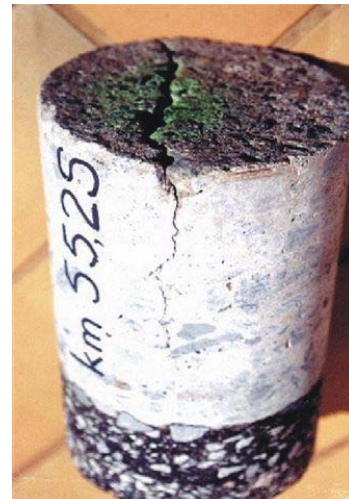
The second core was drilled at N1/20 km 55.2 across a transverse crack that apparently showed signs of pumping. Although the crack was approximately 5 to 10 mm wide on the road surface, the crack also feathered out about two-thirds through the depth of the core (Photo 2).

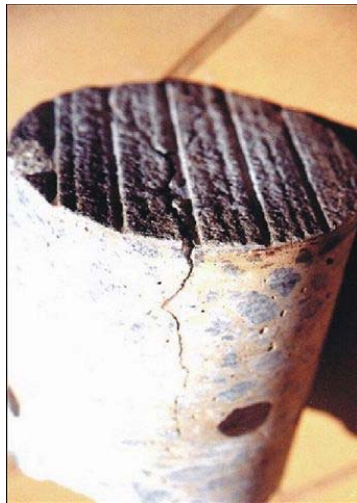
Finally, in an attempt to obtain a core that was cracked right through, a position was chosen at N1/21 km 3.8 on the southbound carriageway, where a transverse and random crack met and where pumping was also observed, (Photo 3). Unfortunately, the core had to be broken off, as the drilling process was slow due to the high strength of the concrete and the fact that reinforcing steel was encountered.

**Photo 3: Intersection of transverse and random cracks (left)**  
**Photo 4: Good adhesion between asphalt and concrete (right)**

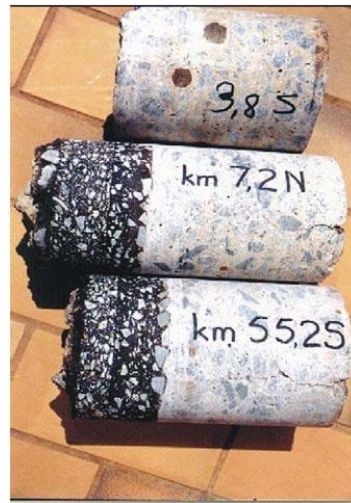
The first three cores confirmed that the existing pavement was structurally sound and that no further drilling of cores was necessary. The cores also showed that there was no ingress of water into the asphalt beneath the CRCP at transverse cracks, since no stripping of asphalt was evident. Nor was there any movement of the CRCP relative to the asphalt, as there were no gaps between the CRCP and the asphalt (Photo 4). Signs of pumping on the surface were therefore defined as stains originating from an unknown source.

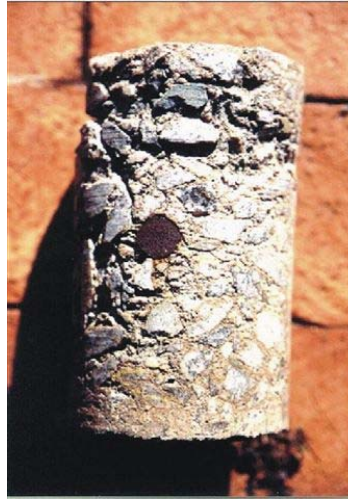
During construction of the CRCP in 1987/8, inadequate mixing of the cement and ggbs did occur at times. The relevant sections of concrete were removed, but cores were taken from these sections prior to their being broken out. Photo 5 shows the extent to which one of these cores had weathered after 10 years of exposure to the elements.

**Photo 5: Weathering of concrete containing badly mixed cement/ggbs mixture, after 10 years' exposure to elements**

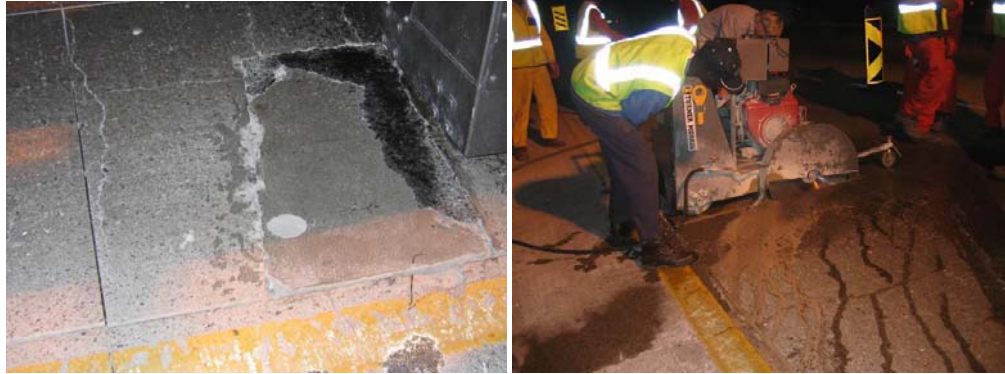
**Photo 6: Pop-out in slow lane – temporarily repaired with asphalt (left)**

**Photo 7: Saw-cutting along edge of repair patch (right)**

Once the repair areas were identified (Photo 6), they were scanned with ferro scanners to locate the position of existing steel reinforcement. This was in order to cut marked areas within reinforcement boundaries so as to minimize cutting of further bars with the inevitable over cuts. It was decided from the outset, due to time restraints, that the concrete would be cut full depth and lifted out in full panels. The following is a summary of the construction sequence and observations made during the process:

- ☐ Saw cut into panels of 1.5 x 1.2 m. Cutting of heavily reinforced concrete needs specially designed diamond blades (Photo 7).
- ☐ Drill holes and fix bolts into panel to lift it out (Photo 8).

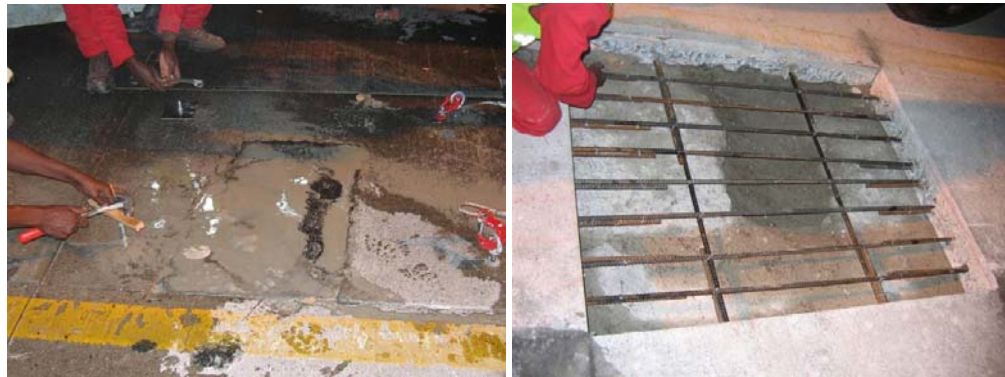
**Photo 8: Anchors fixed to lift out failed concrete (left)**

**Photo 9: Reinforcement steel in place – note tie-bars (right)**

- ☐ Scabble all vertical faces.
- ☐ Re-instate all longitudinal, main and transverse distribution steel (Photo 9).
- ☐ Prime all vertical faces with concentrate of Contec QSF binder.

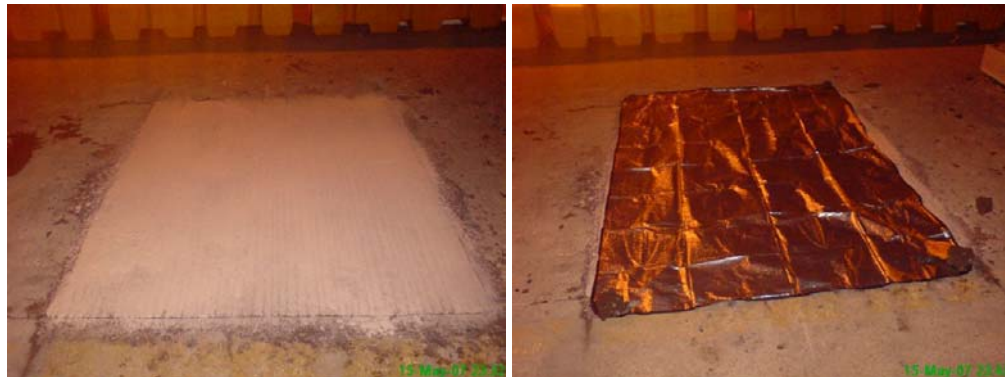
**Photo 10: Repaired with rapid hardening concrete (left)**

**Photo 11: Covered with a thermal blanket (right)**

- ☐ Finish off surface texture with soft broom (micro texture) and spring steel tine (macro texture).
- ☐ Cure with a resin based curing compound (Photo 10) and, in cold weather (night time), a thermal blanket to retain heat (Photo 11).

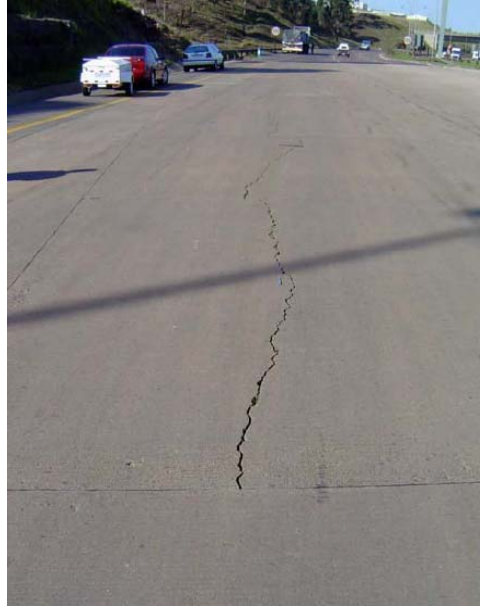
the Mariannhill toll plaza was completed in 1987 (at the same time as the Ben Schoeman was constructed). The original pavement structure consisted of 225 mm un-reinforced jointed concrete with un-doweled transverse joints on two 150-mm thick cement stabilized subbase layers (C3). By 2003 numerous slabs were cracked either longitudinally or transversely, with water and fines pumping out at the joints (Photo 12).

**Photo 12: Longitudinal crack in un-doweled jointed concrete pavement**

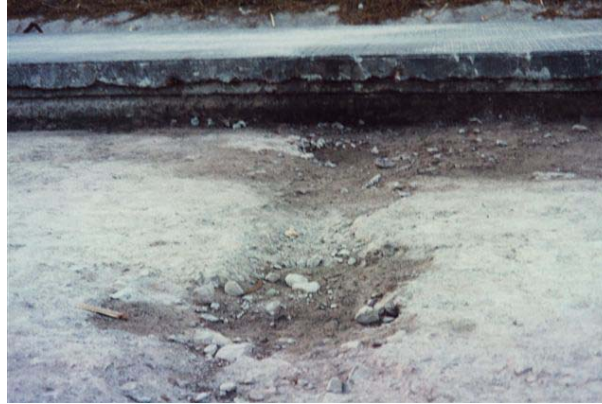
After removal of the concrete slabs, erosion trenches were observed beneath both the longitudinal and the transverse construction joints. These erosion trenches were up to a meter wide in places, and as deep as 100 mm, in other words, two-thirds through the upper subbase layer (Photo 13). A stiff mixture of soil and 5% cement was used to reinstate the subbase levels, prior to repairing the concrete slabs.

**Photo 13: Erosion trenches in subbase beneath transverse and longitudinal joints in concrete pavement**

The trenches observed beneath the joints were a clear indication that there was poor load transfer at the joints in both directions, but also that water got trapped inside the pavement.
