# Performance of a Thin CRCP Inlay Designed for a Five-Year Life: a Case Study

P J Strauss<sup>1</sup>, B D Perrie<sup>2</sup> and D Rossmann<sup>3</sup>

The steep uphill section of an interstate highway had experienced considerable damage in the form of serious rutting due to slow-moving heavy vehicles. The asphalt pavement had had to be rehabilitated every 4 years and a decision was made to mill and replace the top 180mm of the slow lane with a CRCP inlay. The inlay design was based on an anticipated 6 million equivalent 80 kN axles over five years and it was envisaged that a concrete overlay would be placed over the full width of the road at the end of this period. However, at the end of six years only approximately 0.25% of the area of the inlay had shown serious distress. It was decided to determine the remaining structural life of the pavement with a view to repairing failed areas permanently, rather than temporarily, if the remaining structural life was found to be significant.

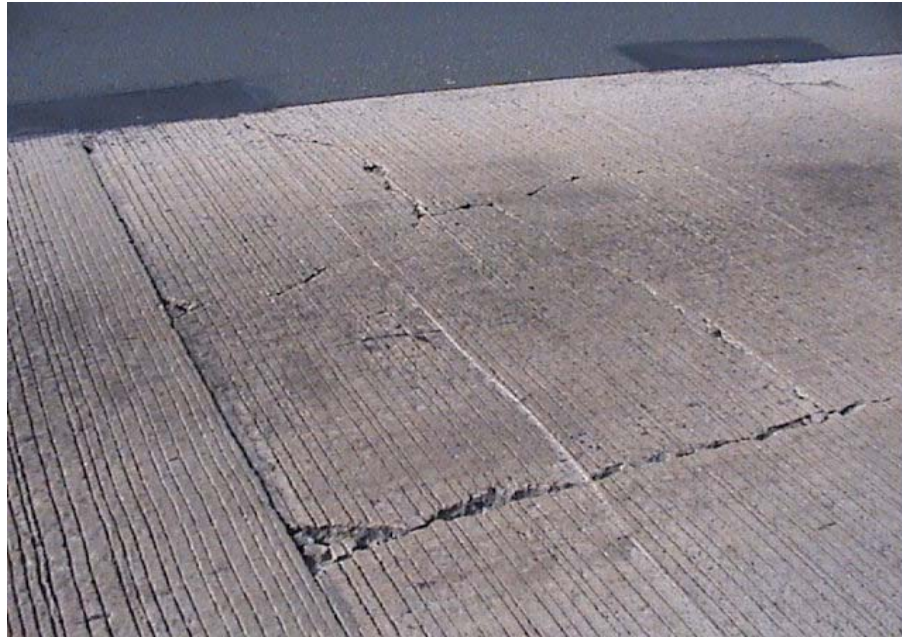
The CRC inlay was designed to carry 6 million equivalent 80kN (E80) axle loads and several punch-outs had occurred after approximately 7 million E80 axle loads. Figures 1 to 3 illustrate the type of distress encountered on the pavement which was found to lead to the development of punch-outs as typically experienced on the CRC inlay. Figure 1 shows the most likely location where a punch-out is to be expected, namely at a construction joint where closely spaced and erratic cracking occurs at a permeable edge joint between the concrete inlay and the adjoining flexible pavement. The cracks are normally associated with relatively poor concrete, possibly caused by segregation, excessive fines, excessive water in the concrete or adverse environmental conditions during construction. As soon as the cracks start showing spalling, relative vertical movements occur under a wheel load moving across the cracks, initiating a loss of load transfer and a loose block develops as shown in Figure 2. This is defined as a punch-out since the block will become loose and create a safety hazard. Figure 3

**Figure 1.** A cluster of cracks at a transverse construction joint and an open edge joint

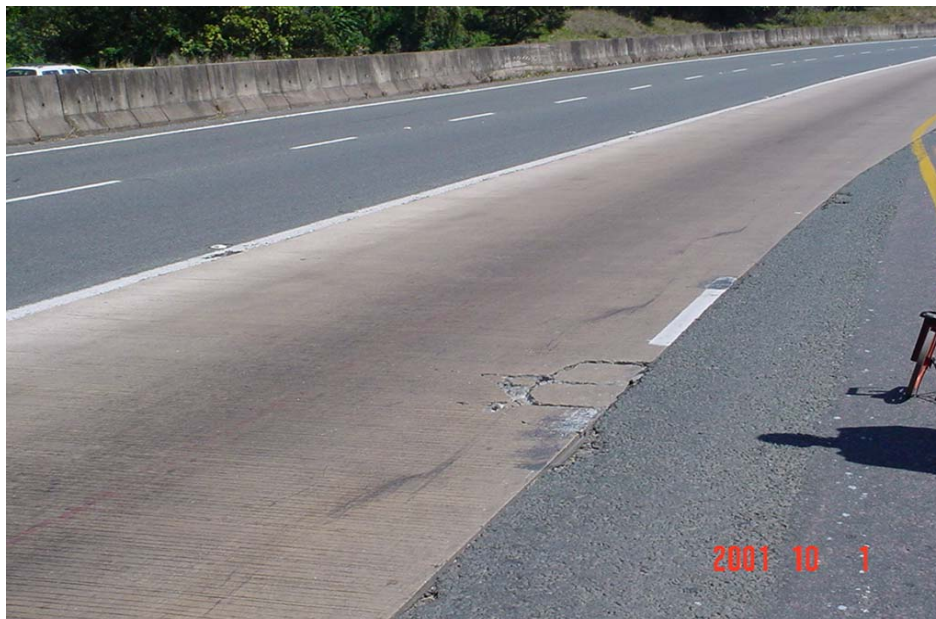
**Figure 2.** A cluster of cracks, an open edge joint and edge loading lead to a punch-out

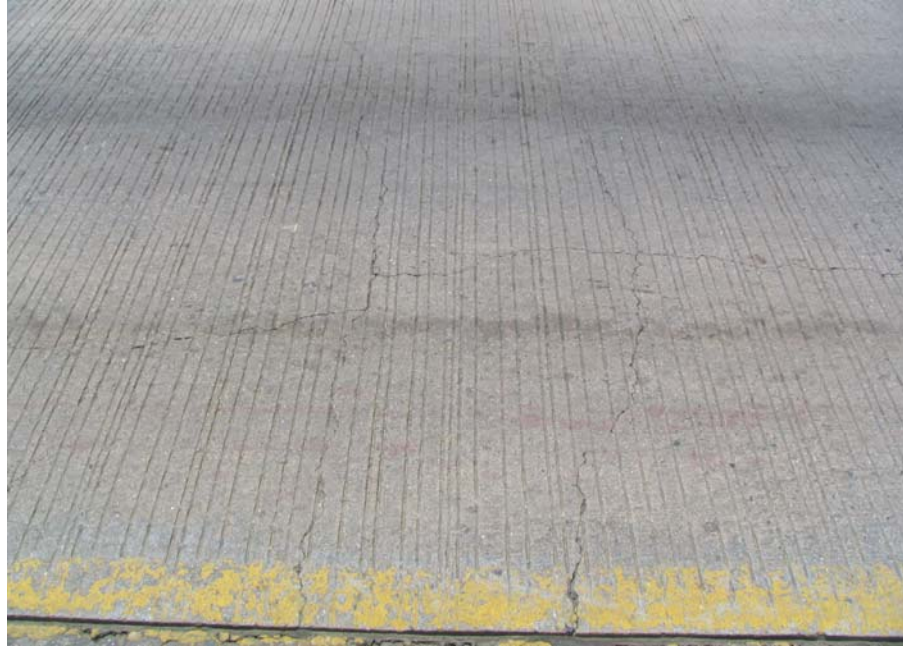
shows the development of a longitudinal crack down the middle of the travelling lane as a result of a combination of a loss in slab support at the edge of the pavement and wheel loading close to the edge of the inlay.

**Figure 3.** Longitudinal cracks at clustered transverse cracks can lead to punch-outs

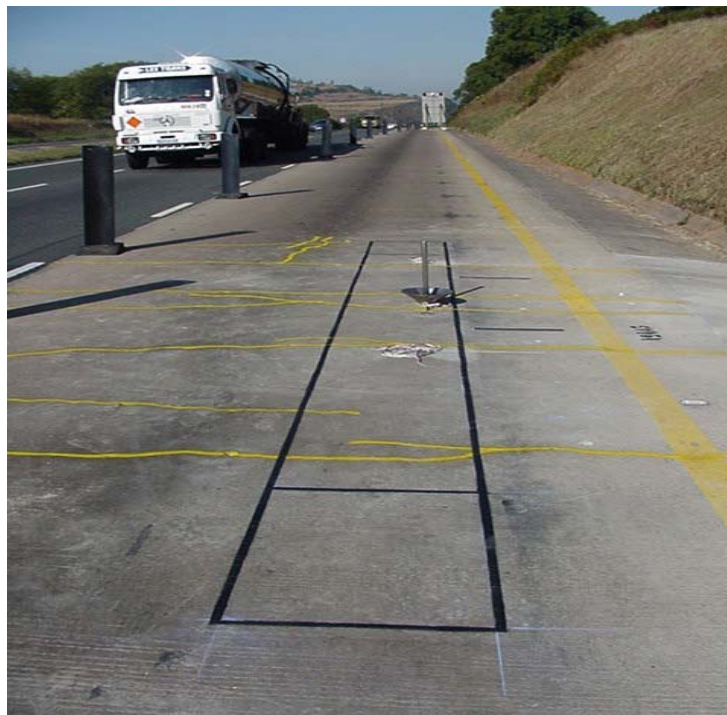
In order to obtain an indication of remaining life, a section was selected for testing with the HVS in a location where the existing crack pattern suggested the potential of a punch-out developing. As shown in Figure 4, cracks occur in a cluster with some secondary cracking already occurring – suggesting the possibility of imminent failure.

**Figure 4.** Test site for HVS testing

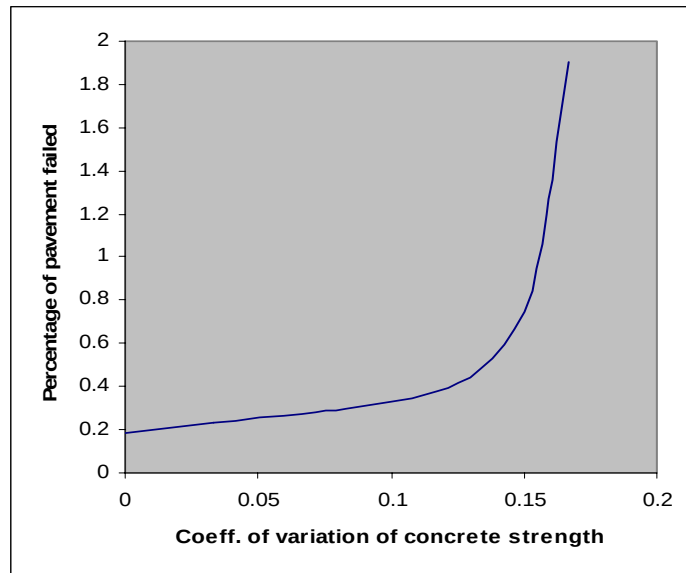
The effect of variable concrete strength on the development of punch-outs can be illustrated by a plot, shown in Figure 6, of variation in concrete strength versus percentage of inlay failed after 7 million equivalent load applications. The mechanistically-based design program cncPave, which uses variation in input parameters to predict the area failed through Monte-Carlo simulations, (Strauss et al. 2001 and 2004) was used to develop the curve. The area failed was calculated assuming an absolute maximum value for concrete strength likely to be attained in the field and the coefficient of variation for concrete strength was allowed to increase from 0 to a value of 0.17. Figure 6 clearly illustrates the importance of uniform concrete in the construction of inlays. It is also clear that a coefficient of variance in concrete strength above 0.15 implies a high risk of punch-outs occurring.

**Figure 6** The effect of a variation in concrete strength on the development of punch-outs

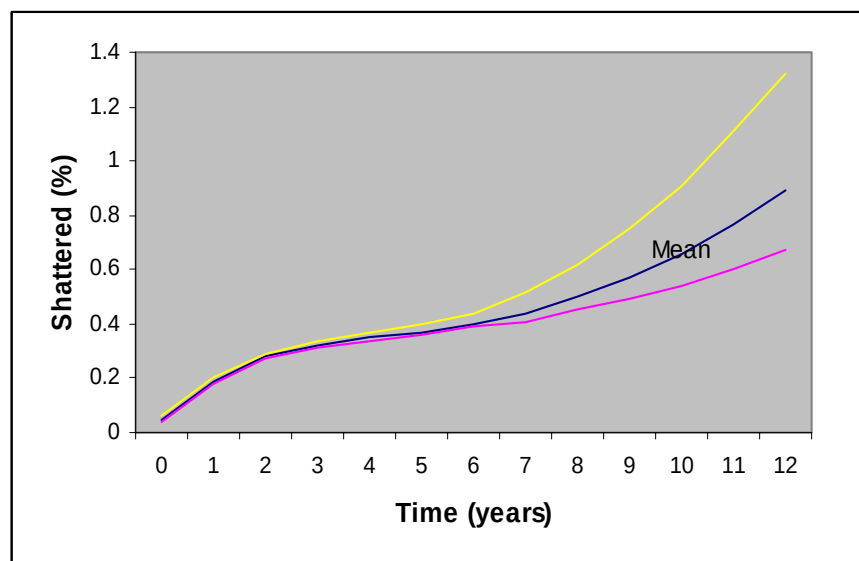
Figure 7 shows a plot that can be compiled using this information as well as a more detailed evaluation using the concrete pavement design program cncPave. This figure shows the best estimate of the area of failure likely to occur (defined by the mean on the graph) as well as the optimistic (ninetieth percentile) and pessimistic (tenth percentile) values based on variation in design parameters.

**Figure 7.** Percentage cracked CRCP on N3 to be repaired as a function of time
