# **The High Performance of the Concrete at the Shuttle Landing Facility**

William R. Weiss<sup>1</sup>, P.E., Bob Bryan<sup>2</sup>

## **Abstract**

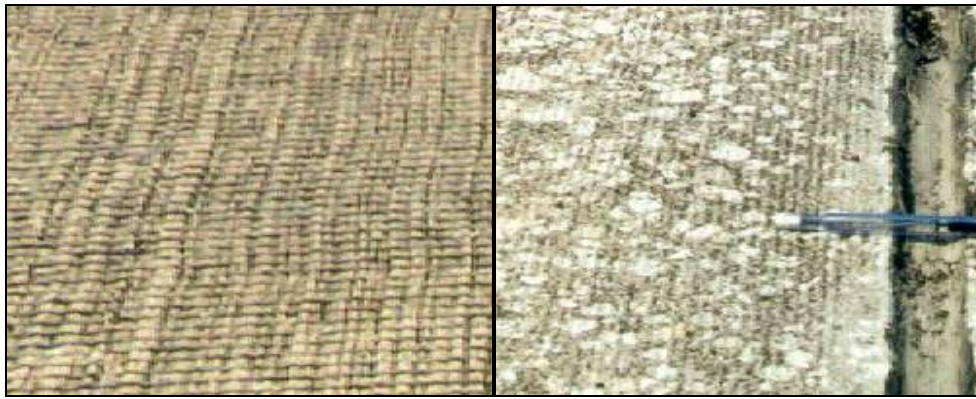
The original texture on the SLF was an extremely rough surface produced by a brush dragged longitudinally through the plastic concrete creating numerous peaks and valleys. This texture represents the macrotexture that can be felt by rubbing one's hand across the surface of the pavement. In addition, the entire runway was grooved transversely (see figure 1, left side). The original thinking was that most of the tire wear occurred during the spin-up phase when the tire first contacted the pavement. In 1988, the nominal touchdown regions of the runway were diamond ground deep enough to remove the original transverse grooves (figure 1, right side). These regions are the first 1,067 m (3,500 ft) at each end of the runway and now resemble corduroy with its texture aligned with the centerline of the runway.

Figure 1. Original texture on runway (left), corduroy texture after milling (right).

The diamond ground ends helped to reduce the spin-up wear on the tires, but it was discovered after additional landings and tests that the rollout phase (the distance between the main gear down and the orbiter coming to a complete stop) still added unacceptable tire wear. Further, it was discovered that the diamond ground surface had little or no effect in reducing tire wear during the rollout, so simply milling the remainder of the runway would not have corrected the issue. At this point, despite the improvements in tires and texture modifications, the runway was still short of the operational goal to handle landings with 20-knot crosswinds. However, the limiting factor was now known to be excessive tire wear during the rollout, whether induced by the pilot maneuvering the orbiter or a crosswind, both of which produce tire side energy. Extensive studies focused on the rollout phase and how additional texture modifications could satisfy operational goals, yet offer enough texture during wet conditions. A second and final texture modification was performed in 1994 over the entire runway surface using a Humble Equipment Company Skidabrader<sup>TM</sup> shootpeening machine. This device uses pressurized air to propel small steel shot at the pavement, basically rounding off the sharp peaks and reducing the average texture depth. After impact, the shot and any debris were vacuumed up, and the SLF was finally in full compliance operationally (Daugherty, 1997).
