## **Design, Construction, Performance and Future Direction of Dowel Bar Retrofit in Washington State**

**Linda M. Pierce, PE**  
Pavement Management Engineer  
Washington State Department of Transportation

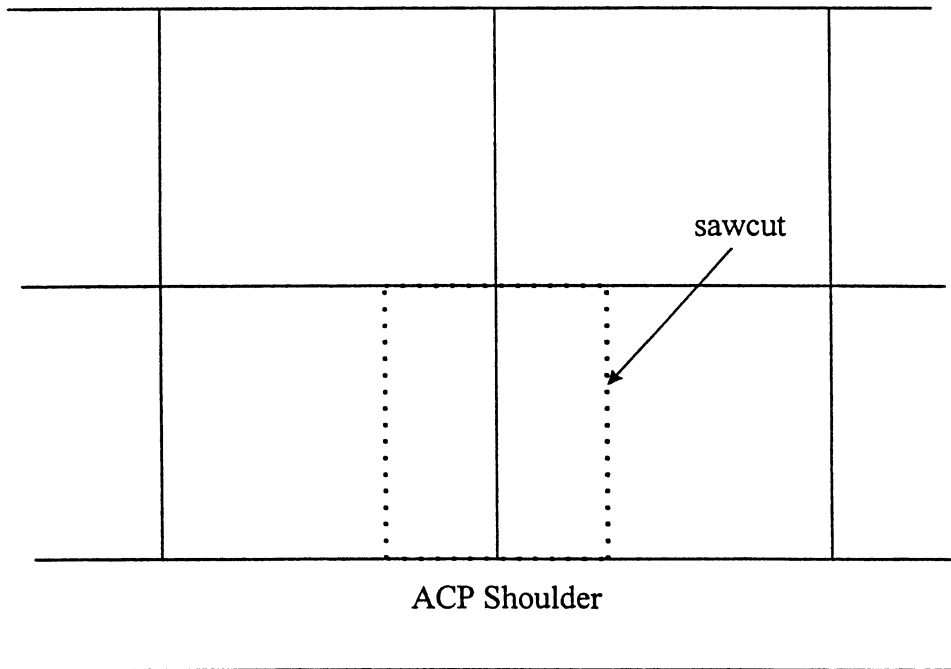
Figure 1. Sawcut Detail for Panel Removal.

In order to verify the results of the FWD testing and the void detection method, WSDOT lifted (removed) nine slabs in various locations across the state. Since the transverse joints were the area of concern, sawcuts were made approximately 1.5 m (5 ft) on either side of the joint and along the longitudinal joint between the concrete lanes and the asphalt shoulder (Figure 1).

The sawcut concrete was then lifted vertically to expose the underlying base material. From this analysis, it was determined that voids developed only in locations where the underlying base material was cement treated base. All other locations, where the base course material was crushed stone, no void could be detected. At these locations it appeared that the fine material mitigated upward as well as horizontally across the joint, resulting in a wedge of fine material directly beneath the slab, presumably causing a reduction in slab support. This hypothesis is supported by the gradations taken on either side of the joint for the wedge material and for the crushed stone base. Without exception, all tests showed that the base material beneath the leave slab was finer than the material beneath the approach slab. In addition, measurements were taken on the topography of the concrete slab and the wedge material, it appears that the faulting measurement and the height of the wedge material are roughly equal. Measurements were taken when the slab temperatures were approximately 16°C (60°F), when slab curling was improbable.

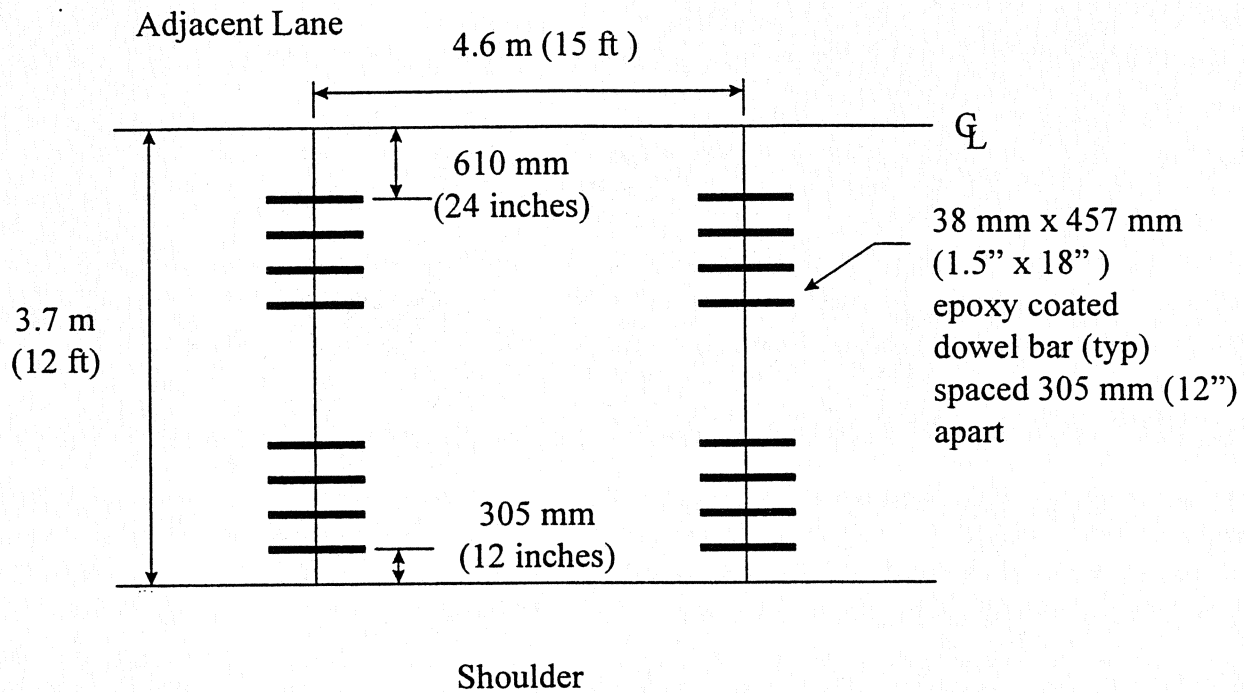
Figure 2. Dowel Bar Retrofit Layout.

The dowel bar slots were cut to a width of 64 mm (2.5 inches), a depth of approximately 146 mm (5.75 inches) or as required to place the center of the dowel at mid depth, and the required length for bar placement. The dowel bars were spaced 305 mm (12 inches) apart. The first dowel bar in the outer wheel path was placed 305 mm (12 inches) from the lane/shoulder edge. The first dowel bar in the inner wheel path was placed 610 mm (24 inches) from the longitudinal joint with the adjacent lane (see Figure 2 for dowel bar layout).

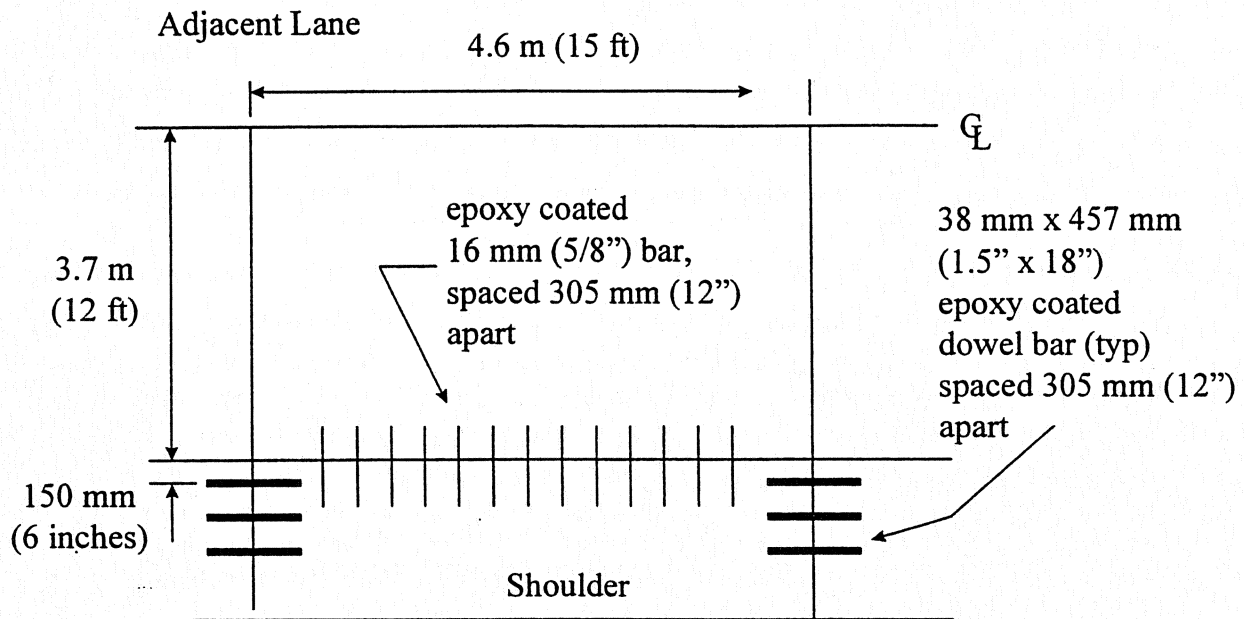
Figure 3. Tied Shoulder Layout.

A major advantage in using tied PCC shoulders or a widened concrete outside lane is the reduction in slab stresses. Reducing slab stresses has shown to increase the pavement performance life. Therefore, to minimize edge stresses a 1.2 m (4 ft) concrete shoulder was tied to the existing outside lane with 16 mm (5/8 inch) reinforcing bars with a length of 762 mm (30 inches). Three epoxy coated dowel bars were also placed in the transverse contraction joints (see Figure 3).

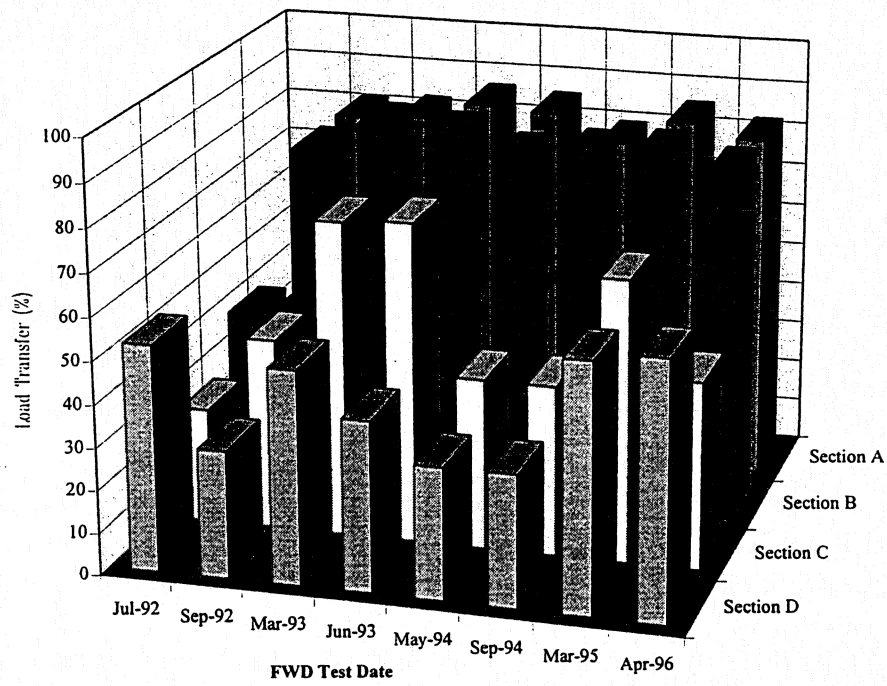
Figure 4. Joint Load Transfer Efficiencies.

In summary, the experimental features which contain dowel bars at the transverse joints, Sections A and B, have maintained an average joint load transfer between 80 to 90 percent over the last 4 years. In addition, out of the 48 joints that were measured for joint faulting, only 5 joints have faulted 1.6 mm (1/16 inch) and one joint has faulted 3.2 mm (1/8 inch). Section C (concrete shoulder beam only) has not performed as well as expected. One reason for the lower performance may be that Section C had the lowest initial joint load transfer efficiency and there may be a point at which the load transfer efficiency is too low to expect improvement with only a tied concrete beam. The control section is performing as expected with a reduction in joint load transfer efficiency and essentially all joints having measurable joint faulting.
