## EVALUATION OF THE IMPACT OF CONCRETE PAVEMENT RESTORATION TECHNIQUES ON PAVEMENT PERFORMANCE

Yi Jiang  
Special Projects Engineer  
Indiana Department of Transportation  
Division of Research  
West Lafayette, Indiana

### ABSTRACT

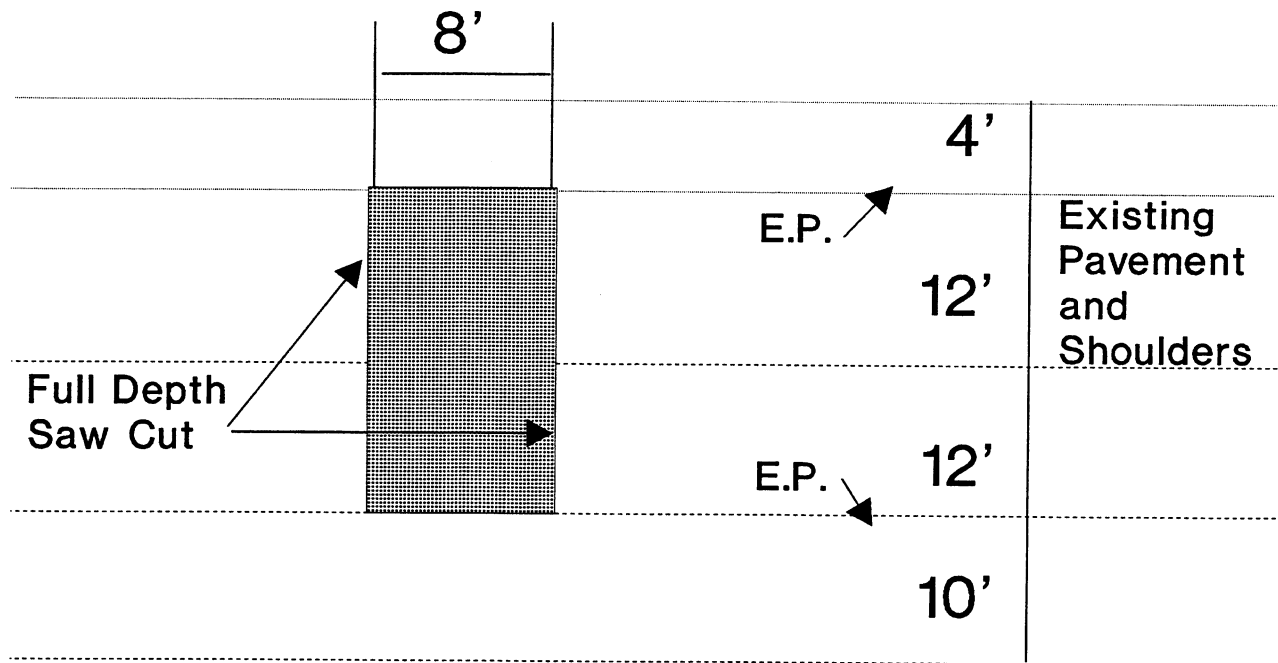
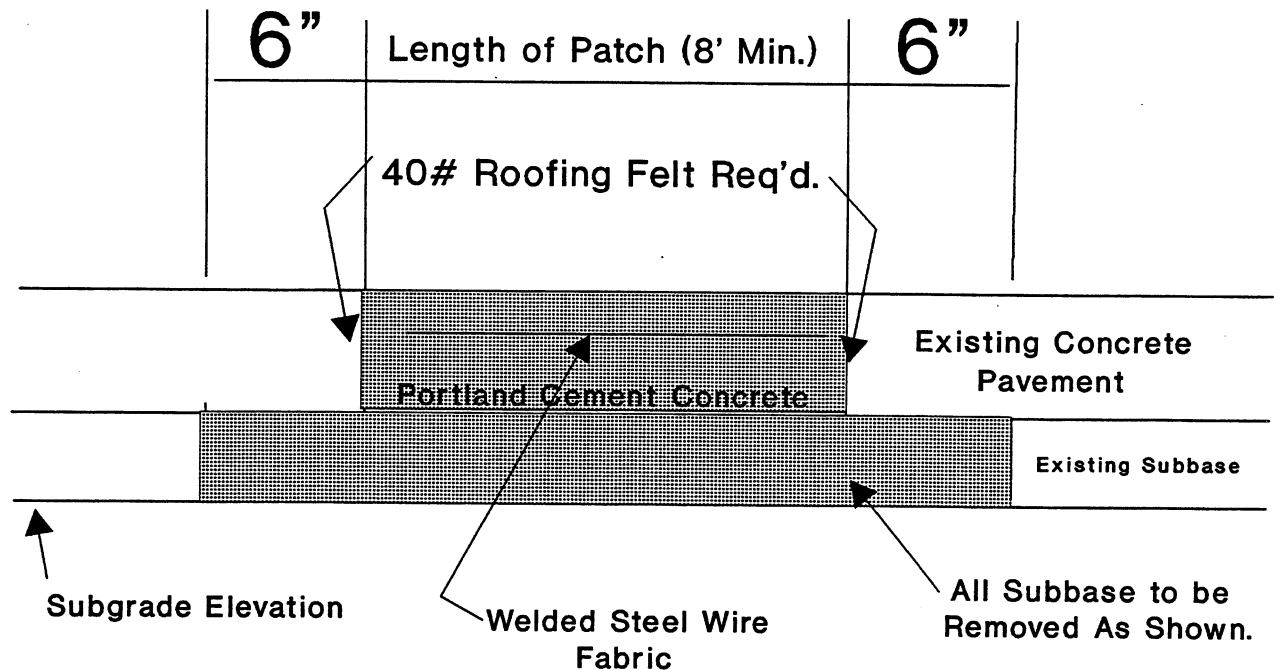
Figure 1: Inverted T Full Depth Patch

Both types of inverted T patches (with or without center contraction joint) had better load transfer than the dowelled patches. Apparently, the added concrete under the adjacent existing slab acts like a "sleeper slab" and improves load transfer between slab and patch. The load transfer coefficients at the last joint on each of the inverted T patches were relatively high even though the sawn face provided very little grain interlock at the joint. It was also noted that in the direction of traffic, the first joint for each of the three types of patches had lower load transfer coefficient than the last joint of these patches. Load transfer is achieved by mechanical devices, such as dowel bars and sleeper slabs, and/or grain interlock between adjacent slabs. However, the above observations may imply that some other factors may also affect the values of load transfer coefficients. In an attempt to explain the observations, it was found that load transfer was also affected by the strength of the pavement which the load was applied to. The values of deflections (sensor No. 1 reading) and load transfer coefficients for each type of patches are given below:

The inverted T patches showed very good load transfer. Slight faulting was found one year after CPR. The slight faults also remained the same by the end of the five year period.

**Inverted T Full Depth Patching:** The INDOT Standard Pavement Joints Sheet A specifies ten 1.25" diameter dowel bars for this type of patches. However, the inverted T full depth patches in this project did not have dowel bars and performed very well. Based on the results of this study, it is therefore recommended that the inverted T patching without dowel bars be applied on Indiana highways to save the extra labor and material costs of dowel bar installation. It should be emphasized that the concrete in the underpinned areas must be well consolidated to minimize faulting and improve load transfer efficiency.

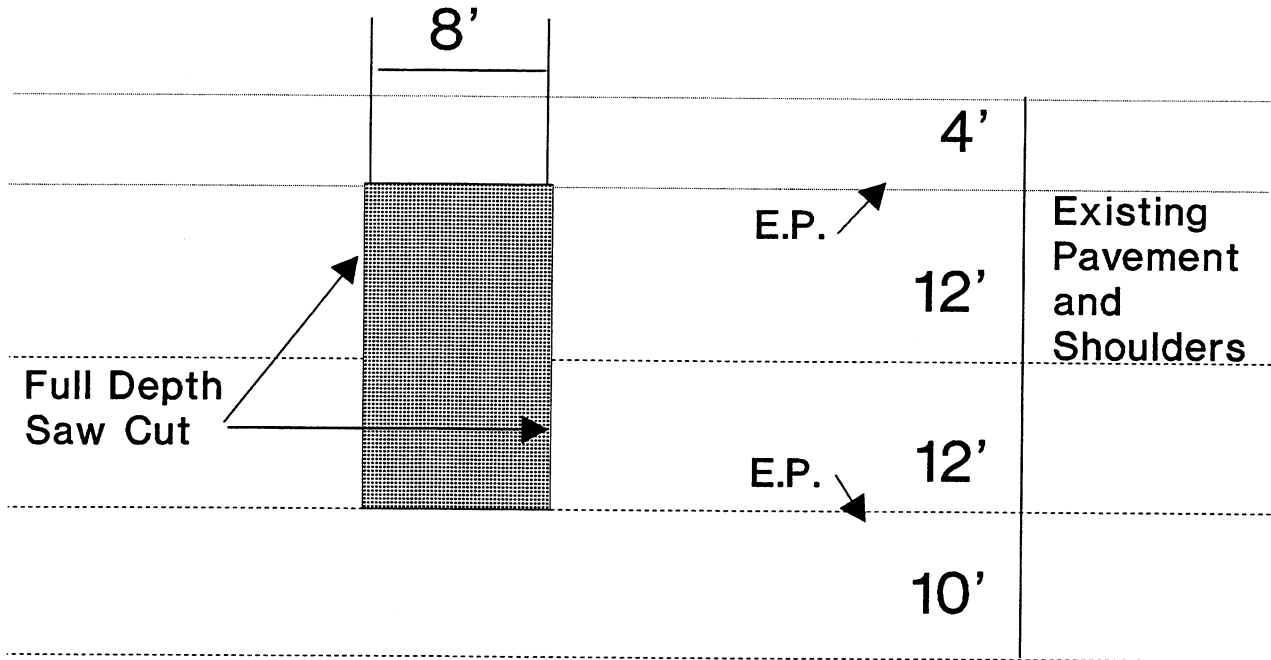
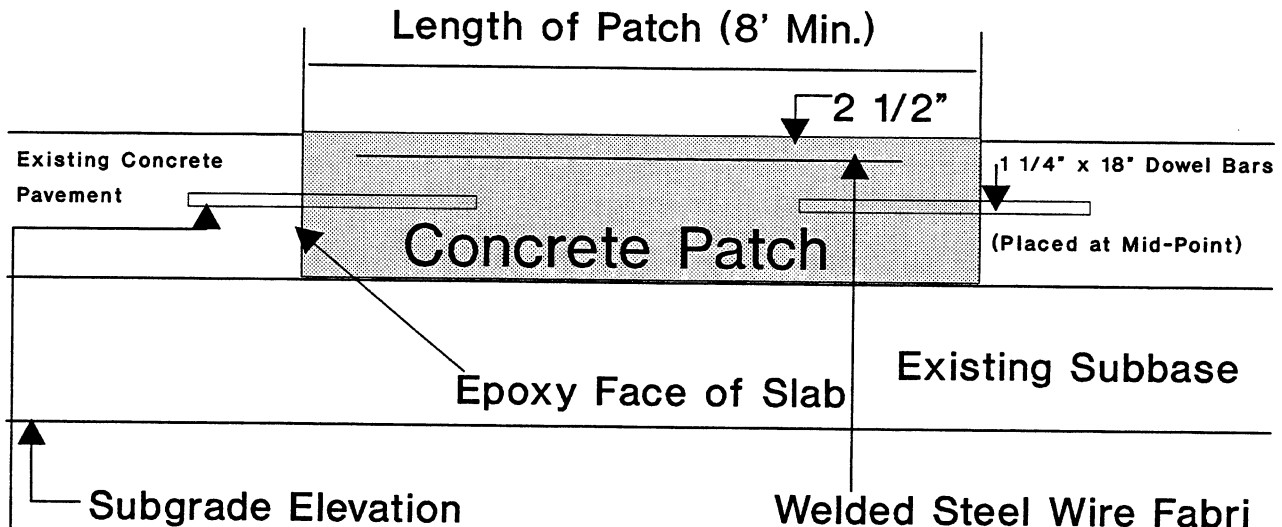
Figure 2: Dowelled Full Depth Patch

Dowel bars are spaced 1, 2, 3, 8, 9, and 10 feet from the outside pavement edge.

The low load transfer coefficients for dowelled patches were probably attributed to:

1. inadequate number of dowels (six) along the joint on this type of patch,
2. relatively lower strength of the concrete slab compared to thicker inverted T patch, and
3. disturbance to the subbase cause by patching construction.

All three types of full depth patches functioned well after five years in service. Dowelled full depth patches had slight faulting at construction joints one year after construction. However, the faults did not further develop during the remaining four year period. The load transfer

coefficients of dowelled full depth patches were relatively lower than those of inverted T full depth patches.

Consequently, to improve the load transfer efficiency, more dowel bars should be used for this type of patch. When constructing the dowelled patch, the removal of existing slabs by sawing them and lifting them out would minimize the disturbance to the subbase, and therefore retain the strength of the pavement.

**Dowelled Full Depth Patching:** Six 1.25" diameter dowel bars were used on each side of a dowelled full depth patch for load transfer between the patch and its adjacent existing concrete slabs. However, an FHWA study [7] recommends to use ten 1 1/2" diameter dowel bars for the patching on heavy traffic roads, and the INDOT Standard Pavement Joints Sheet A requires ten 1 1/4" diameter dowel bars for load transfer. The relatively low load transfer coefficients of this type of patches in this project indicated that the number of dowel bars was not sufficient. Therefore, it is recommended that for dowelled full depth patching ten 1.25" diameter dowel bars be used as specified in Sheet A of the INDOT Standard Pavement Joints. Since it was found that the strength of the patches affected the load transfer, attempts should be made to increase the slab strength of dowelled patches. Where practical, the removal of existing slabs by sawing them and lifting them out would minimize the disturbance to the subbase when constructing the dowelled patch. The dowelled full depth patch with more dowel bars can be used as an acceptable alternative to the inverted T patch, if the existing slabs have adequate strength to retain the dowels without their spalling out.

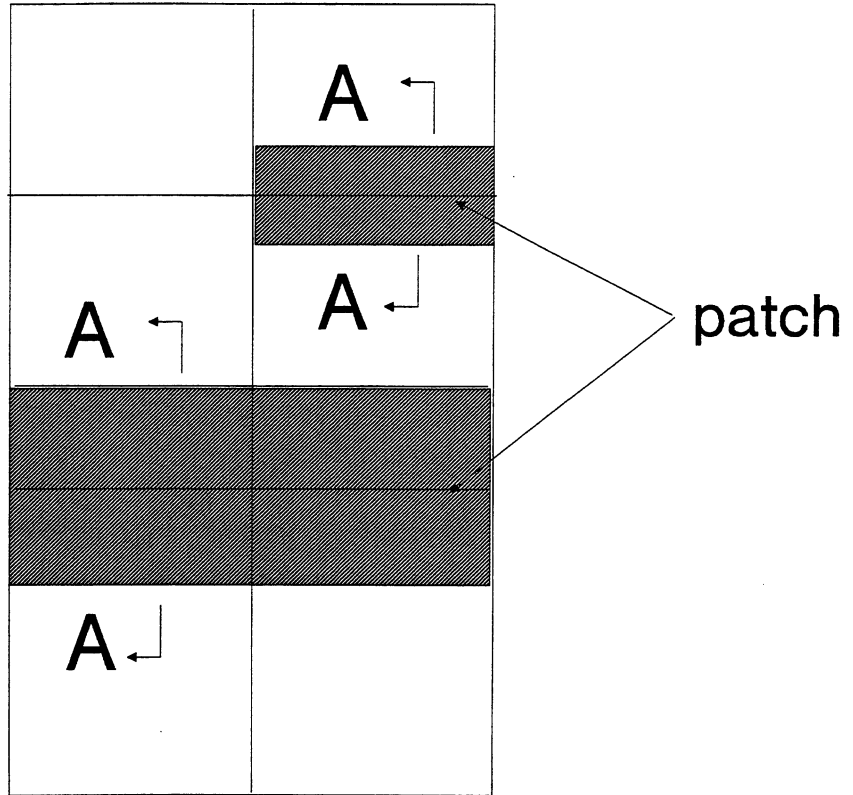
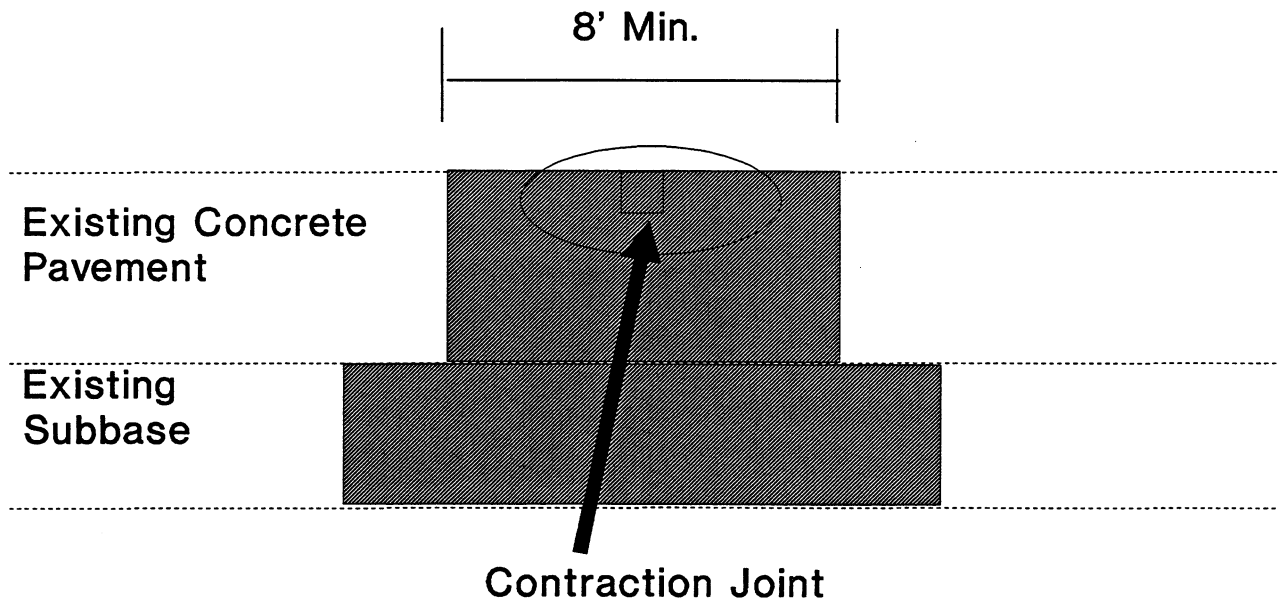
**Figure 3:** Inverted T Full Depth Patch with a Contraction Joint

For the joint replacement inverted T patch, the middle contraction joint had load transfer coefficient of 0.94, which corresponds to solid concrete. This means that the middle joint did not perform as a dowelled joint as desired. Since the patches without a middle joint performed as well as those with a middle joint, the installation of middle joints on inverted T patches was not necessary. Use of dowelled contraction joints in inverted T patches should be discontinued to save the extra cost of installing the middle joint. A dowelled patch or a inverted T patch should be used instead to replace the joint.

The dowel bar assembly in the inverted T patch did not function as a contraction joint and added 15% to the cost of the patch.

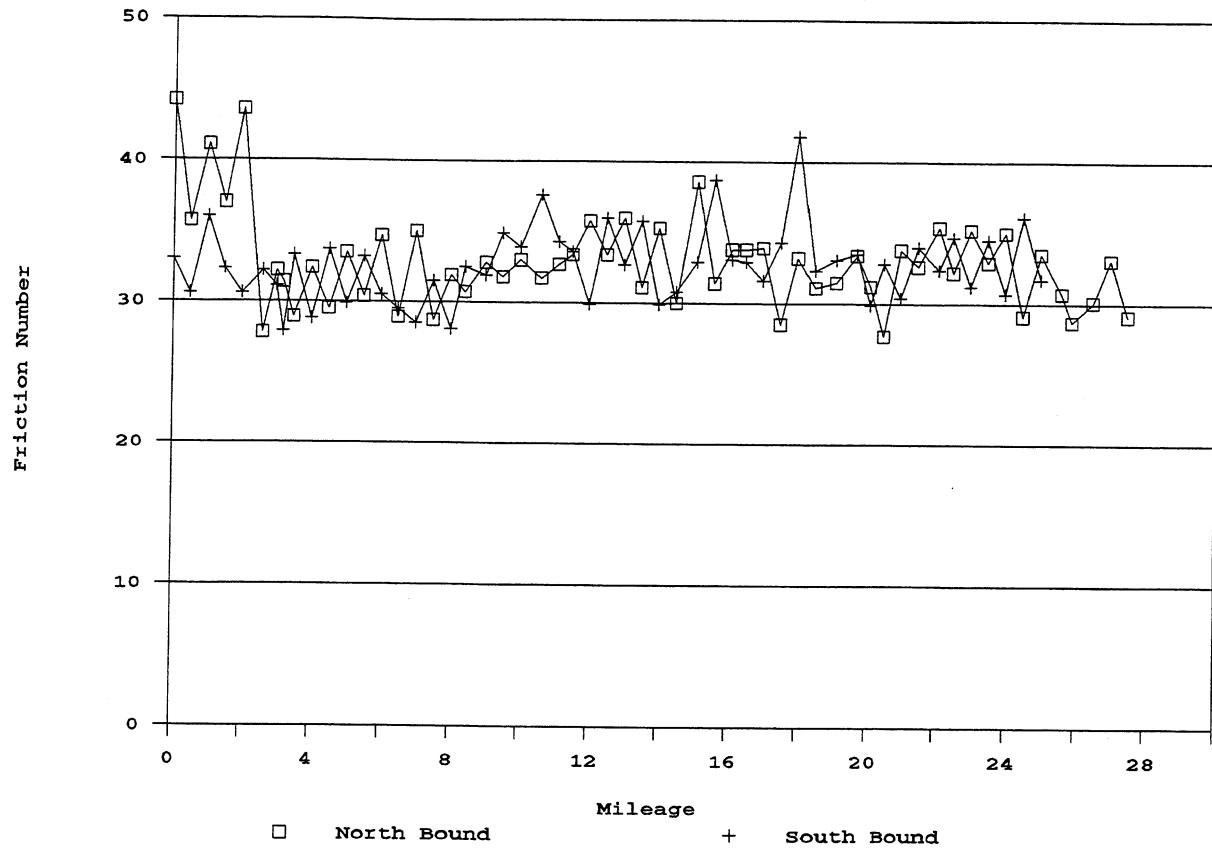
Figure 4: Friction Numbers in 1990

The reason for the increase of friction number in 1986 might be that in the first year after rehabilitation the concrete texture of the ground pavement was being worn away by traffic. As can be seen, after 5 years the average friction numbers have been decreased to 33 from 42. Since friction numbers less than 30 are considered unacceptable, the friction number of 33 indicates that the pavement is very near the terminal friction life. Figure 4 shows the friction numbers of different sections of the pavement in 1990 along the travelling lanes.

It indicates that on several sections the friction numbers were already below 30, or the coefficients of wet pavement friction were below 0.30. That is, 5 years after rehabilitation, some portions of the pavement were once again in a potentially slippery condition, and an immediate repair is recommended to restore the pavement skid resistance on these sections.
