# LONG TERM PERFORMANCE OF UNCONTROLLED LONGITUDINAL CRACKING AND FAILED LONGITUDINAL JOINTS IN CONTINUOUSLY REINFORCED CONCRETE PAVEMENTS

Eric D. Moody

B. Frank McCullough

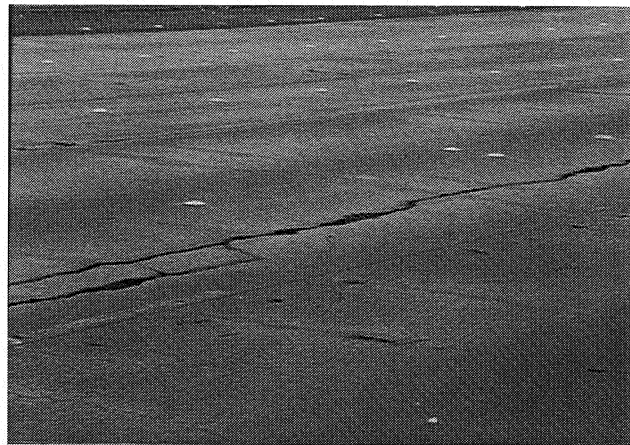
FIGURE 1 Typical uncontrolled longitudinal cracking.

In 1980 the Center for Transportation Research assisted the Houston District of the Texas Highway Department in developing a repair procedure for the extensive uncontrolled longitudinal cracking that was present on I-610 in Houston. An example of this type of cracking is presented in Figure 1. After examining numerous cores, it was observed that the cracks generally formed around longitudinal bars, apparently because of poor concrete consolidation below the reinforcing steel (see Figures 3 and 4). The objective of this repair procedure was to seal the cracks in order to prevent water intrusion and further corrosion of the reinforcing steel.

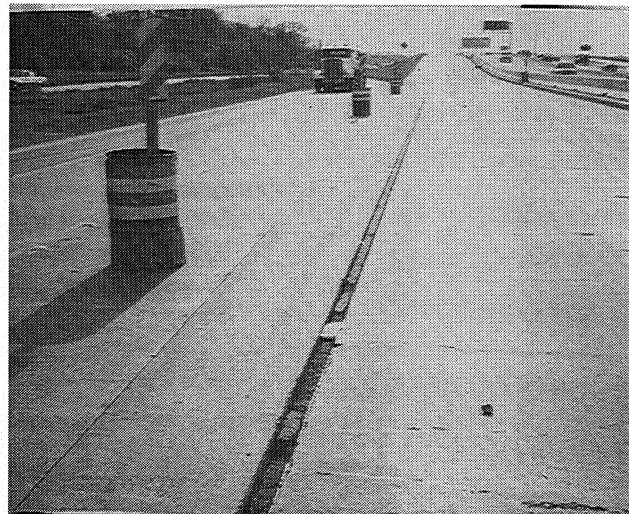
FIGURE 2 Typical failed longitudinal joint.

The second repair technique that this paper addresses is on failed longitudinal joints. An example of this type of distress was given in Figure 2. The objective of the repair is to reestablish load transfer across failed longitudinal joints and cracks and to prevent further widening.

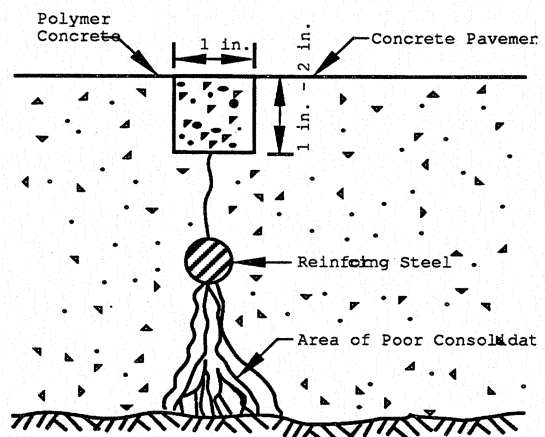
FIGURE 3 Distress Illustration.

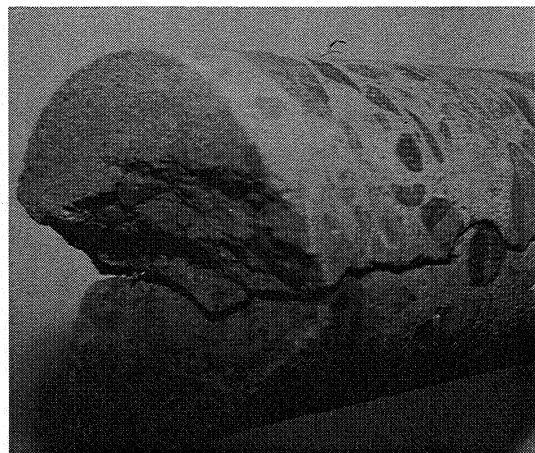
FIGURE 4 Core showing steel bar in crack.

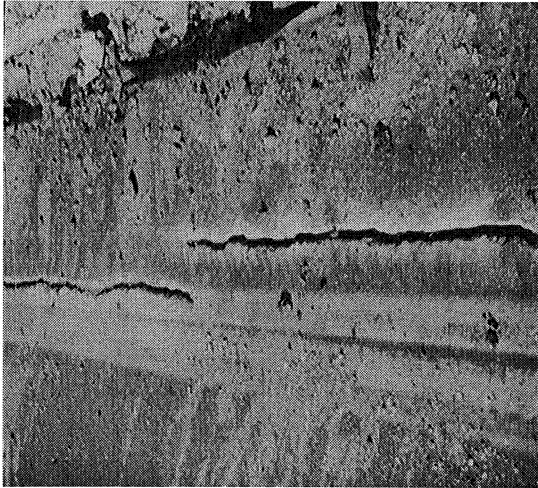
**FIGURE 5** Routed crack.

A single-piston pneumatic crack router (crack chaser) was selected as the best available piece of equipment to enlarge the cracks (Figure 8). The bit had a 0.75 inch diameter, and each crack was enlarged to a width of approximately 1 inch. The crack depth varied, but was usually 0.75 to 1 inch. The polymer was placed by filling the enlarged crack with clean, dry concrete sand and pouring methyl methacrylate (MMA) monomer system over the sand until it was completely saturated (Figures 6 and 7).

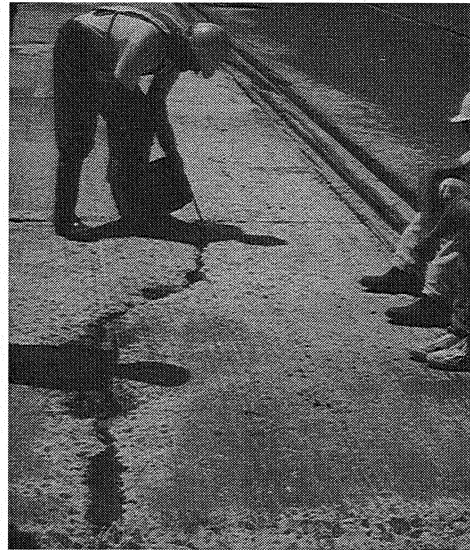
**FIGURE 7** Application of monomer.

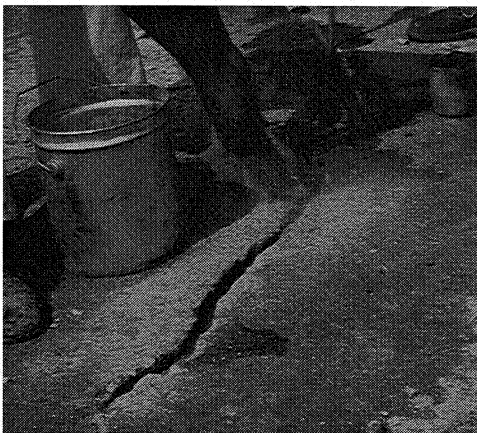
**FIGURE 6** Application of sand.

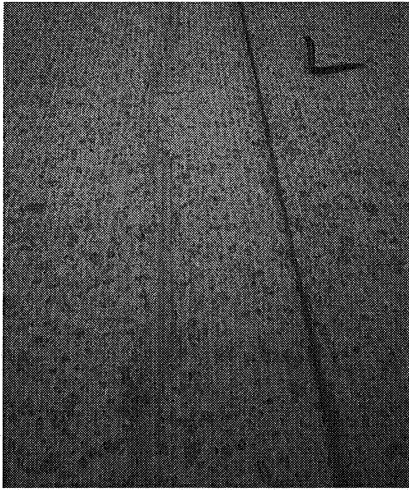
The repairs rated fair or poor generally showed evidence of wear or erosion on the surface, apparently due to evaporation of monomer from the surface or depletion of the monomer caused by leakage through the bottom of the crack during the repair. When a portion of the West Loop was scarified in preparation for placement of bonded portland cement concrete overlays, many of the repaired cracks could easily be observed. In nearly every case, the repairs appeared to be sound with full bond between the PC and original concrete (Figure 8).

**FIGURE 8** Repair after milling.

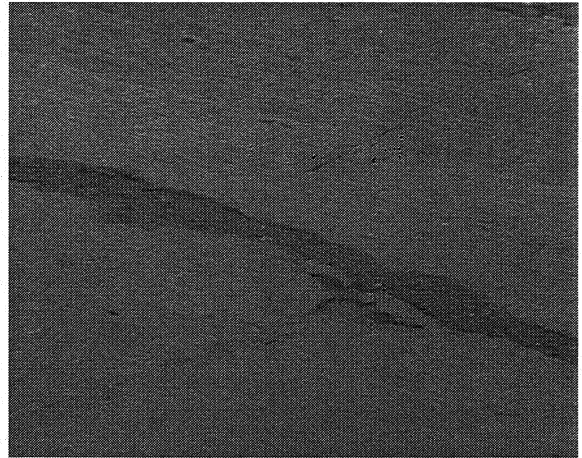
The repairs were evaluated as being in good, fair, or poor condition. A rating of "good" required that the crack be completely filled and sealed with the original repair material. A rating of "fair" required that the majority of the original repair material be in place; the crack could be slightly reopened, and small, infrequent cracks could be evident in the material. A rating of "poor" required that most of the repair material had spalled. Photos representing each rating condition are included in Figures 9, 10, and 11.

**FIGURE 9** GOOD.

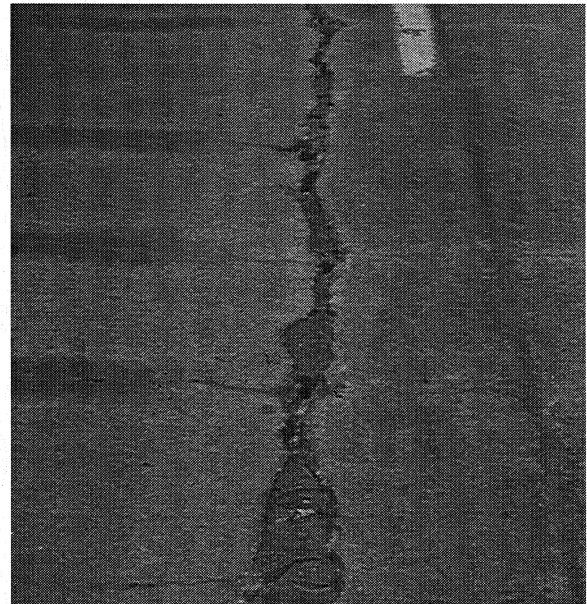
**FIGURE 10** FAIR.

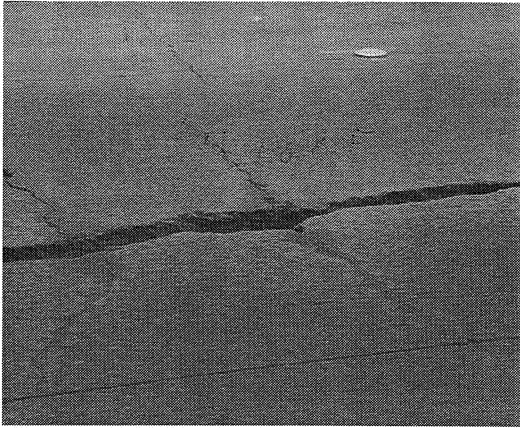
FIGURE 11 POOR.

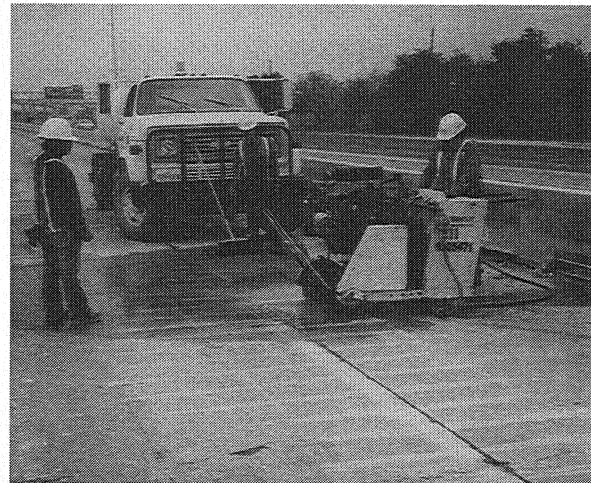
FIGURE 13 Stitching repair process - cutting slots.

In 1989, the Houston District of the Texas Department of Transportation repaired 3,000 linear feet of longitudinal joints on I-610 in Houston. The objective of this repair is to reestablish load transfer by "stitching" the two sides of the crack together. In this context, stitching refers to cutting 1-inch wide slots at 12-inch centers perpendicular to the joint. These slots were cut to a depth of 3 inches and an overall length of 54 inches, centered on the joint or crack. After the slot was cleaned, a #5 tiebar was epoxied in the slot. A drawing of the repair is shown in Figure 12. Normal surface preparation preceded all repairs. Photos of the repair process are shown in Figures 13 and 14.

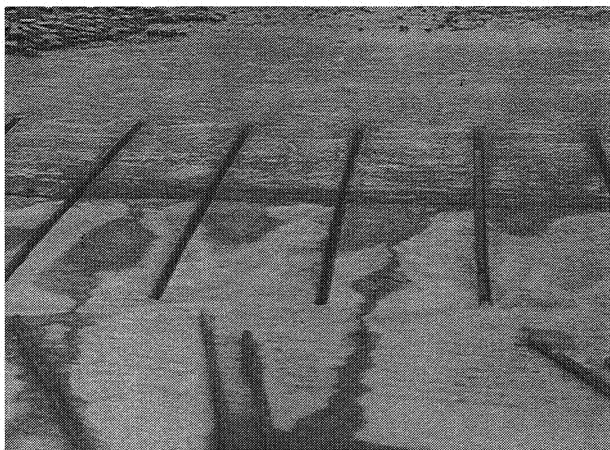
FIGURE 14 Stitching repair process - bar placement.
