## PERFORMANCE OF A CONCRETE PAVEMENT CONSTRUCTED UNDER EXTREME WEATHER CONDITIONS

### ABSTRACT

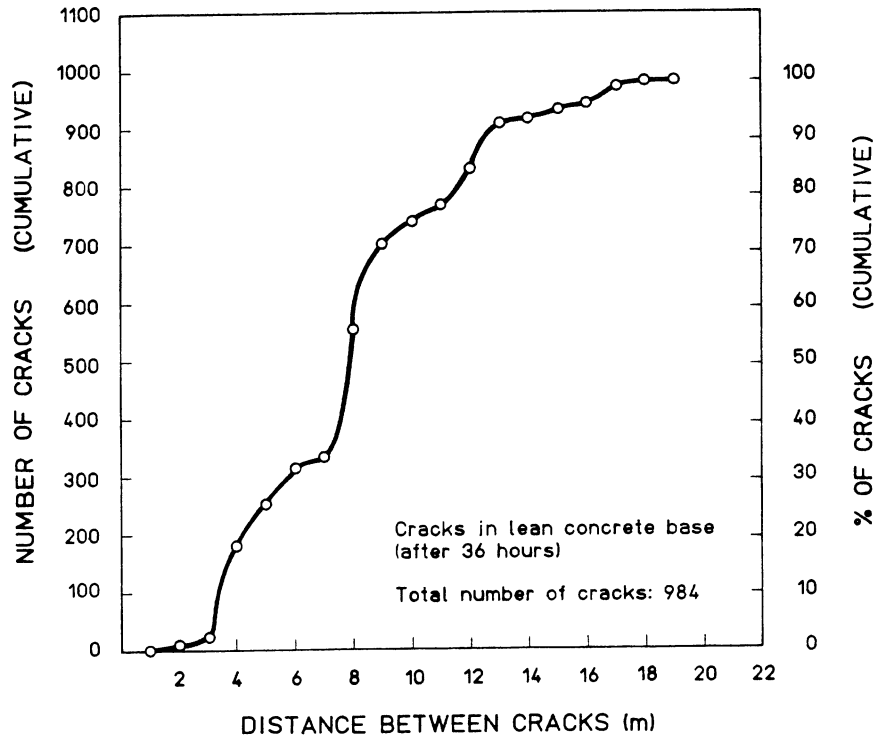
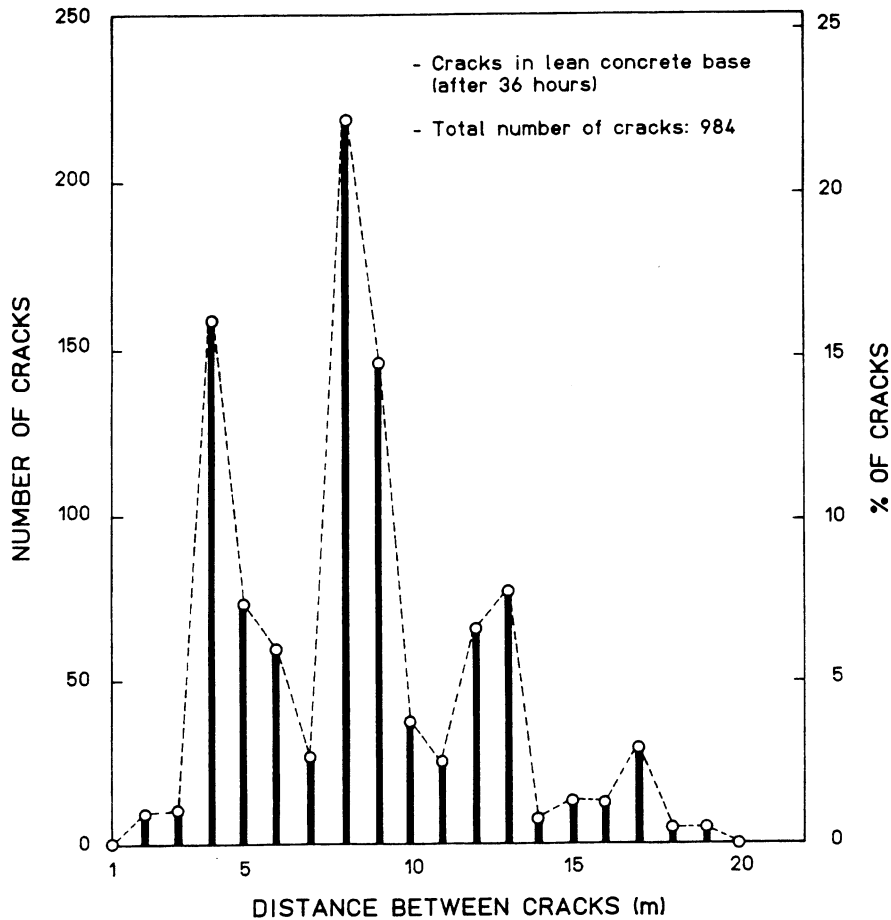
The relationship between the spacing between cracks in the lean concrete base and the number of them observed after 36 hours following placing, is shown in Figures 3 and 4. Figure 3 shows the cumulative curve of the number of cracks, while Figure 4 shows the distribution curve, taking an interval of 1 m in abscissas, which is that which makes an easily interpretable graph. In Figures 5 and 6 these same relations have been shown after a longer term (up to the placing of the top-layer concrete several days later which, as has been mentioned, was the maximum period in which the study on the base could be carried out). The results included in these graphs (Figures 3 to 6) relate to a length of 8,329 m of half the roadway. After 36 hours (Figures 3 and 4), a total of 984 cracks was counted which gives an average distance between cracks of 8.5 m. After several days (Figures 5 and 6), the total number of cracks counted was 1,210, producing an average distance of 6.9 m. Logically, with the passing of time, the number of cracks went on increasing and the average distance between them decreasing until the final situation was reached.

**Figure 3.** Cumulative relationship between number of cracks and crack distance for the lean concrete base (after 36 hours).

**Figure 4.** Number of cracks - crack distance relationship for the lean concrete base (after 36 hours).

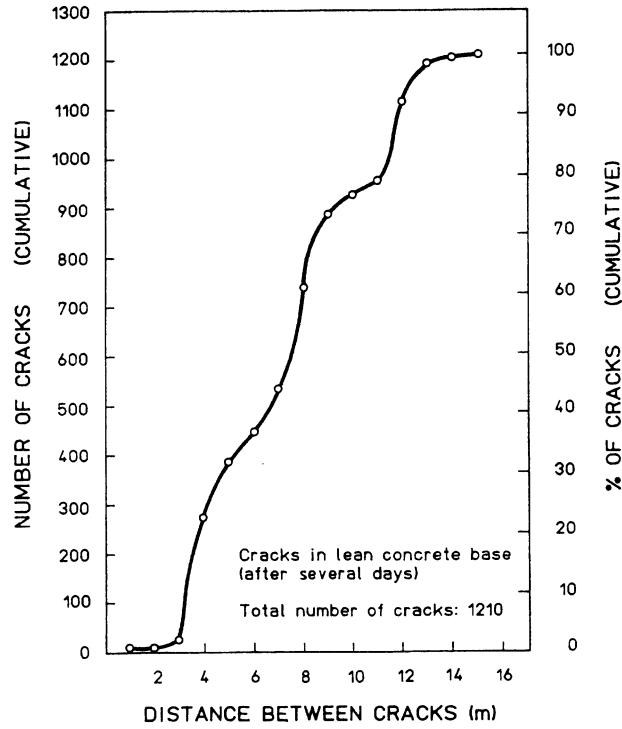
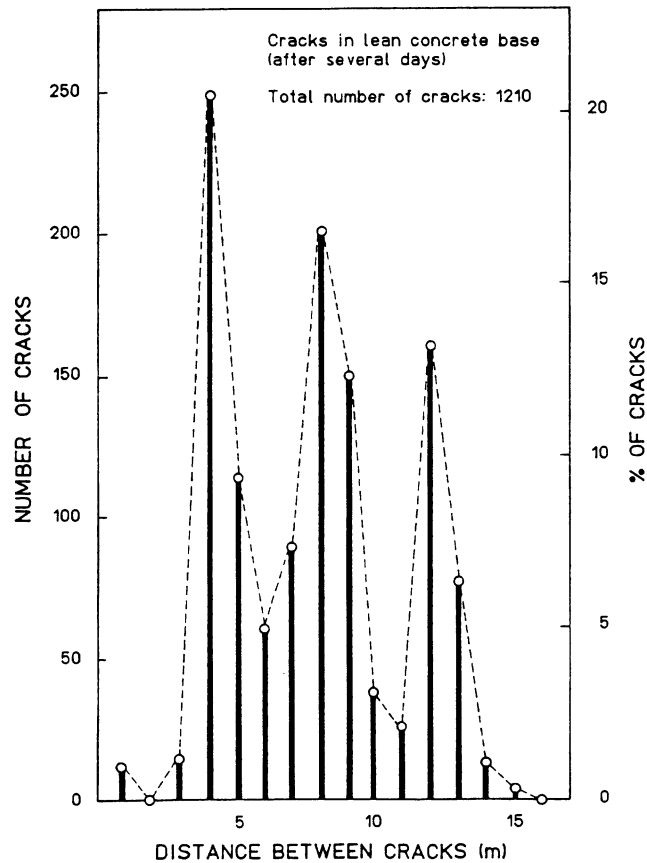
It is interesting to note in these Figures, especially in numbers 4 and 6, that the distances between cracks exhibit some clearly marked maxima. These maxima coincide with distances between cracks of 4 m and multiples of this distance (8 m, 12 m, 16 m). This fact indicates that the concrete cracking process tends to be produced at distance intervals of 4 m (i.e. about 25 times the thickness of the layer), which corresponds to the final situation and that, in the initial stages following the laying of the concrete, the cracks occur at multiples of this distance (of the order of 16 m), creating slabs which are subsequently sub-divided ( $16 \text{ m} \rightarrow 8 \text{ m} \rightarrow 4 \text{ m}$ ). This process can be observed more clearly in Figure 7 (superposition of Figures 3 and 5) and in Figure 8 (superposition of Figures 4 and 6). In Figure 8 a certain degree of deviation towards the left of the graph can be seen with the passing of time, maintaining the distances in which the maxima are produced.

Figure 5. Cumulative relationship between number of cracks and crack distance for the lean concrete base (after several days).

Figure 6. Number of cracks – crack distance relationship for the lean concrete base (after several days).

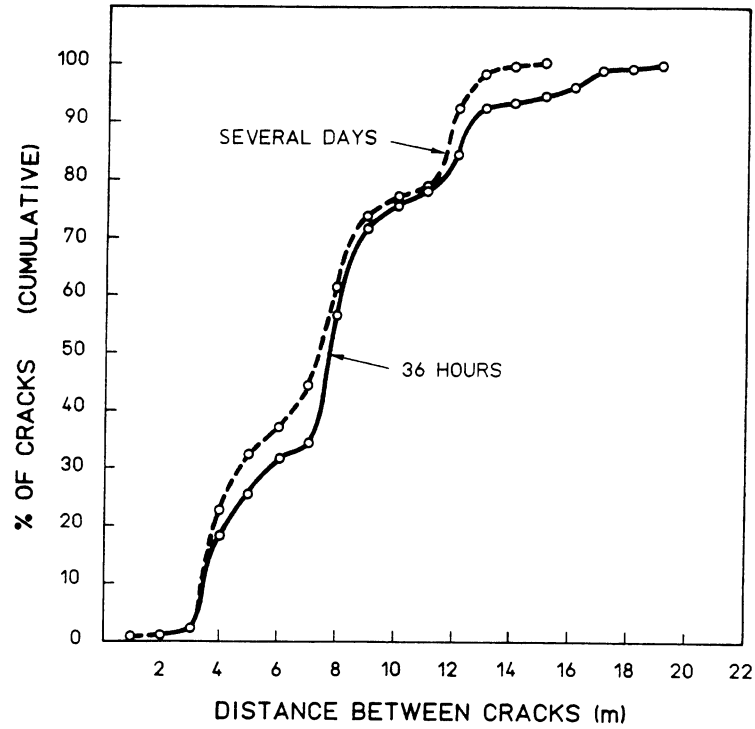
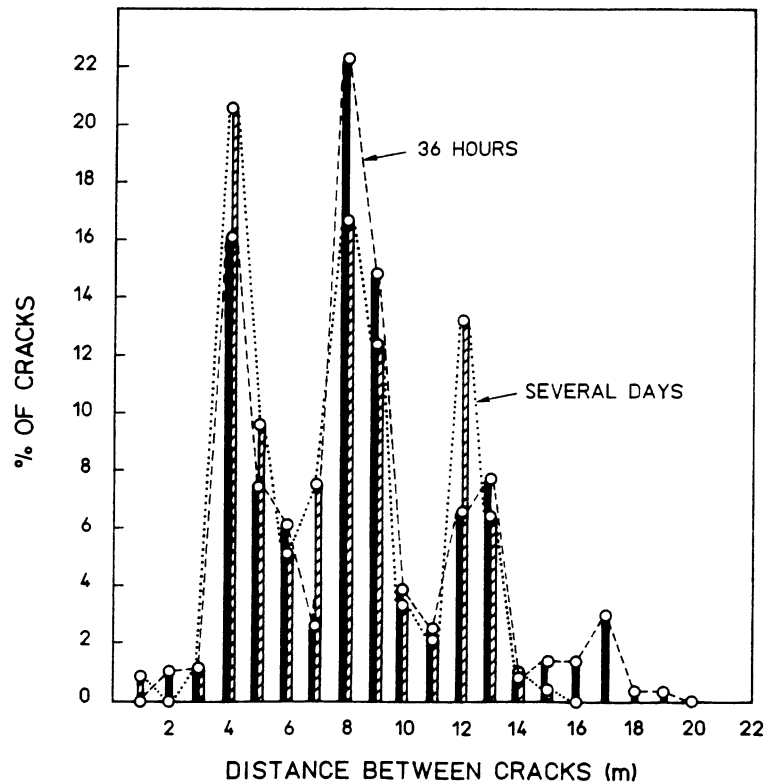
**Figure 7.** Cumulative relationship between number of cracks and crack distance for the lean concrete base (after 36 hours and after several days).

**Figure 8.** Number of cracks – crack distance relationship for the lean concrete base (after 36 hours and after several days).

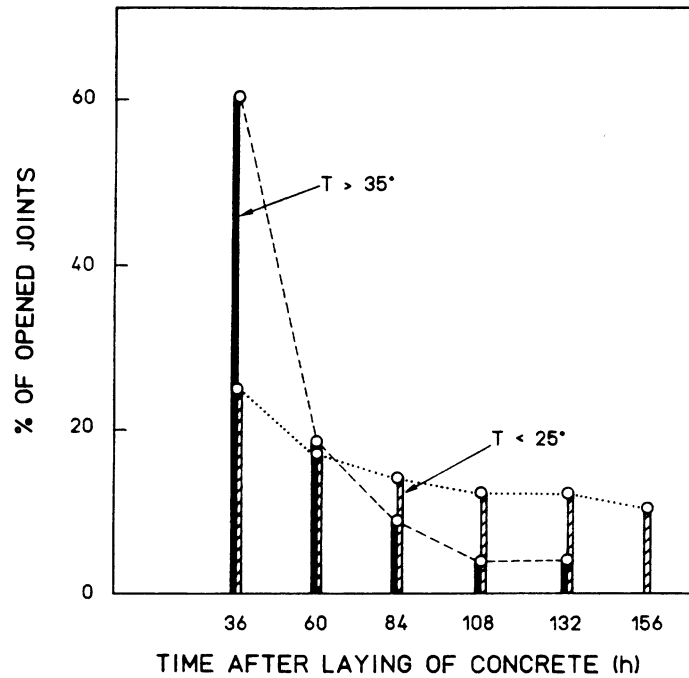
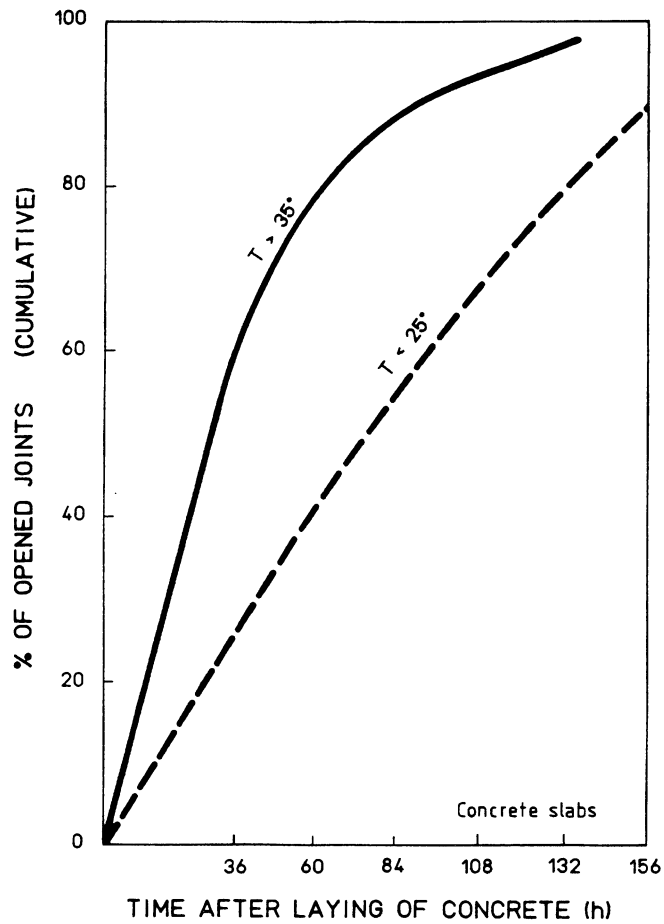
In Figures 9 and 10, the results are shown in this case relating to the joints opened depending on the time elapsed from the laying of the concrete, this one divided into intervals of 24 hours. Figure 9 corresponds to the distribution curve and Figure 10 to the cumulative curve. In both Figures, two cases are differentiated. The first relates to the major portion of the work, when the temperature was usually over 35°C and the second relates to the last week of the job, when climatic conditions were milder and the temperature usually under 25°C. These curves demonstrate the importance which temperature, particularly thermal gradients, has on the speed of joint opening. In this respect, for example, almost two thirds of the joints were open at 36 hours from the concrete placing when temperatures were in excess of 35°C, while only a quarter of them were open when temperatures were under 25°C. Clearly, in the long term in both cases, 100% of joints opened. Consequently, joints must be sawn in time to avoid spontaneous cracking, and this depends on the weather conditions during construction (temperature and thermal gradients). In the case described in

this paper, joints had to be sawn before, and certainly not later than, 12 hours after concrete placing.

Figure 9. Evolution of opened joint percentage of the top layer with time after concrete laying when temperature is higher than 35°C or lower than 25°C.

Figure 10. Evolution of cumulative opened joint percentage of the top layer with time after concrete laying when temperature is higher than 35°C or lower than 25°C.

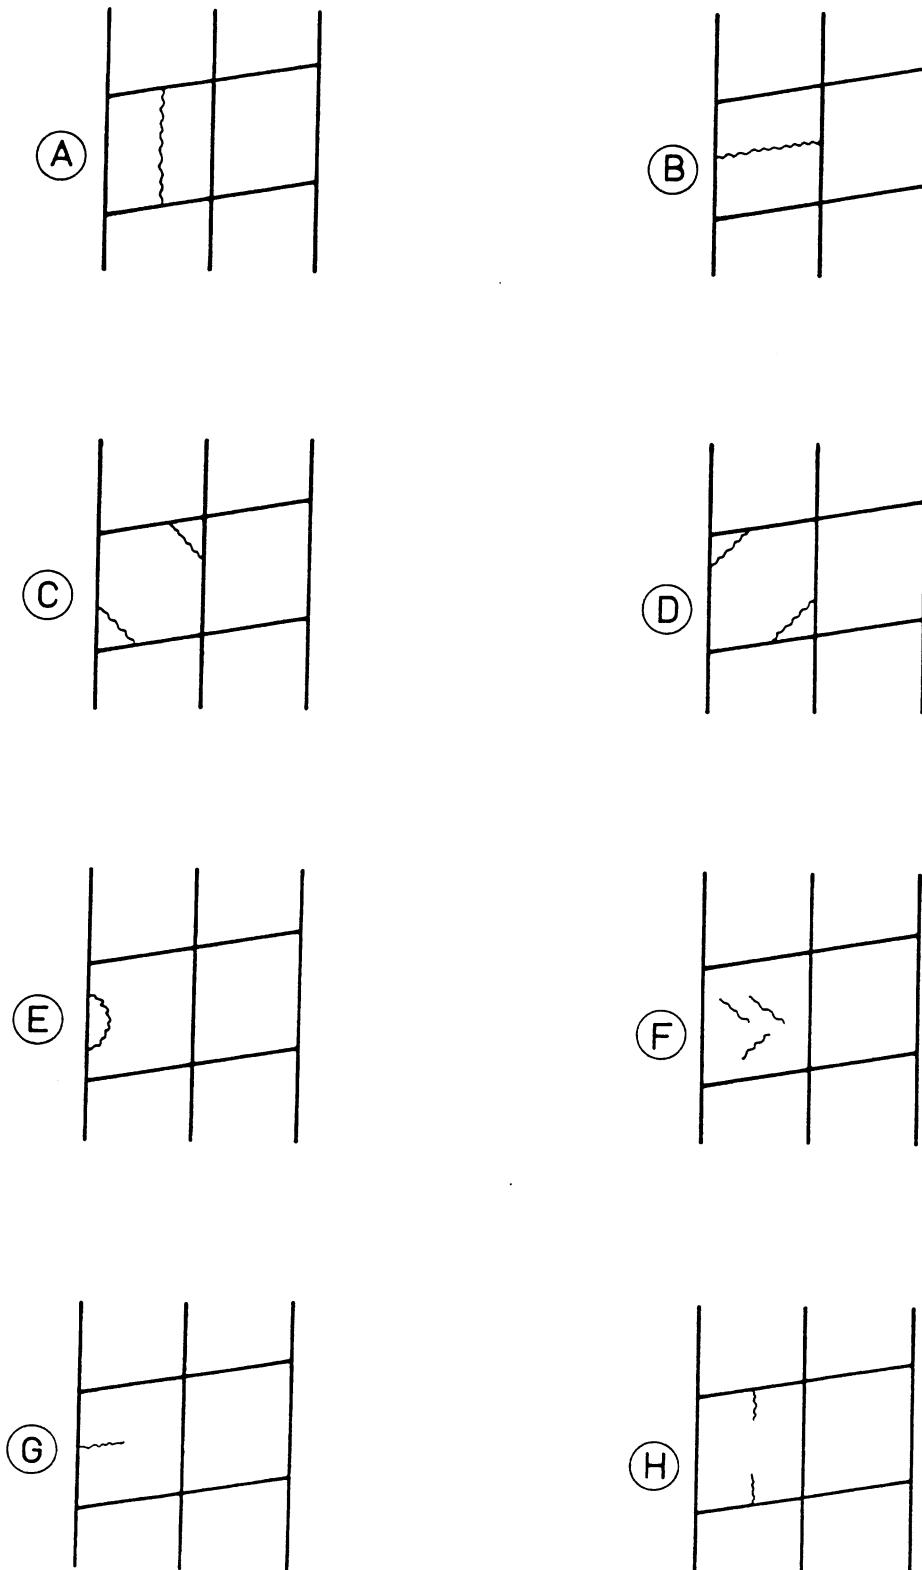
With regard to the cracking observed, Figure 11 shows the 8 different types of cracks which were taken into consideration when carrying out the count of the number of slabs affected in each case and which have been identified successively by the letters A to H. These types of cracks were selected in an effort to include the majority of foreseeable possibilities and so that each of them corresponded to a specific case of interest. Thus, types A and B correspond to cracks which divide the slabs in half, either (approximately) transversally (A) or parallel (B) to the roadway axis; types C and D to corner cracks which form a triangle, either acute (C) or obtuse (D); type E to localized edge defects; type F to small surface cracks, usually at 45° to the roadway axis, which do not reach the edges, and types G and H to cracks parallel (G) or transversal (H) to the roadway axis which start from one edge but which do not reach the other. Evidently, some other additional types could have been considered. Nevertheless, the types indicated could cover all the cases observed. The cause of the appearance of each of these types of cracks could be assigned to a specific phenomenon. However, with the exception of the cracks appearing in the short term which could have been due to shrinkage, the rest are indications of concrete fatigue. The count of the slabs affected was carried out distinguishing between the two lanes of the roadway.

- corner cracks have developed basically in the acute angles, while the obtuse angles have hardly presented any problems. This fact can be explained by taking into account the fact that, in acute angles, the breaking section is less and so, consequently, is the structural capacity. In spite of this, it is worth pointing out that the difference between some angles and others is very small (the 1/6 bias of the joint means only some 19° of difference). On the other hand, there

- cracks have particularly developed from edge to edge, parallel to the roadway axis and not perpendicular to it. In this case, there could have been an influence from the specific stress state caused by traffic loads and thermal gradients;

Figure 11. Crack types considered in the 1986, 1987 and 1992 inspection campaigns.
