**PERFORMANCE OF  
ONTARIO'S FIRST MAJOR REHABILITATION AND  
OVERLAY PROJECT**

Tom Kazmierowski, Ministry of  
Transportation, Ontario  
Harry Sturm, Canadian Portland Cement  
Association

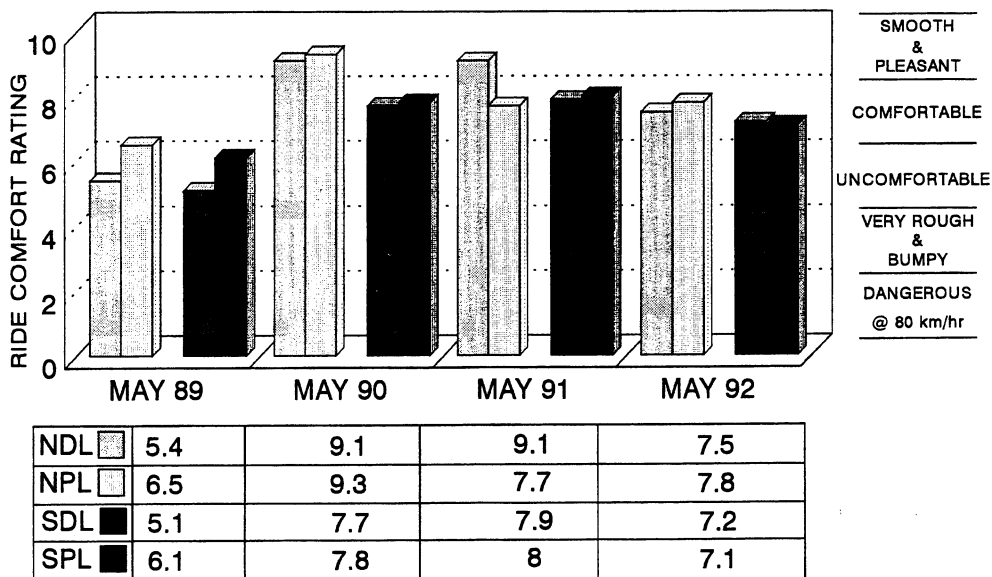
FIGURE 1

The unbonded overlay on the SBL exhibited an improvement in ride from 5.1 and 6.1 to 7.7 and 7.8 in the driving and passing lanes respectively, see Figure 1. The newly tined surface texture on the unbonded overlay was very aggressive and may have contributed to some of the initial roughness. The wearing of this aggressive texture may also have been accountable for the very slight improvement in ride between post construction readings of 7.7 and 7.8 compared to the May 91 readings of 7.9 and 8.0 in the driving and passing lanes respectively.

The more recent roughness measurements show a moderate decline in RCR for both the NB & SBL's. The northbound lanes have shown the most significant declines in RCR of 15 to 17 percent, from 9.2 and 9.1 to 7.8 and 7.5 in the driving and passing lanes respectively. The southbound lanes have shown an 8 to 10 percent decline in RCR from 8.0 and 7.9 to 7.1 and 7.2 in the driving and passing lanes respectively.

This rapid deterioration in RCR over the past year may be attributable to the very unusual environmental conditions in 1992. Precipitation levels over the last year along with a mild wet winter may have been a significant factor in reducing the RCR. Along with these environmental conditions the NBL has also exhibited additional distress in the last year which is detailed in the following section. PURD values for 1992 were retested with excellent correlation to confirm accuracy.

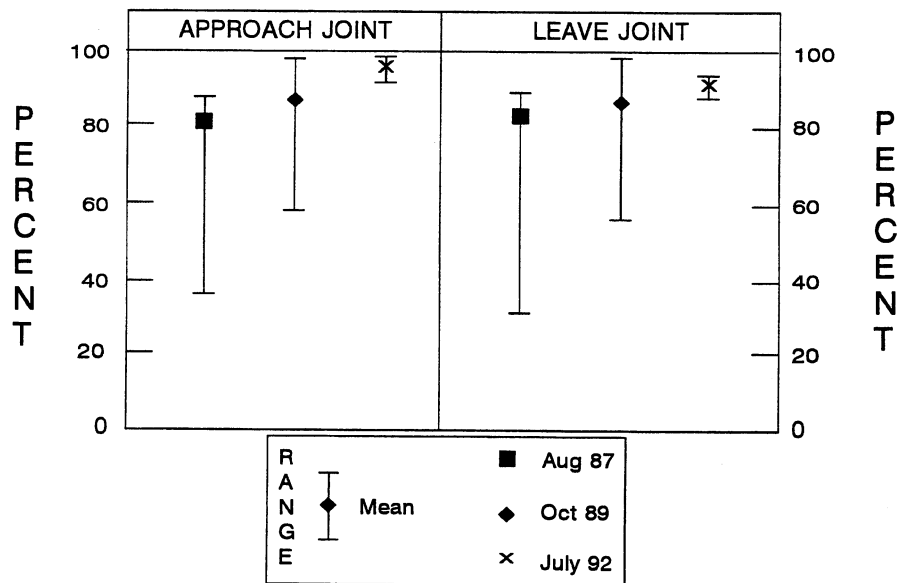
FIGURE 2

The three year test data shows a slight improvement in load transfer efficiencies to mean values of 93 and 96 percent with a significant reduction in the range of the transfer efficiencies. See Figure 2. The significant reduction in range may be attributed to transfer of all joints into a working state as compared to the early life of the pavement where a limited number of joints are operational. The subsequent redistribution of working joints would lead to a more uniform performance.

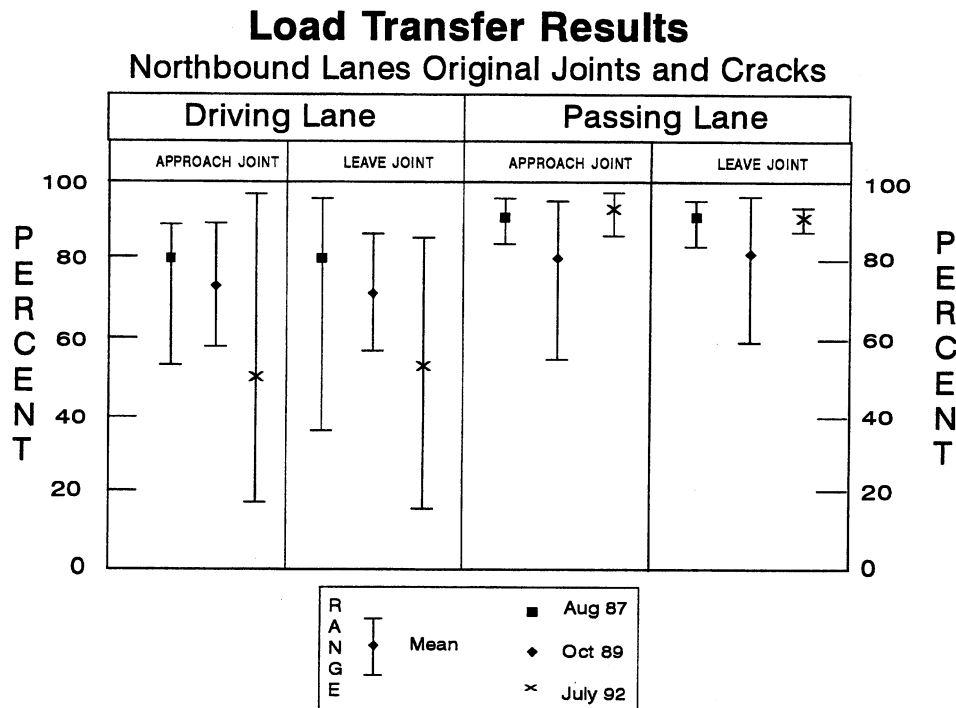
FIGURE 3

On the NBL, post construction and three year testing was carried out on unrepaired joints and cracks as well as repaired sections. All results for the unrepaired sections in the passing lanes were very similar to previous data with some minor deviations due to normal test variations, refer to Figure 3. There was however a significant reduction in the 3 year tests

for the driving lane. Load transfer efficiencies dropped from an approximate average of 80% to 50% in the driving lane. This is probably due to the high percentage of truck traffic using this lane which results in a reduction of aggregate interlock at cracks and joints. This hypothesis is substantiated by the observation of faulting at a few cracks.

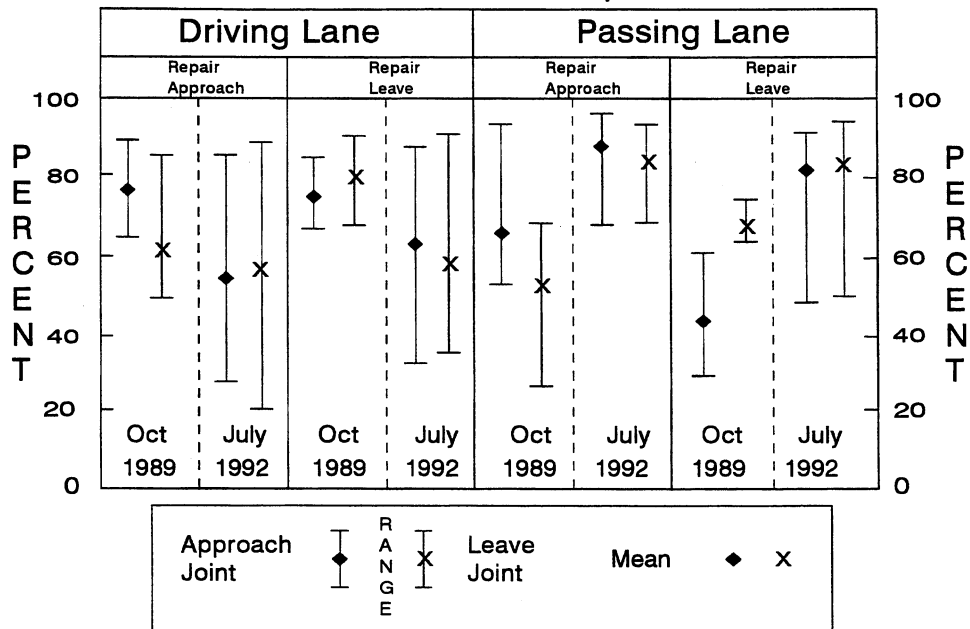
FIGURE 4

The initial results of FWD testing across the full depth repair joints indicated load transfer had been reduced in areas where improvements were anticipated. A general pattern of lower load transfer values, in the order of 20 percent, was observed when loads were applied on the repair itself versus loading on the old concrete. This data is shown graphically on Figure 4. Subsequent testing on other projects revealed that the combination of surficial loosening/softening of the granular base in the repair area and the use of grease as debonding agent on dowel bars contributed to this situation. After three years, FWD test results indicate this anomaly is no longer present.

Load transfer across the repair joint has apparently stabilized. This is probably due to a number of factors. In the driving lanes the load transfer values have generally declined to equitable levels in the 60 percent range, probably due to slight deterioration of the dowel support. In the passing lanes the load transfer efficiencies have improved significantly. This may be due to a general stabilization of the full depth repair and adjacent slabs. Generally there is a very wide range in performance, especially in driving lanes.

Overall performance appears to be satisfactory with slightly lower efficiencies in the driving lanes than would be anticipated.

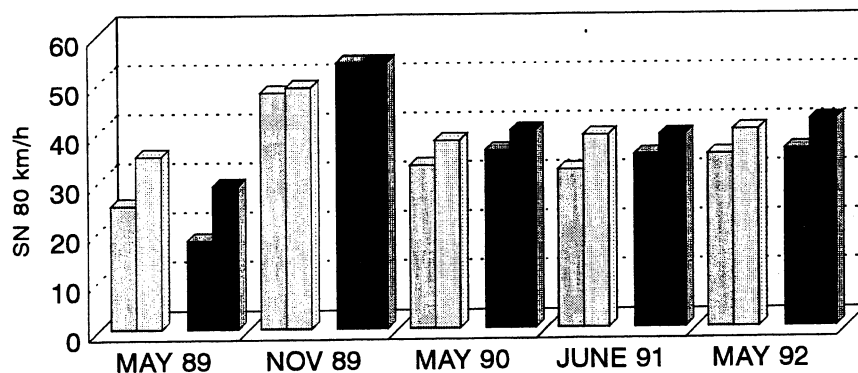
FIGURE 5

Results of skid resistance testing are detailed on Figure 5. The test results

indicate a substantial increase in skid resistance on both the northbound and southbound lanes immediately following rehabilitation as one would expect. The skid numbers in the southbound lanes increased to an average SN 80 of 55 for both lanes from an SN 80 of 18.3 and 28.9 in the driving (SDL) and passing lanes (SPL) respectively. On the diamond ground surface the skid numbers improved from an average of 24.8 and 35.1 to 48.0 and 50.4 for the driving (NDL) and passing lanes (NPL) respectively.

Skid numbers of this magnitude indicate a good friction factor and are similar to numbers obtained on premium hot mix surface courses [7]. The corduroy type of texture developed by grinding visually indicates high frictional resistance. The ridges improve the surface macro-texture and provide an escape route for moisture under a tire. The broken ridge surface, concrete fractured between the saw blades, improves micro-texture.

As anticipated in the first year the initial sharp projections of both the ground and drag/tined surfaces have been worn, polished or sheared off by traffic and snow removal operations. This elimination of sharp projections reduced SN 80 values from values in the high 40's and mid 50's to the mid 30's for the driving lanes and low 40's for the passing lanes. Based on previous experience this trend was anticipated, however it is interesting to note that the diamond ground surface is performing similarly to the tined surface at present.

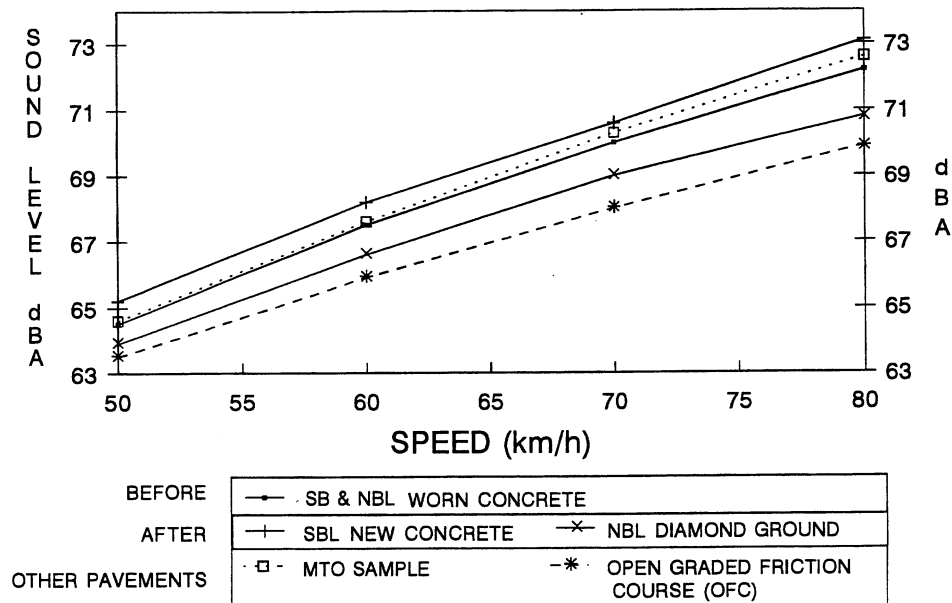
FIGURE 6

The procedure used to measure pavement noise on this project was to measure noise from individual vehicle passbys at a 15 m distance from the travelled lane. The results are plotted on Figure 6 and indicate that the diamond ground surface was approximately 1 dBA quieter than the old worn concrete and the Ministry of Transportation of Ontario (MTO) sample. The ground surface was only 1 dBA louder than an open graded asphalt friction course which is used for its low noise characteristics and good skid resistance. The MTO sample is obtained from Reference [8] and was derived by testing several hundred vehicles on a variety of pavement surfaces, predominantly asphaltic concrete, across the province.

The burlap dragged and transversely tined concrete surface was approximately 1 dBA noisier than the old worn concrete and MTO sample. The new concrete on the SBL may become quieter as some of the very coarse tining wears off.
