## THIN CONCRETE INLAYS ON OLD CONCRETE ROADS

### SYNOPSIS

The purpose of this paper is to evaluate thin concrete overlays as a repair method on out worn concrete roads. A test section has been carried out in south of Sweden. Fibre reinforced high strength concrete was used. Bond strength tests indicate a good bond between old and new concrete. Creep and shrinkage tests are discussed.

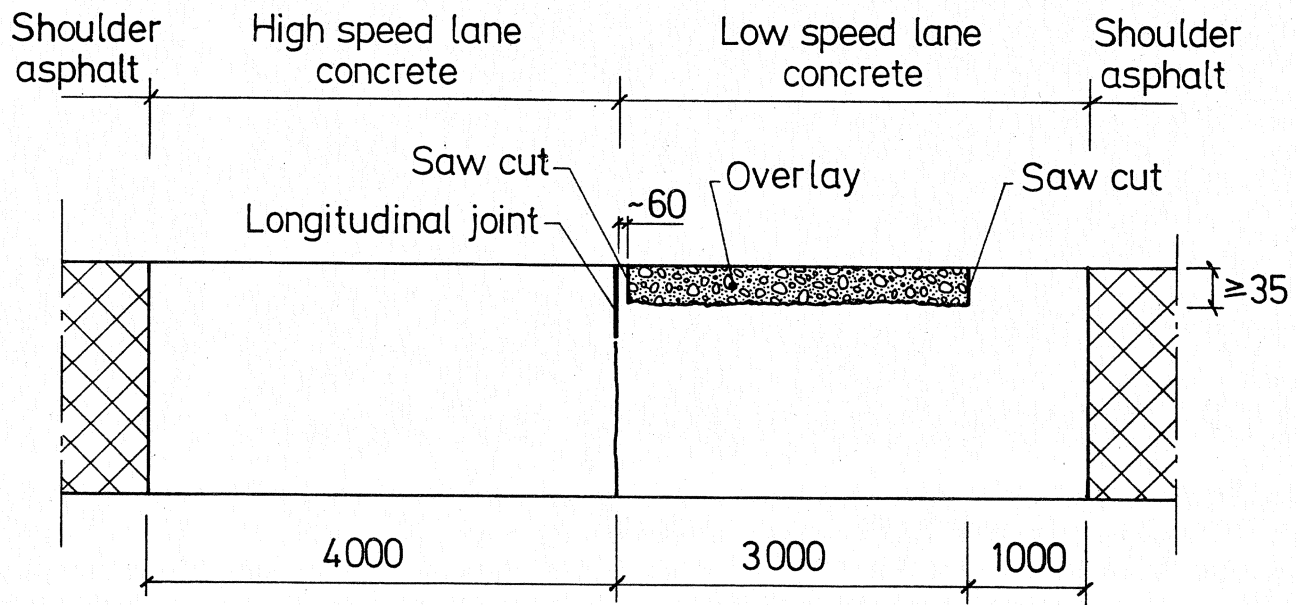
In order to give room for a concrete overlay of decent thickness without enhancing the surface level, 35 mm concrete was removed. A planer was used. The removal was limited to a 3 m wide strip in the middle of the lane. One meter was saved close to the shoulder. The intention was to save another 60 mm close to the longitudinal joint not to damage the joint. Consequently, the new concrete could be placed in a 470 m long, 3 m wide and 35 mm deep "box" (Figure 1).

Figure 1. Repair of concrete road. (The scale in the thickness direction is exaggerated).

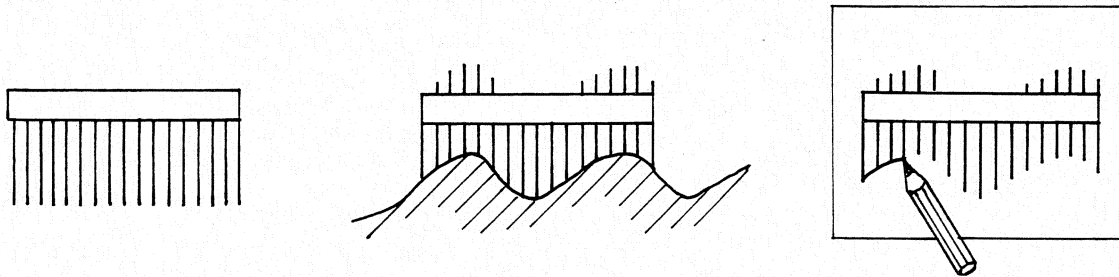
The roughness of the contact surface was measured on several slabs with a simple equipment (Figure 2). Measurements were made between scarifying and water blasting as well as after water blasting. In (3), the measured surface profile is proposed to be transferred to a saw-tooth curve with two

Figure 2. Measurement of surface roughness. From Silfwerbrand (3).

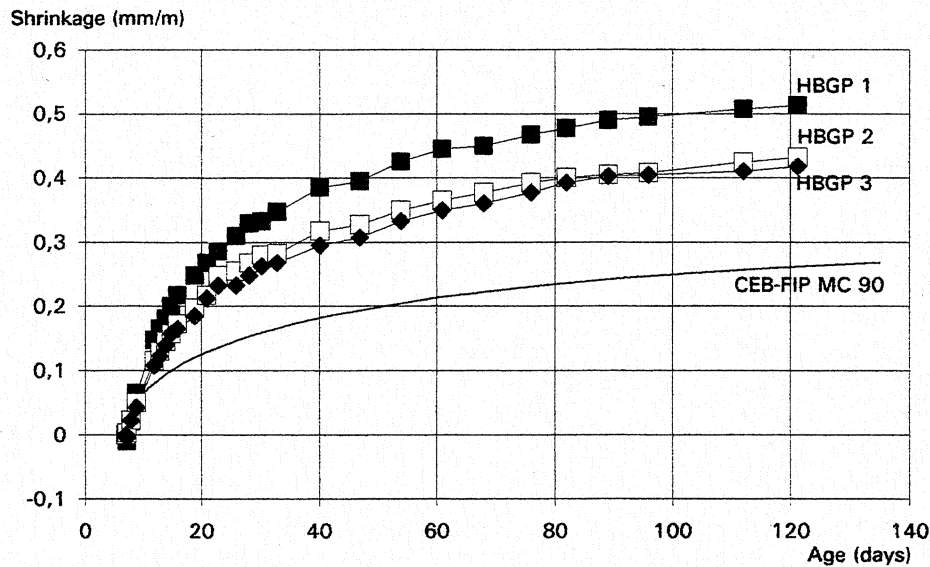
Figure 4. Measured shrinkage on prisms Nos. HBGP-1, HBGP-2 and HBGP-3 and calculated shrinkage according to CEB-FIP MC 90 (5).

The shrinkage was measured on three prisms (Figure 4). After 120 days, the measured shrinkage was approximately 0.045 %. The measured shrinkage is compared with CEB-FIP MC 90 (5). The observed shrinkage is twice as large as the calculated one. At the test site, however, the shrinkage will be less because of higher relative humidity.

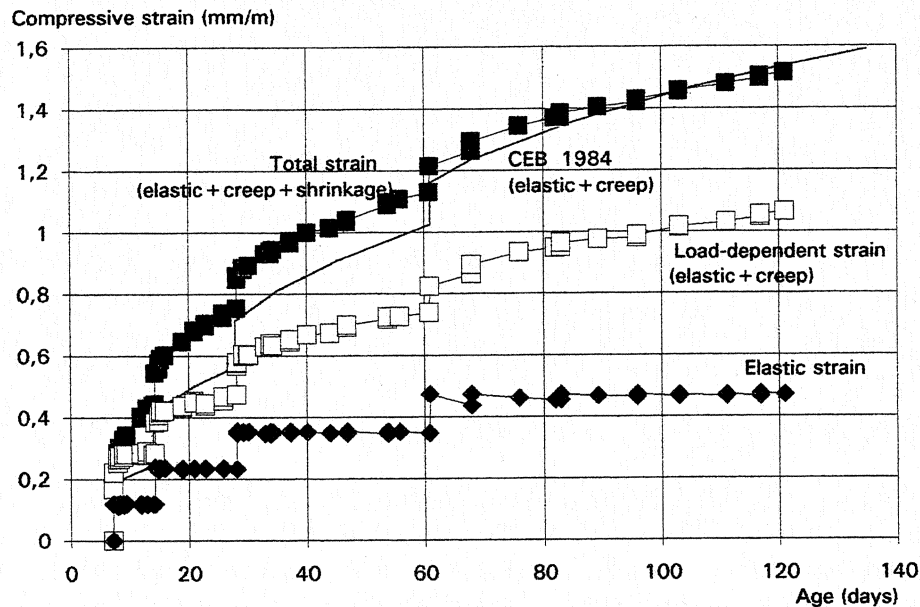
The total strain was measured. It includes also shrinkage. The load-dependent strain can be estimated as the difference between total strain and the average shrinkage strain according to Figure 4. Total strain (elastic strain + creep + shrinkage), load-dependent strain (elastic strain + creep) and elastic strain (ratio between stress and modulus of elasticity) are shown in Figure 5. As a comparison, the load-dependent strain for the actual loading is calculated according to CEB 1984 (6). The observed load-dependent strain was lower than the calculated value. The actual creep coefficient  $\phi$  might be only around unity instead of CEB's  $\phi = 2$ . At the test site, the creep might be even less because of the higher relative humidity.

Figure 5. Measured strain values of creep prism and load-dependent strain according to CEB 1984 (6).
