# PERFORMANCE OF CONCRETE PAVEMENT WITH ECONOCRETE BASE

Shie-Shin Wu and Thomas M. Hearne, Jr.

North Carolina Department of Transportation  
Raleigh, North Carolina

**ABSTRACT**  
A three-lane, 16 mile section of I-85 in Randolph and Davidson Counties, North Carolina, was opened to traffic in 1984. The spring following the opening of this section of highway, reddish-brown stains were visible on the concrete shoulders. Water was determined to be flowing under the slabs and blowing out through weak points along the joints.

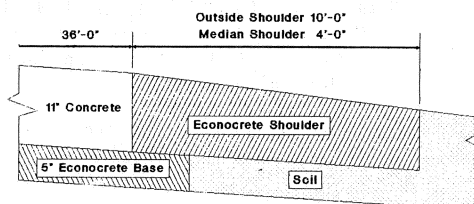
Fig. 1. - Pavement Design Detail

A typical pavement section for this project is shown in Fig. 1. Since areas beneath the concrete shoulder were back filled with low permeability soils, the pavement structure is actually constructed in a trench or bathtub section. No shoulder drains were constructed; therefore, once water entered this system, it was trapped with no easy escape route.

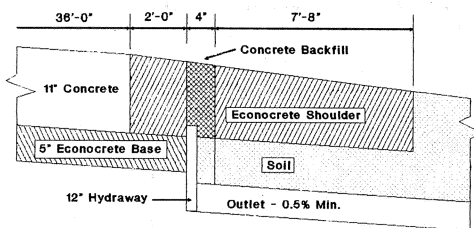
Fig. 2. - Hydraway Installation - Design 1

Subsequent field observations indicated that the Design 1 shoulder drain installation functions well. Throughout the entire section where this installation was used, there is no sign of water flowing up through the joints. Field personnel report that water runs out of the outlets within 10 to 15 min. after rain begins.

Shoulder drains were installed along both outside and median sides of the pavement. Details of the shoulder drain installations are shown in Figs. 2 and 3. Shoulder drains installed on the low side of the pavement are to provide outlets for water that infiltrates into the pavement structure, while drains installed on the high side of the pavement are to intercept water that would normally infiltrate the pavement structure through the opening at the concrete-soil interface. The cost of shoulder drain installation is slightly over \$3.00 per linear ft.

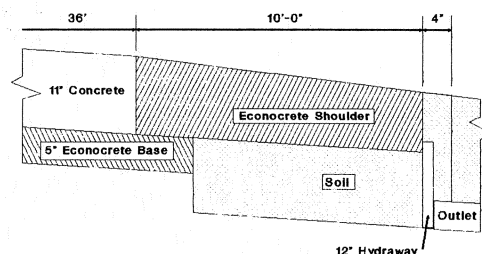
Fig. 4. - Hydraway Installation - Design 3

The Design 3 shoulder drain installation did not perform as well. Although an improvement over sections without shoulder drain installations, signs of water flowing up through joints is still noticeable where this design was utilized.

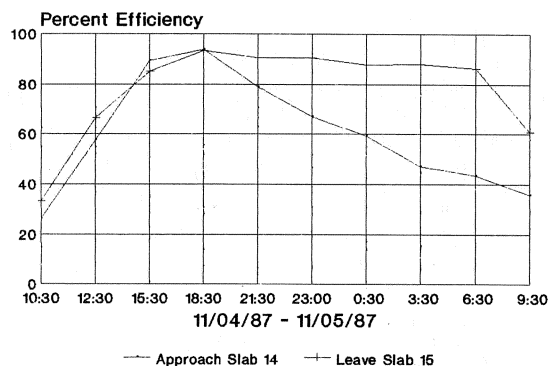
Fig. 9. - Joint Load Transfer Efficiency  
Concrete Slabs 14 & 15

Figures 9 and 10 illustrate the load transfer efficiency of two typical joints. The efficiency peaks at approximately 6 P.M. -- which corresponds to the time of day when the temperature difference between the top and the bottom of the slab is a minimum as shown in Fig. 11.

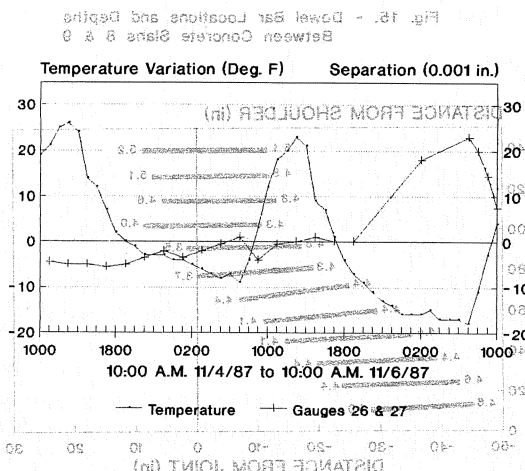
Fig. 11. - Pavement Temperature Variation/Slab Separation

Placing two rigid layers, namely concrete pavement and econocrete base, against each other is a major concern among NCDOT engineers. As shown by the field measurements, when the top surface of the concrete slab is significantly cooler than the bottom, as would occur on any cold night, the concrete pavement will curl and lift from the base -- resulting in a complete loss of support along all edges of the slab. Depending on a variety of factors including traffic loading conditions and the concrete thickness, stiffness, and strength, this phenomenon could very dramatically reduce the fatigue life of the slab.
