### **Lessons from Michigan's Oldest Concrete Pavement – Still Serving After 100 Years**

In 1906, the village of Red Jacket, Michigan (the present day village of Calumet) constructed over 1½ miles of street with a two layer cast in place stamped concrete system known as a granitoid brick block concrete pavement. Today, some of this pavement is still exposed, carrying traffic after 100 years of service. Historical records about the construction and the results of a laboratory analysis of a core specimen from the pavement are presented. The durability of this concrete is remarkable since it was constructed without air entrainment in a severe freeze-thaw climate. The granitoid pavement of Calumet has long outlived the major paving material competitor of its day: creosoted wood block pavement.

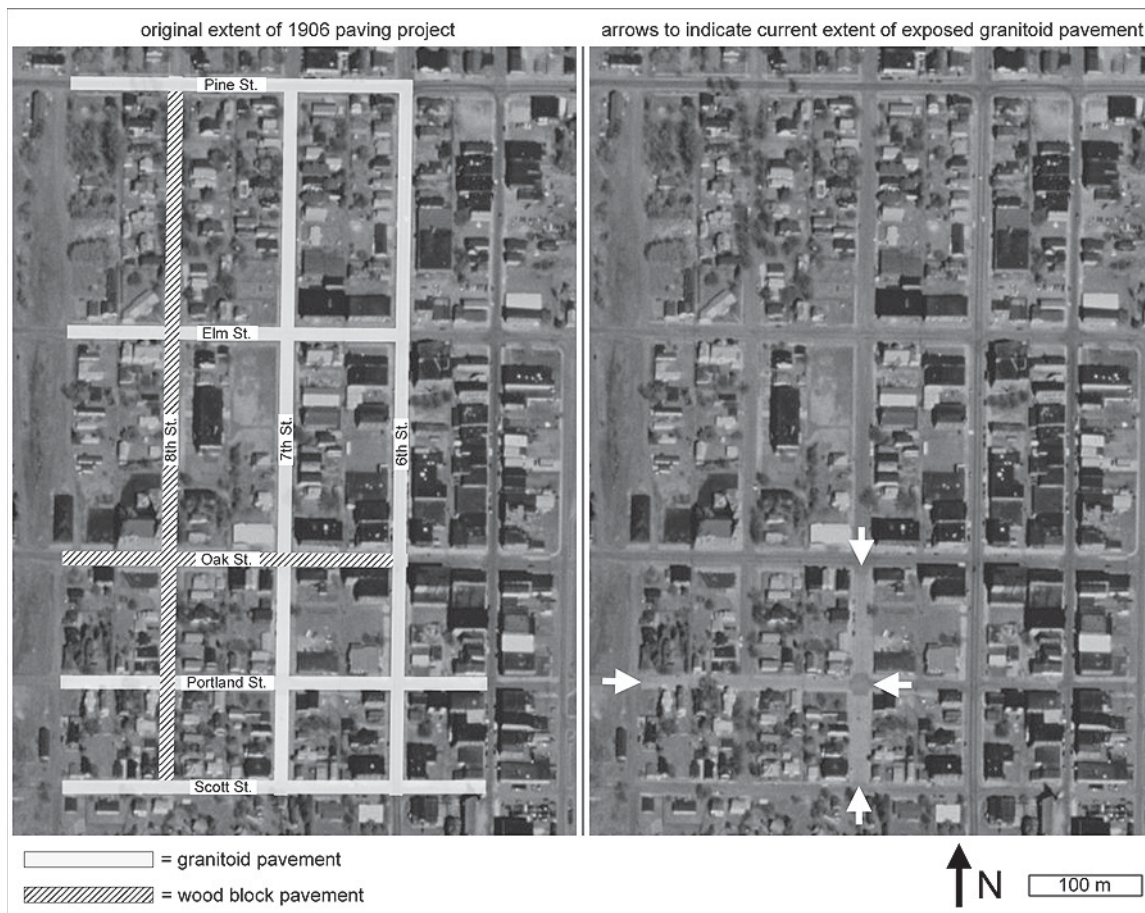
**FIGURE 2:** USGS aerial photography from 1998 showing extent of the 1906 street improvement project, (left) and white arrows to show present day extent of exposed granitoid pavement (right).

the contractors on April 3<sup>rd</sup> (19). In total, \$125,000 worth of street paving and improvement bonds were approved for sale by the village of Red Jacket on April 9<sup>th</sup> (20). Figure 2 is an aerial photograph of downtown Red Jacket with overlays to show which streets were scheduled to be paved with what material. Figure 2 also illustrates the current extent of pavement that remains in its original condition.

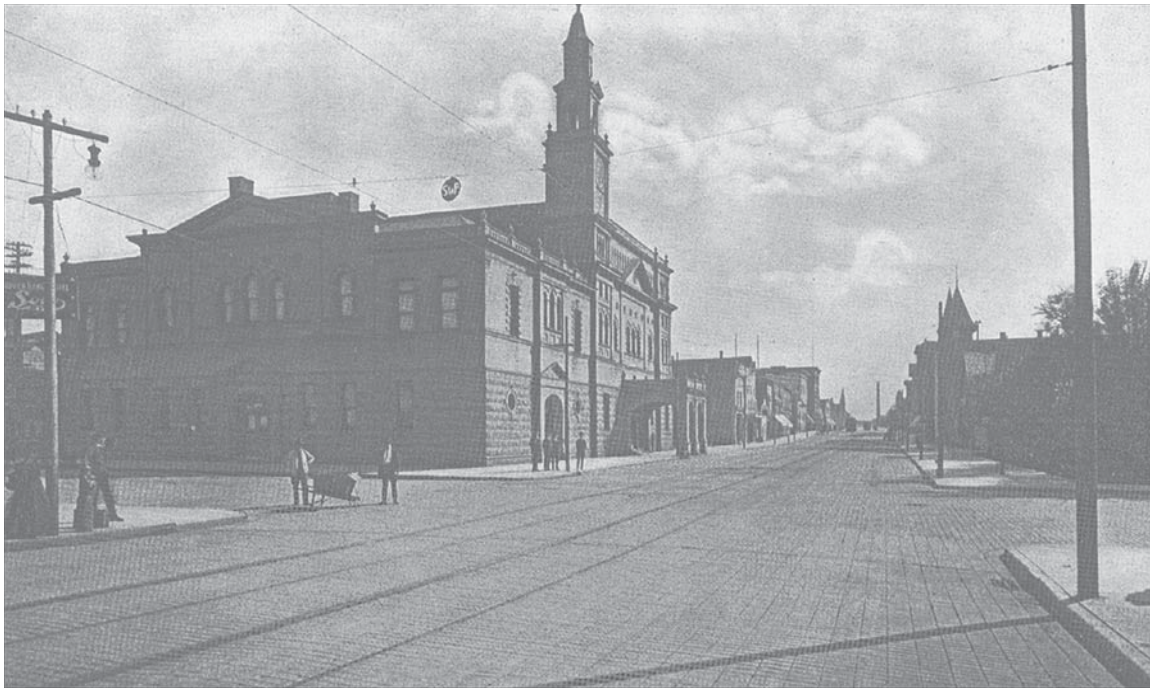
**FIGURE 5:** Southerly view of 6<sup>th</sup> Street, showing newly finished granitoid pavement, reproduced from circa 1910 advertisement brochure (51).

continued to persist (31,32,44). Construction with granitoid was completed on September 29<sup>th</sup> (45). The CCEN had only good things to say about the R. S. Blome Company, writing that the company “has done remarkably well,” and that “nothing but favorable comment is being heard on the way the R. S. Blome Company has carried out its contract” (45,46). There was even talk of a public vote of thanks towards the Village Council for its handling of the project (47). During the time that Blome was hard at work paving sections of downtown Red Jacket, they received additional contracts from around the country. On August 8<sup>th</sup>, the CCEN reported that Blome had been awarded a contract for \$200,000 to pave the town of Gary Indiana with granitoid (48). Likewise, over the next two months, Blome won additional contracts from the United States Government to pave parts of Washington, D. C. for \$100,000, and several more to pave streets in Michigan City, Indiana and Chicago (49,50). The CCEN reported that “granitoid as a paving material is rapidly coming to the front in the country,” and that “Red Jacket is to be congratulated for securing it for some of its streets” (49). Many of these projects were advertised in a brochure published by the R. S. Blome Company circa 1910, including images from the 1906 paving project, as shown in Figures 5 and 6 (51).

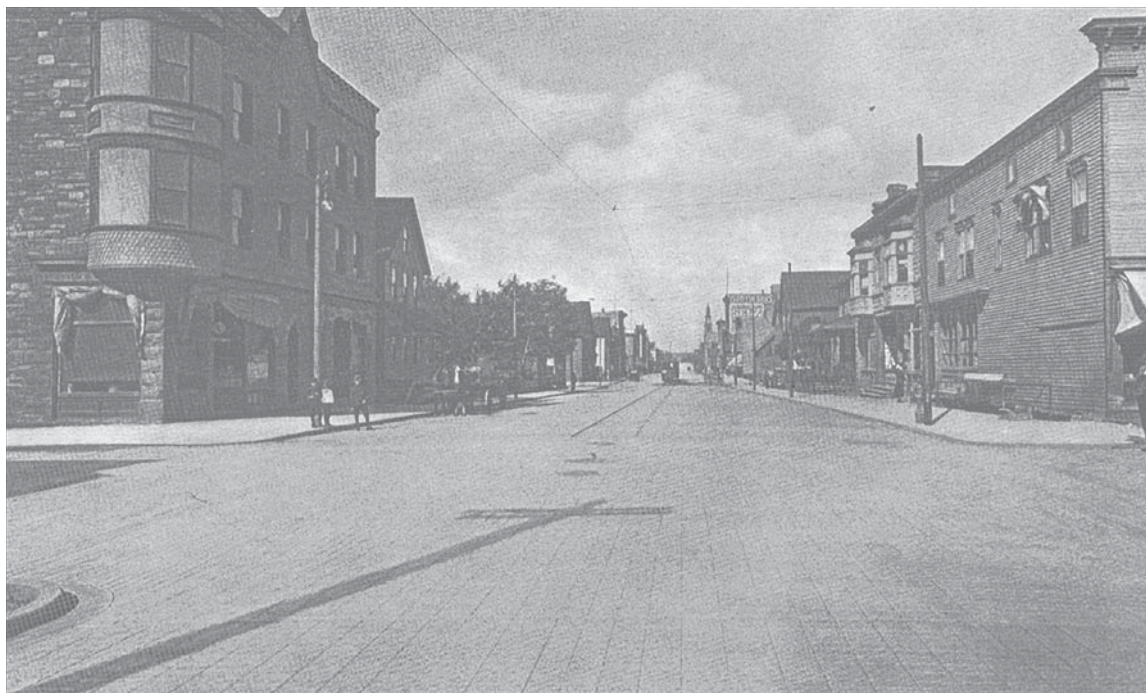
**FIGURE 6:** Northerly view of 6<sup>th</sup> Street, showing newly finished granitoid pavement, reproduced from circa 1910 advertisement brochure (51).

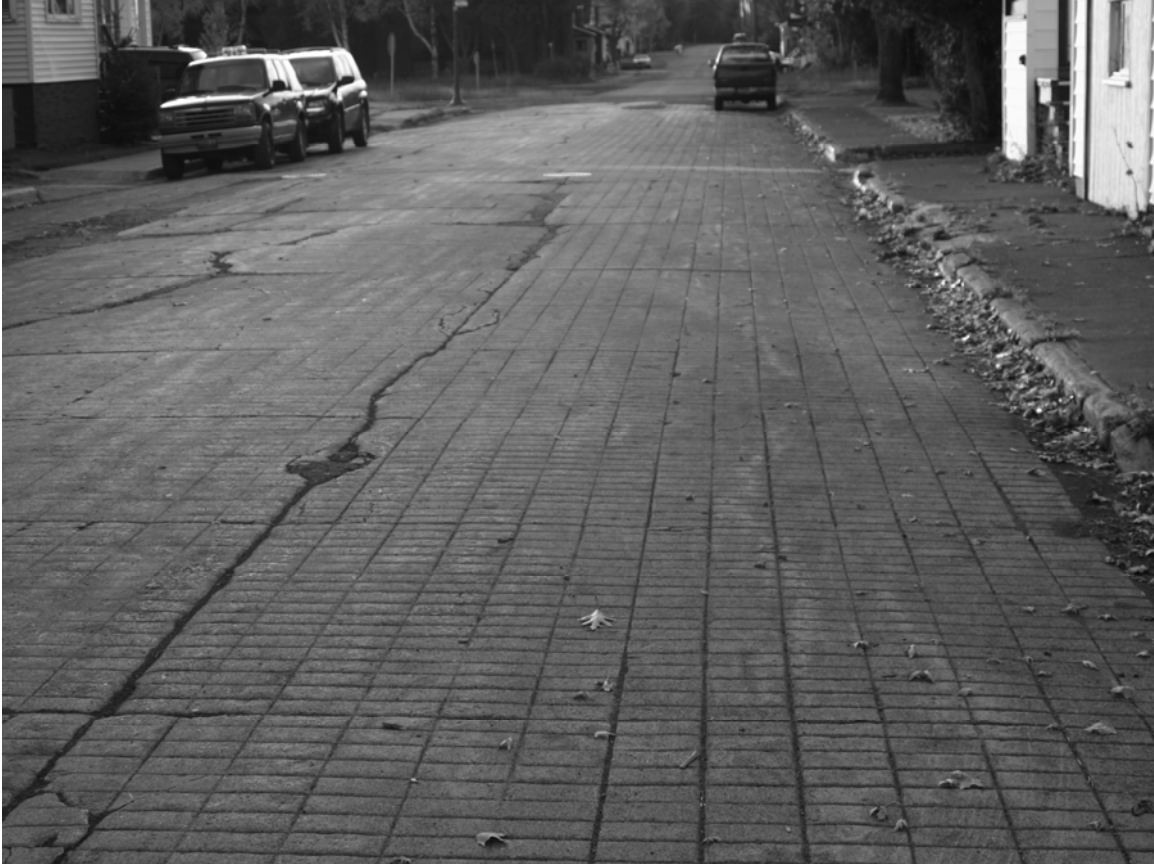
**FIGURE 12:** Recent picture of Portland Street in Calumet, MI showing no scaling after 100 years of service.

First of all, the durability of the granitoid pavement is somewhat surprising given the absence of entrained air, especially the complete absence of any scaling in the existing pavement (Figure 12). This is likely due to the high density of the cement paste in the upper mortar layer which suggests significantly reduced capillary porosity as compared to the cement paste of typical modern concrete used for paving. In fact, the microstructure shares a lot of similarity to that of modern ultra-high performance concrete (UHPC) that is also produced without air entrainment. It is believed that the extremely low capillary porosity of UHPC cement paste effectively eliminates the need for air entrainment to ensure good freeze-thaw durability. Figure 11 compares BSE images of the cement paste from the granitoid pavement upper mortar layer to the cement paste of a modern UHPC. As can be seen, the two mortars share some distinct similarity in microstructure even though they are separated by 100 years of technology. In contrast, modern paving concrete has much greater capillary porosity. It is plausible therefore to assume that the low capillary porosity of the hydrated cement paste in the 100 year old mortar provided a level of protection to the underlying, poorer quality concrete, although cracking is evident in the underlying concrete as seen in Figure 8. It can only be speculated as to what led to this very dense microstructure, but it is likely that a relatively low water-to-cement ratio was used, the mixture was thoroughly densified, and wet curing was employed. Further, the cement used at that time was coarsely ground and contained a high percentage of dicalcium silicate (belite) as compared to modern cements that are more tricalcium silicate (alite) rich. This led to slower hydration producing more calcium silicate hydrate compared to calcium hydroxide. Similar effects can be obtained with modern cements if they are blended with a suitable pozzolan, such as Class F fly ash, silica fume, or metakaolin, or a slag cement.
