# Unique Aspects of the Design and Construction of the Bristol Motor Speedway CRC Pavement

Stephen Swift<sup>1</sup>, D. Zollinger, P.E., Member ISCP<sup>2</sup>, A.Bhasin<sup>3</sup>, E. Masad, P.E.<sup>4</sup>, Anol Mukhopadhyay<sup>5</sup>

The reconstruction of the Bristol Motor Speedway (BMS) track surface presented some unique challenges to the placement of a continuously reinforced concrete (CRC) pavement. Due to the steep embankments of the radial sections, it was not feasible to use a traditional type of bond breaker to isolate the CRC from the subbase layer and so it was determined to bond the CRC to the base and eliminate the interlayer from the pavement section. Reflection cracking from the subbase was a concern and as a counter measure special crack control precautions were taken to insure the uniformity of the crack pattern using early aged crack control which required additional modifications to the sawing equipment to adopt it to the geometry of the track. The design of the steel was also configured to account for the bonded condition and the geometry of the track.

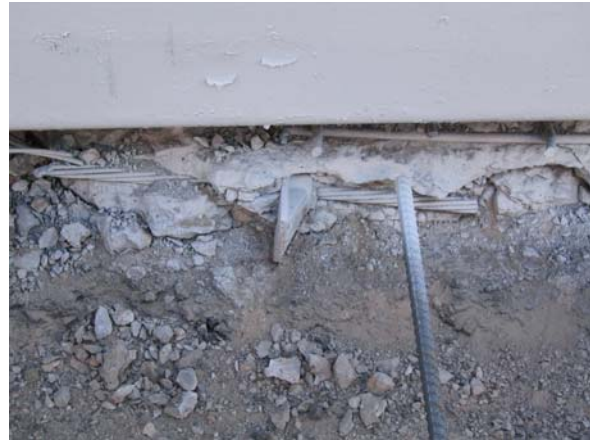
**Figure 2** Failed cable anchor.

Speedway Motorsport Inc., owners of the track, decided to totally remove the existing post-tensioned concrete track and replace it with a new continuously reinforced concrete (CRC) pavement. The original track, constructed in 1992, consisted of a 4 inch post-tensioned slab (with cables running at 12" O.C. in the longitudinal direction and 3' O.C. in the transverse direction) that was designed into 4 sections via expansion joints at the quarter points of the oval track to serve as points of stress relief. Over the years due to poor drainage and modifications to the original design, the post tensioned concrete had been subjected to considerable deterioration and cracking that in part appeared to be alkali-silica reactivity (ASR) related, creating weakened sections in and around cable anchor points (Figure 2). These

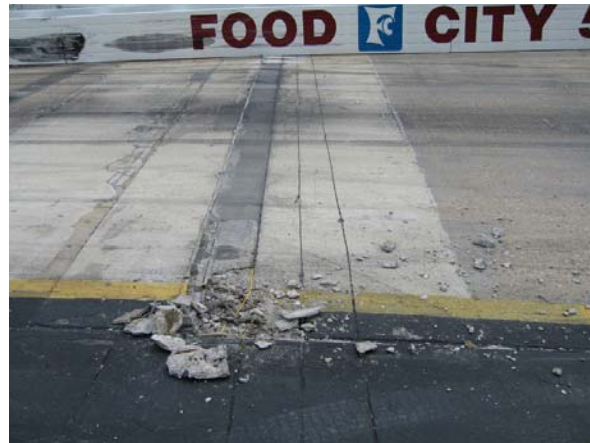
**Figure 3** Expansion Joint Failure.

The track was designed with 4 expansion joints or termination points for tensioning and stress relief purposes. These areas created 4 different slabs (one in each full turn and then the 2 straight a ways). The post-tensioned slab only provided 14 years of service as it had under gone a series of worsening consequences mainly at the expansion joints due to thermal expansion and contraction in the track. Early in the life of the pavement, restriction induced at the joints essentially caused the track to constantly move inward. As the slab, particularly through the turns would contract, it would creep down the slope towards the infield of the track. Temperature induced expansion within the oval track could not overcome the force of gravity causing failure at the expansion joints (Figure 3) in the post-tensioned track. 2" of concrete were cut out of the track on the night before the race in March 2007. The joints had moved from 2" to 0" in a matter of 3 weeks of warm weather.

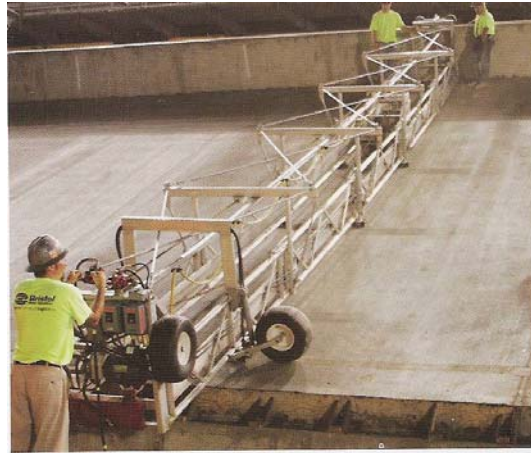
**Figure 14a** Sawing in the Banked Sections (Gomaco World, 2008)

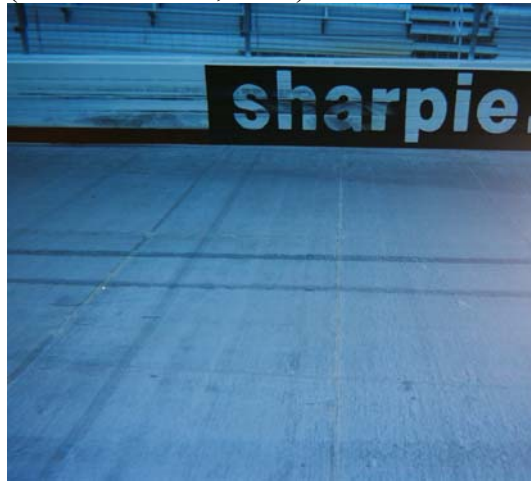
**Figure 14b** 5 Foot Sawcuts.

A.1) most likely failed to properly initial cracking. Approximately 8 and 15% of the sawcuts in the North and South ends of the track, respectively, were closely aligned with random transverse cracks. Due to the grouping of some of this type of cracking, timing of the sawcut may have played a role in the capability of the notch to control the random cracking. However, since more than half of the random cracks occurred in the center of the sawcut segments, it seems likely that those cracks would have been controlled

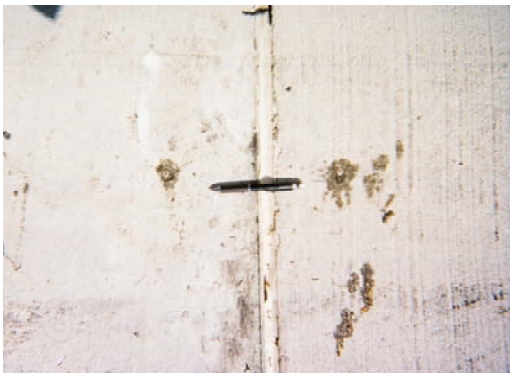
There was noted debonding along the expansion joints where the joint sealant had separated from the inside wall of the joint (Figure 15). The width of these joints was approximately 1 inch in October 2007 and 1.5 inch in January 2008 where the temperature was approximately 15°F. The concrete set temperature was approximated to

**Figure 15** Expansion Joint.

be 100°F which means the temperature drop was approximately 85°F. It appears that construction preparation may have played a role in the debonding since the joint was originally placed at approximately 0.75 inches. The net opening is approximately 0.75 inches at a temperature change of 85°F compared to a predicted opening of 1.12 inches (from Table 1) at a temperature drop of 100°F which is an over estimate of approximately 22% (this of course assumes the contribution due to drying shrinkage is incorporated in the temperature drop).
