# **Accelerated Repair of Jointed Concrete Pavements (JCP) using Precast Concrete Panels-Colorado Experience**

## **Abstract**

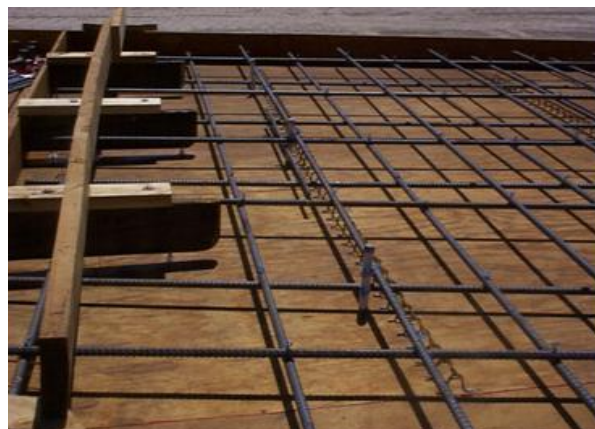
**Figure 1.** Structural details of the precast panel.

The precast PCC panels were fabricated by the contractor at a nearby casting yard and transported to the project site. The typical structural details of the panels are illustrated in Figure 1. The tie bar slots were placed at 36 in. on center and were formed during the panel fabrication process. The panel also consists of #4 (for the 5.5 in. thick panels) or #5 (for panels thicker than 6 in.) reinforcing steel bars. The panel lengths varied so as to match the existing pavement geometry.

a) Design layout

b) Reinforcing steel placement

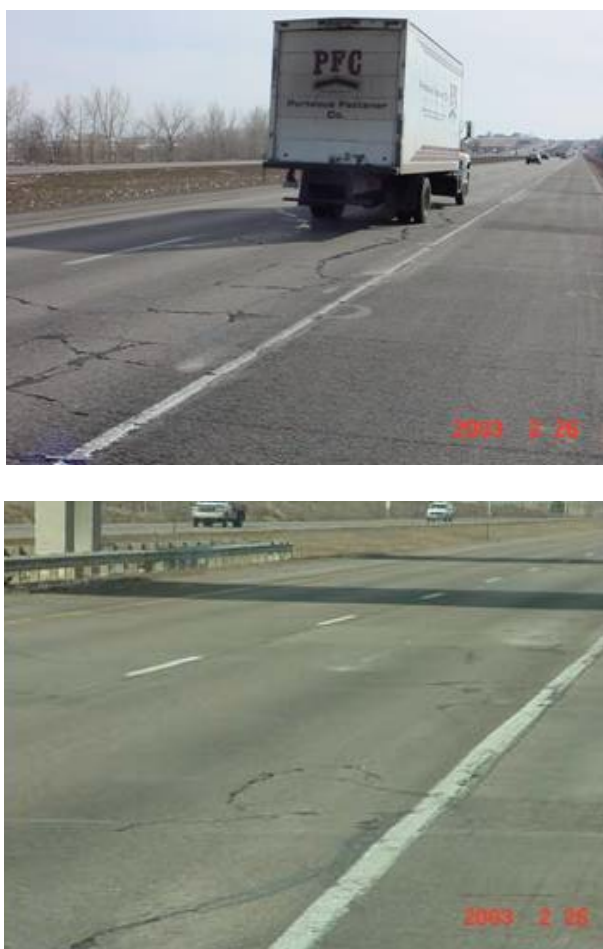
**Figure 2.** High severity corner breaks with associated spalling.

Prior to the removal of the selected panels a distress survey was conducted. Typical distresses observed during the survey included (i) mid panel transverse cracks with associated spalling; and (ii) joint sealant damage, spalling and asphalt patch

deterioration and (iii) corner cracking. Examples of the typical distresses are illustrated in Figure 2.

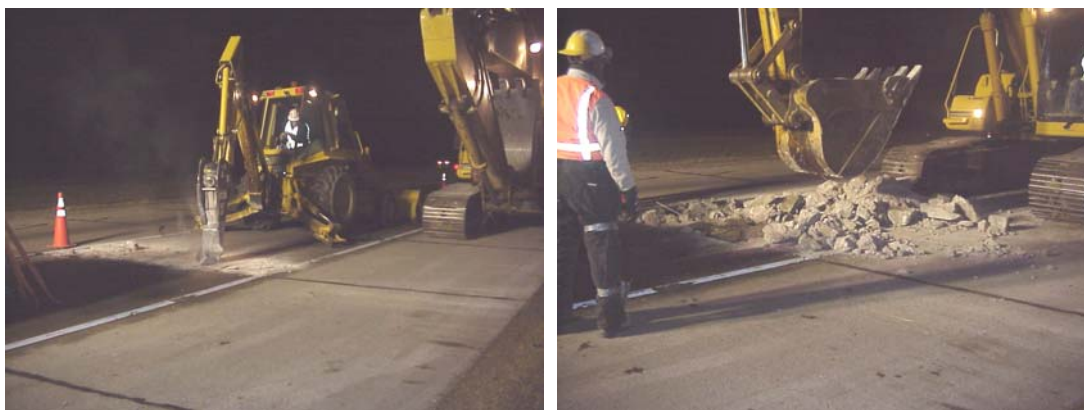
**Figure 3.** Slab demolition process.

***Slab Demolition and Removal.*** The perimeter of each distressed panel was sawcut. Additional transverse cuts were made to expedite the panel breaking operation. The initial breaking of concrete was done using a standard backhoe fitted with a jackhammer. An additional track-hoe was used to excavate and remove the demolished concrete. Figure 3 illustrates the slab demolition and removal process.

a) Slab demolition

b) Removal of debris

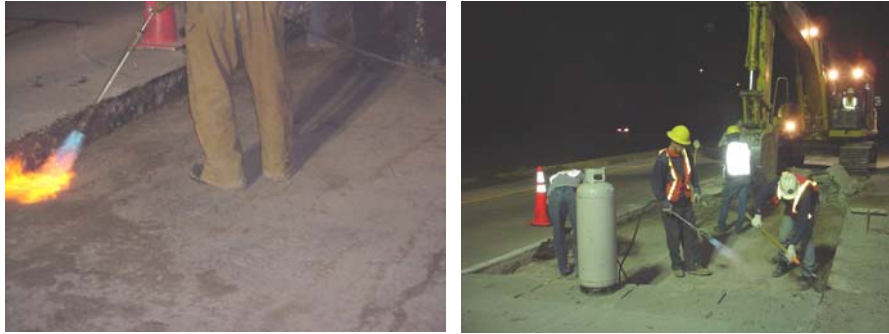
**Figure 4.** Base preparation activities.

**Base Cleaning and Preparation.** The exposed concrete base layer was swept and cleaned using compressed air. In addition to the cleaning the base and joint edges were dried (to remove any traces of moisture) using a hot air lance. A secondary effect of using the hot air lance was to expedite the curing of the slab jacking foam. Figure 4 illustrates the base preparation activities.

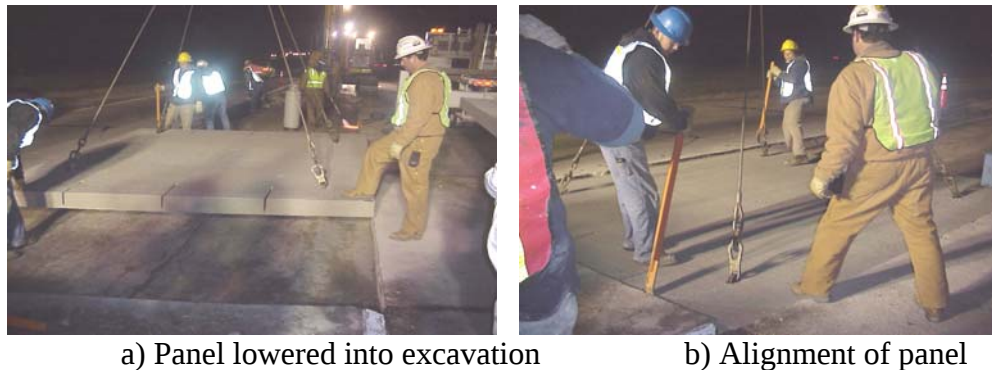
**Figure 5.** Panel placement process.

**Panel Placement and Alignment.** The panels were brought to site on flatbed truck and lowered into the excavation using a 30 kip truck mounted crane. Figure 5 illustrates the panel placement process.

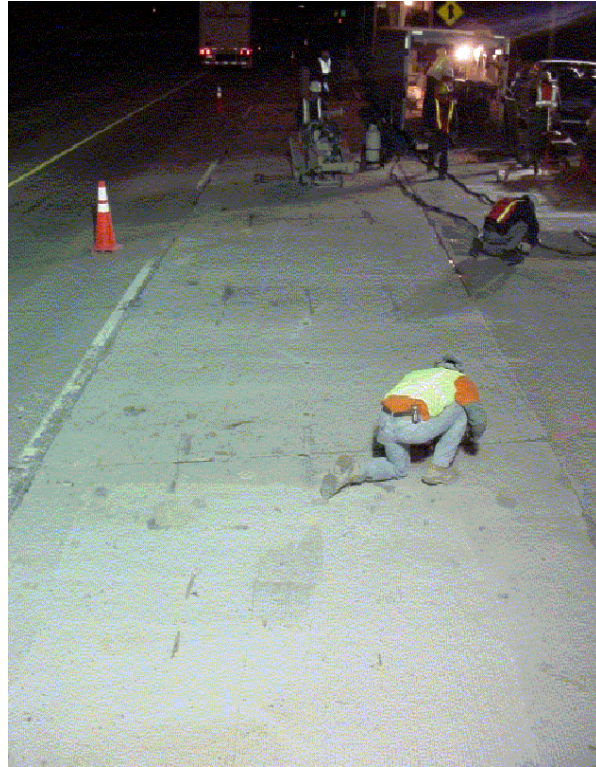
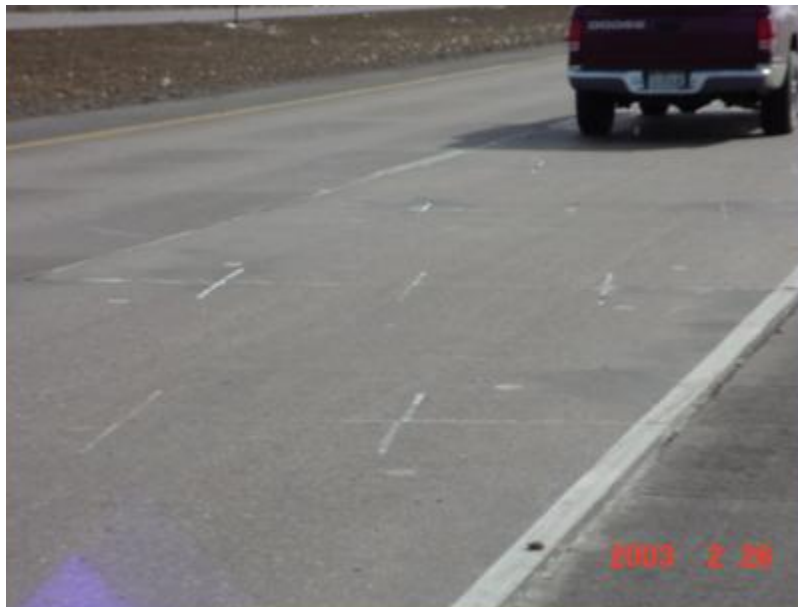
**Figure 7.** Completed cluster of precast panels.

The injection ports were sealed using a non-shrink grout. The procedure included (i) drilling out left over jacking foam; (ii) cleaning the surface of the concrete for proper adhesion; and (iii) placing of the grout. Figure 7 illustrates a group (cluster) of precast panels consecutively placed.

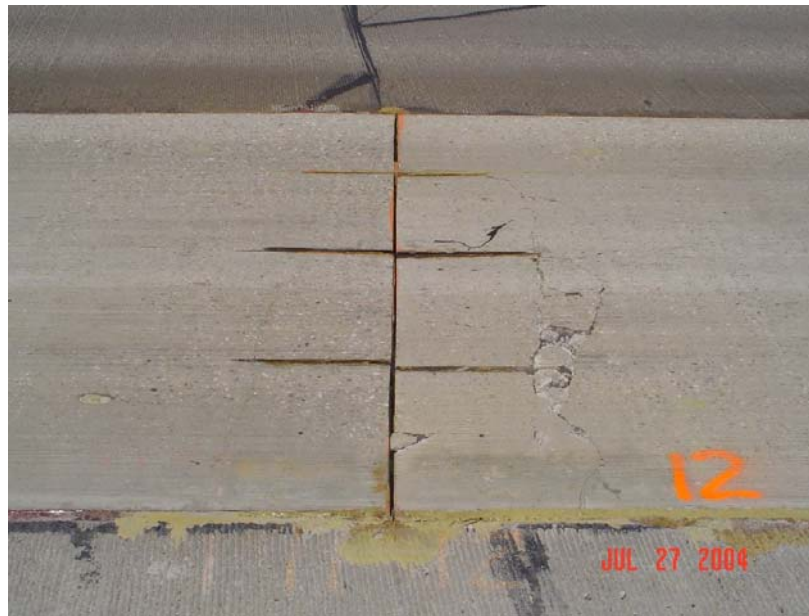
**Figure 16 Typical crack patterns**

The distress survey of the panels revealed the presence of low to medium severity cracks in approximately 20% of the precast panel slabs. The majority of these cracks were in the vicinity of the fiber glass stitches. A typical crack pattern is illustrated in Figure 16.

The possible reasons for this premature failure include: (i) non-uniform support in the vicinity of the stitches resulting in tensile stresses at the top fibers of the panel; (ii) inadequate slab thickness to carry the axle loads; and (iii) longer effective slab lengths due to joint ties.
