# THE APPLICATION AND VALIDATION OF AN ANALYTICAL METHOD IN THE STRUCTURAL REHABILITATION OF A CRACKED RIGID PAVEMENT

P J Strauss, Bruinette Kruger Stoffberg Incorporated  
J Du Plessis, V Francis Directorate Road Transport  
and A W Viljoen, National Institute of Transport  
and Road Research

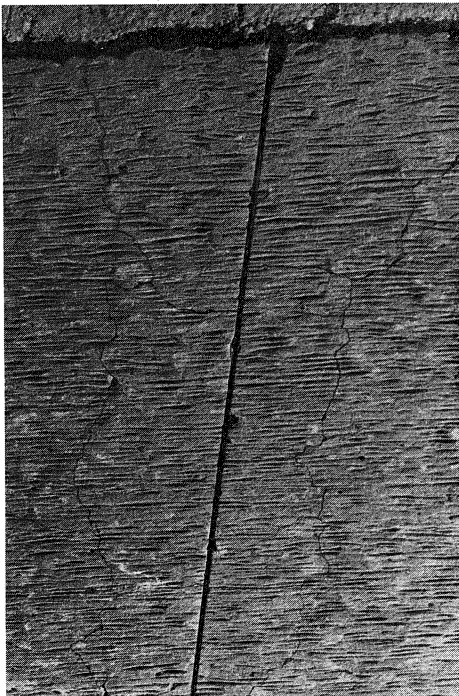
Figure 2. Development of small reaction cracks into load associated cracks (joint condition C = 0,5).

transfer constant C. Figure 2 indicates a C value of 0.50.

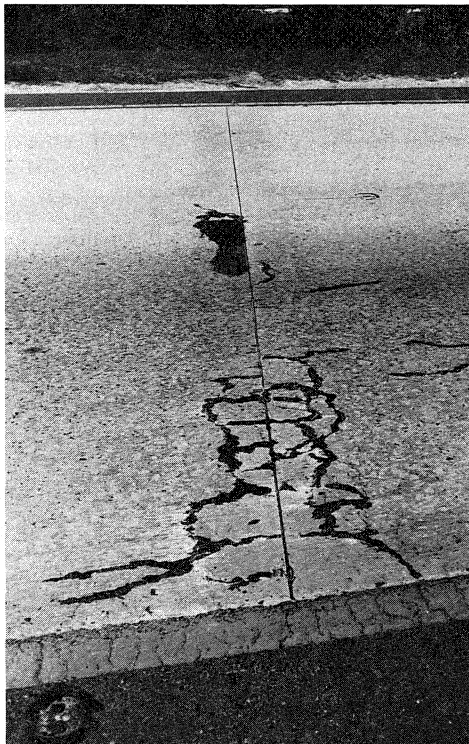
Figure 7. A failed joint with spalling, pumping and a punch out visible (condition rating 0,7).

The deterioration of the concrete pavement can therefore be summarized as shown in Figure 6. Cracks initiate in the concrete owing to a chemical reaction between alkaline cement, aggregate high in silica content and environmental influences such as water. The further development of these cracks into structural cracking can be prevented by maintenance but in practice this has been proved to be expensive and not very effective. The smaller cracks initiated by alkali-aggregate reaction reduce the slab stiffness and increase deflection as well as relative movement at the joints. This results in higher stresses on the subbase, which also deteriorates owing to the alkali-aggregate reaction, since the same cement and aggregate were used in the construction of this layer. Traffic loading therefore causes higher stresses in both the concrete slab and the subbase, and with water penetrating the joints structural cracking is inevitable. In time the joints, the subbase and the slab itself deteriorate further and spalling as well as pumping results. At this time maintenance is of great importance to prevent structural failures, but where deterioration is allowed to progress a loss of subgrade support will lead to structural failures which can only be remedied by major rehabilitation. This final condition of the pavement is shown in Figure 7 where an attempt has been made to seal the cracks

and to replace a punch-out with asphaltic concrete. Pumping at the cracks is also noticeable, with fine reaction cracks visible in the inner lane joint.
