## **EVALUATION OF HYDRAULIC CEMENT CONCRETE OVERLAYS PLACED ON THREE PAVEMENTS IN VIRGINIA**

**Michael M. Sprinkel, P.E.**  
**Associate Director**  
**Virginia Transportation Research Council**  
**Charlottesville, VA 22901**

### **ABSTRACT**

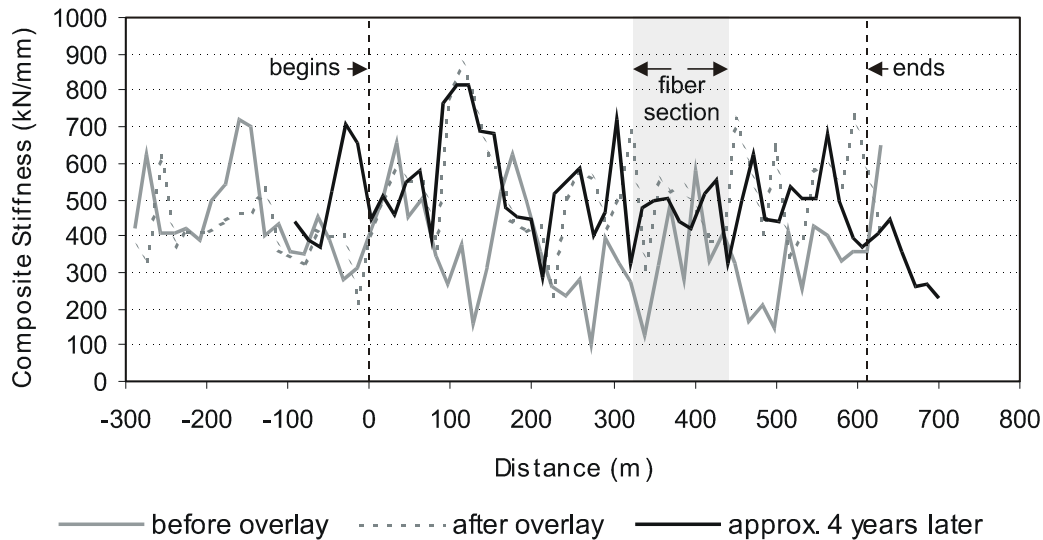
**Figure 4. FWD Data of Overlay on I-295 Outside Lane**

Figures 4, 5, and 6 show the composite stiffness of the pavements based on Falling Weight Deflectometer (FWD) measurements. The stiffness was improved with the placement of the overlay. However, the overall stiffness of the Rte. 29 pavement with asphalt and concrete was low because of the presence of the asphalt layer. Figure 7 shows the stiffness of the Rte. 29 inside lane in 1999 with the 6 mm (3 in) white topping. After 4 years, the stiffness of the section with the 51 mm (2 in) white topping was about the same as that initially.
