# **Joint Performance in Bonded Concrete Overlays of Asphalt**

John DeSantis, Julie Vandenbossche, Kevin Alland, Steven Sachs, Thomas Burnham,  
and Aldo Montenegro

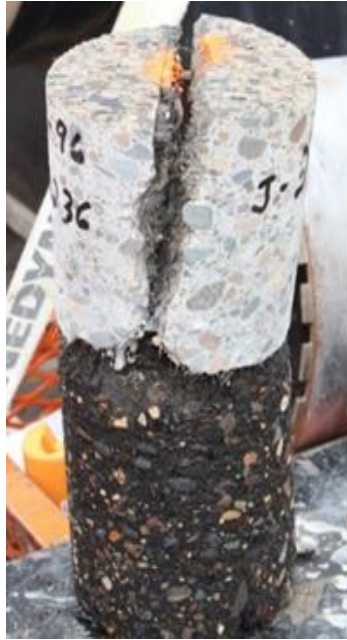
a) Joint A

**Figure 3 Cell 96 Field Cores**

Two joints in Cell 96 (152-mm (6-in) thick) that exhibited transverse joint faulting were examined to validate the method for determining the depth of activation at the joint based on LTE. It was believed based on the LTE data that faulting at these joints was occurring due to pumping at different depths within the BCOA. The LTE at Joint B (Joint 2241) is also about 20 percent less than at Joint A (Joint 2236), which is a good indication that this joint has cracked through the asphalt. Faulting and LTE data can be seen in Figure 2. Faulting measurements six years after construction indicate Joints A and B had similar magnitudes of faulting, as shown in Figure 2. This cell was diamond ground to restore ride after 14 years in-service. When a pavement is diamond ground, only the surface distress is removed. Therefore, it is expected that faulting trends would continue after grinding. However, comparing these two joints four years after grinding, the fault depth at Joint B is 2 mm (0.08 in) greater than Joint A. This could be attributed to the fact that the pumping mechanism continues to transfer the base material and the fault depth continued to increase at Joint B. However, it is difficult to establish the faulting that developed at these joints due to the lack of measurements between 2003 and 2014. Cores were taken recently at these joints to validate the findings. As predicted, Joint B exhibited a crack through the asphalt, similar to the joint shown in Figure 1b, whereas Joint A did not. Joint A is more representative of the joint shown in Figure 1a. These cores can be seen in Figure 3. Note the condition of the asphalt directly below the concrete.

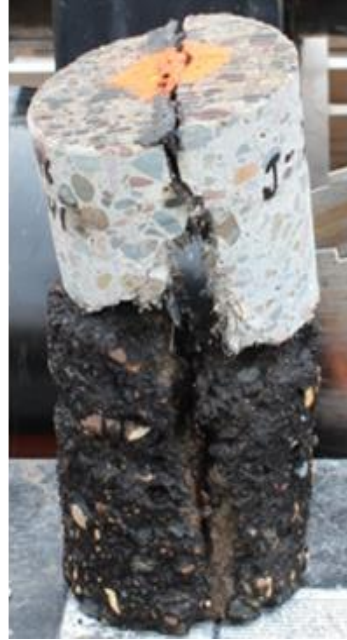
b) Joint B

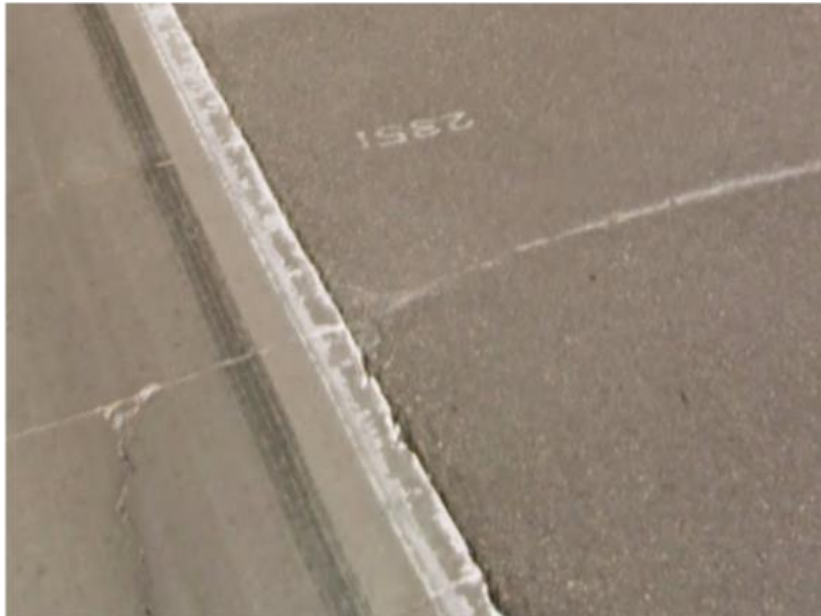
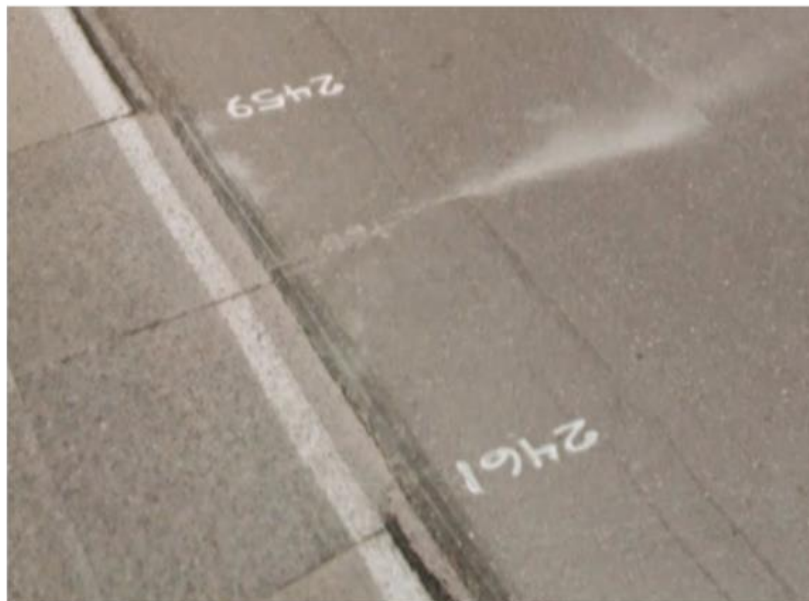
a) Cell 61:  $FSR_{\text{Winter}}=0.9$ , PCC = 127 mm (5 in), Asphalt = 178 mm (7 in)

b) Cell 63:  $FSR_{\text{Winter}}=0.4$ , PCC = 102 mm (4 in), Asphalt = 203 mm (8 in)

**Figure 5 Evidence of Pumping at MnROAD**

Pumping and faulting can occur whether or not the joint activates all the way through the asphalt layer. Staining along the shoulder, typically seen as an indicator of pumping, occurs at MnROAD in locations where the joint activates through the asphalt, as well as in joints that just activate through the concrete layer. Figure 5 shows the shoulders at a joint in Cell 61, which likely activated through the asphalt, and a joint in Cell 63, which likely did not activate through the asphalt. In both cases the shoulders show evidence of pumping. It is also important to note that the shoulders at MnROAD are not full depth. The observed signs of pumping may be due to lane shoulder pumping.

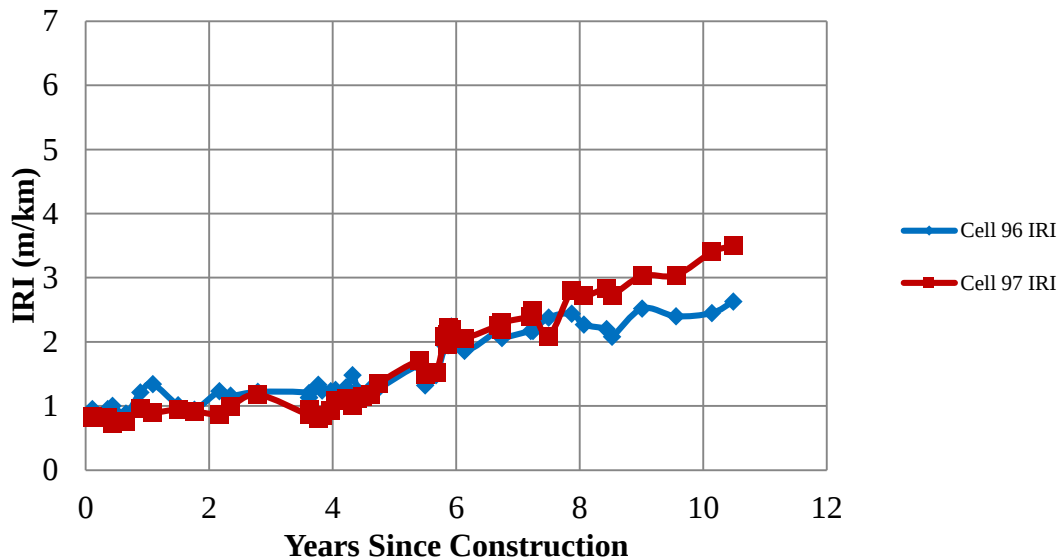
a) IRI for MnROAD Cells 96 and 97

b) Faulting for MnROAD Cells 96 and 97

**Figure 8 IRI and Faulting for MnROAD Cells 96 and 97**

The effect of the magnitude of faulting on pavement roughness is amplified on pavements with smaller panel sizes due to the increased number of transverse joints. With the same magnitude of faulting, a pavement with a longer joint spacing will have a lower International Roughness Index (IRI) than a pavement with a short joint spacing. As previously noted, the designs for Cells 96 and 97 are identical except the panel size. The joint spacing for Cell 96 is 1.5 m (5 ft) while the spacing is 3 m (10 ft) for Cell 97. The IRI for the cells were similar, as can be seen in Figure 8a. However, as can be seen in Figure 8b, the magnitude of faulting for the joints in Cell 97 is higher than the magnitude of the faulting in Cell 96. Therefore, the closer joint spacing produced a similar ride to the longer joint spacing despite having significantly lower faulting. It should be noted that

Cell 96 has not exhibited any cracking and Cell 97 only exhibited mid-slab longitudinal cracking so the only distress contributing to the decrease in IRI for both is faulting. The interesting aspect is that if just the average faulting along the section was evaluated then the performance of Cell 96 and 97 would appear to be the same, as shown in Figure 9. The contribution of the faulting to the increase in IRI can only be found by evaluating the faulting of individual joints. The increase in roughness caused by the additional joints for the shorter slabs when compared to the same magnitude of faulting for longer slabs must be accounted for when establishing faulting failure criteria for BCOAs with short slabs.
