# **MnROAD SHRP2 R21 Composite Concrete Section Performance after Five-Years of Service**

## **ABSTRACT**

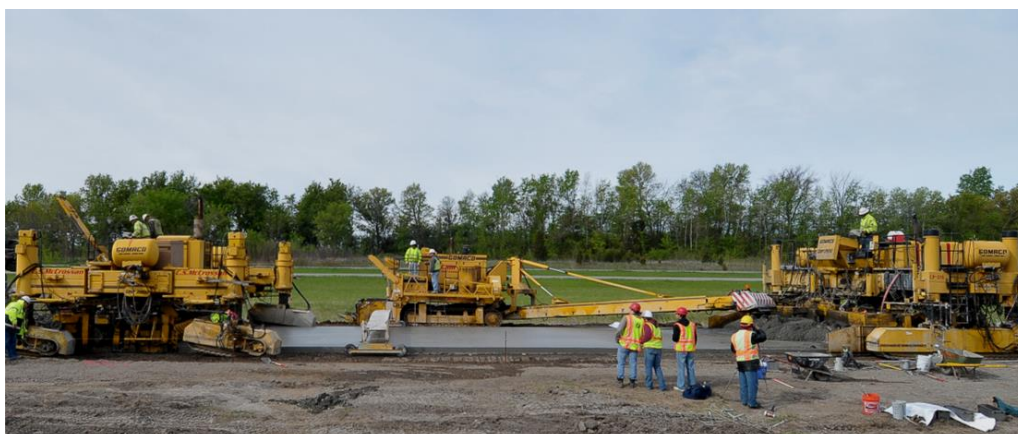
**Figure 1. (a) SHRP2 MnROAD test section design summary in cross-section and (b) two-lift paving train at MnROAD during SHRP2 construction in 2010**

The design of the R21 MnROAD test sections is illustrated in Figure 1a and summarized in Table 1. The construction of these test sections at MnROAD is shown in Figure 1b. The tests were built to feature a 3-inch high-quality PCC layer over a 6-inch “structural” PCC lower lift. Here “structural” PCC denotes that the layer functions structurally in the pavement in a manner similar to conventional concretes, yet the structural PCC uses unconventional, alternative, and/or secondary materials. Two kinds of structural PCC were considered: a low-cement, high fly ash concrete with 50% recycled concrete aggregate (RCA) replacement for the coarse aggregate and a low-cement, high fly ash concrete with inexpensive, locally available aggregates.

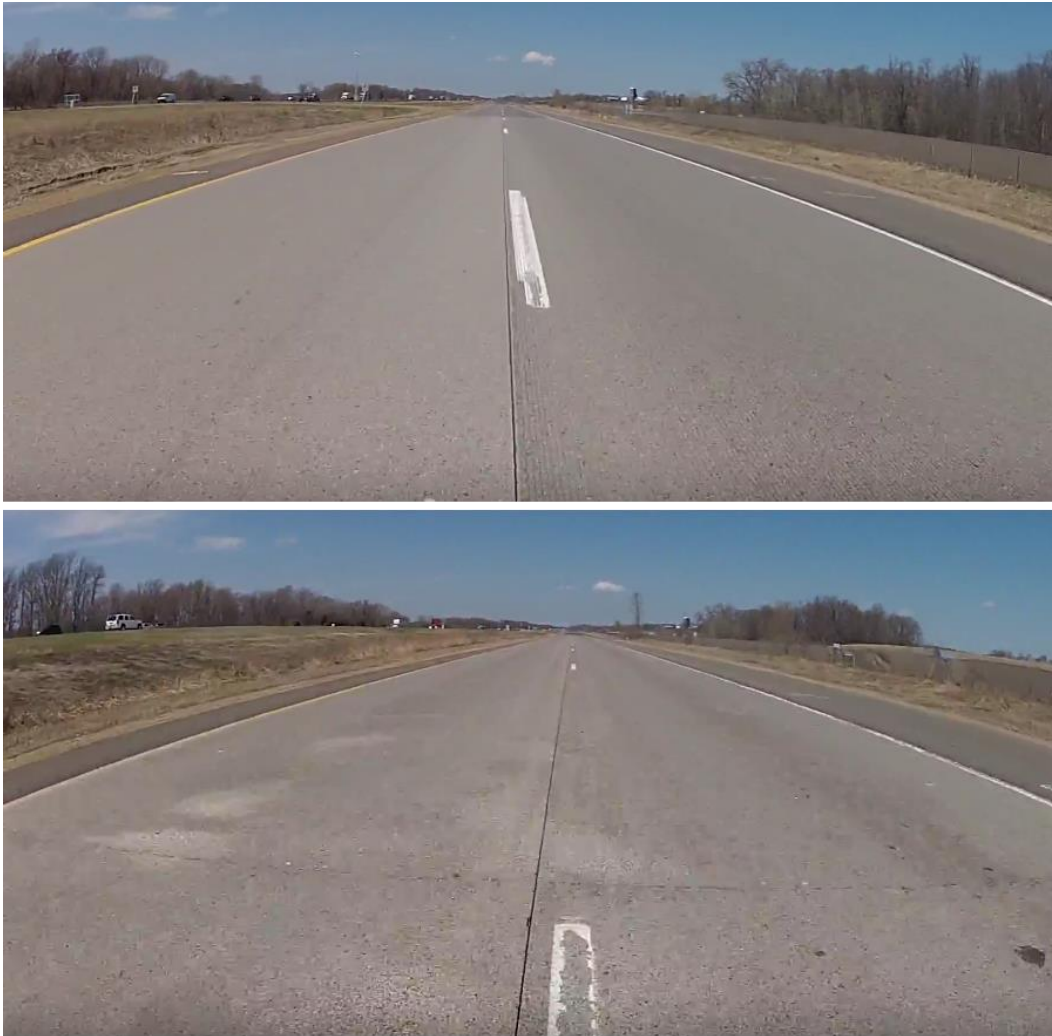
**Figure 2. MnROAD Cell 71 (top) and Cell 72 (bottom) as of November 2013**

As noted, the R21 MnROAD PCC/PCC test sections (Cells 71 and 72) are situated along the MnROAD “mainline” Interstate 94 and were opened to traffic in August 2010. The sections are shown in Figure 2.
