# **Long Term Evaluation of Unbonded Concrete Overlay Technology: A Municipal Case Study**

## **Abstract**

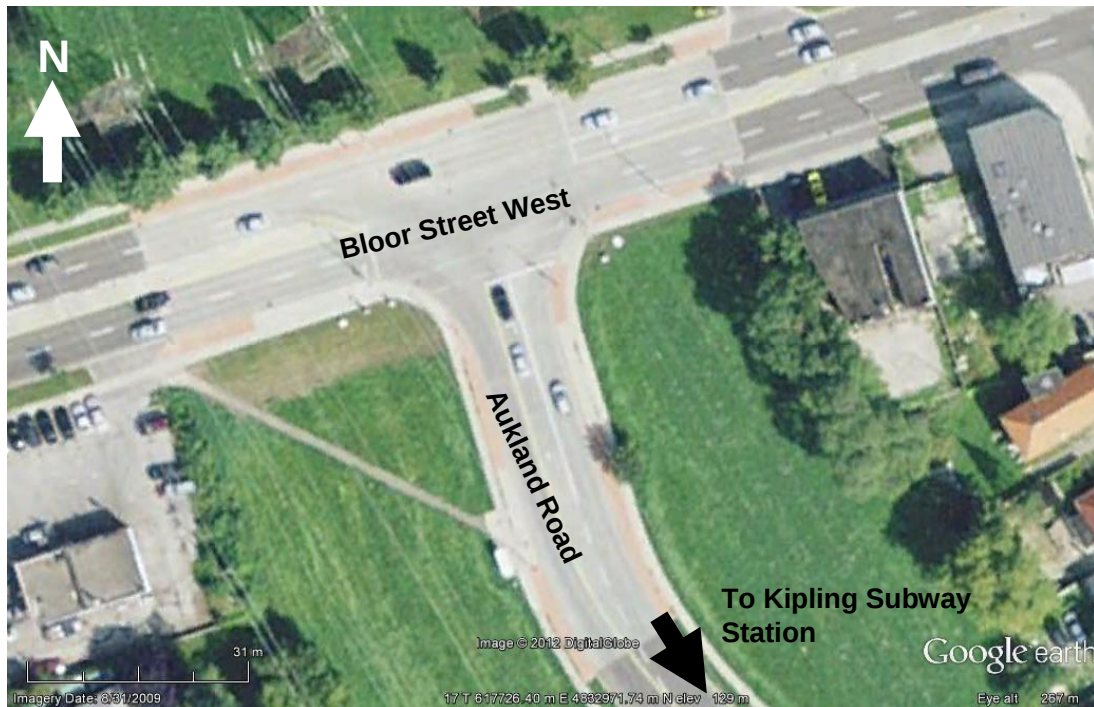
**Figure 2. Plan of Bloor and Aukland intersection (Google 2012).**

The intersection of Bloor Street and Aukland Road, located in west Toronto, is subjected to high traffic volumes and a large number of heavy vehicles. Bloor Street is a major four-lane east-west arterial road with an Average Annual Daily Traffic (AADT) of over 30,000 vehicles and high peak hourly volumes (approximately 1000 vehicles and in excess of 15 buses per hour). It meets Aukland Road, a short north-south collector road, at a T-intersection. Aukland Road leads directly into the nearby Toronto Transit Commission's (TTC) Kipling subway station, located approximately 500 metres south, as shown in Figure 2. Many TTC and MiWay (the adjacent City of Mississauga's transit service) bus routes travel along Bloor St. and turn onto Aukland Rd to travel to and from the subway station.

Frequent, rapid deterioration of the asphalt at this busy urban intersection was being noted by City of Toronto's Transportation Services staff. Rutting and shoving was reoccurring at regular frequencies, particularly near the stop bars, where traffic slows to turn or stops for the traffic signal. These distresses were creating safety concerns, forcing the City of Toronto to intervene with "mill and inlay" treatments at 2-3 year intervals, removing and replacing the damaged asphalt. City staff noted that that traditional maintenance and rehabilitation treatments were not addressing the underlying issues and a more permanent solution was required. The high volumes of heavy, slow moving bus traffic were increasing the pavement deterioration rate above acceptable levels.

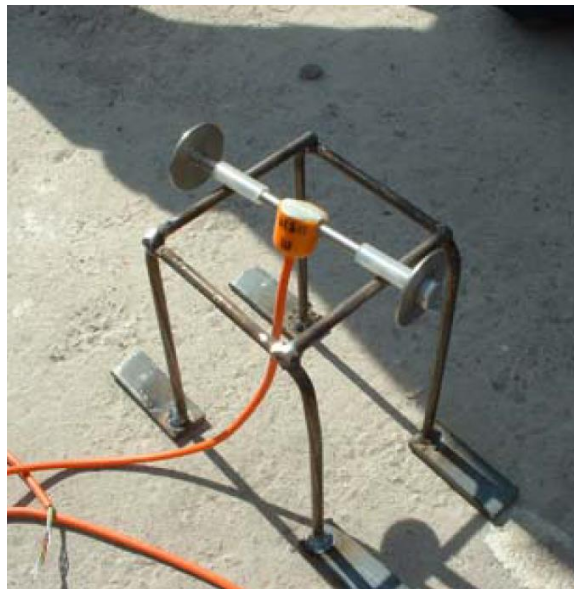
**Figure 4. Typical vibrating wire strain gauge used.**

Waterloo researchers devised an instrumentation plan to monitor pavement responses of interest. Seven vibrating wire strain gauges were placed at various locations in the unbonded overlay, in order to measure pavement responses associated with the bus traffic loadings and environmental effects. The vibrating wire type strain gauges, identical to the one shown in Figure 4, reliably capture the long-term effects of environmental loads, e.g. thermal expansion/contraction, shrinkage, curling and warping, as well as the cumulative effects of repeated traffic loadings.

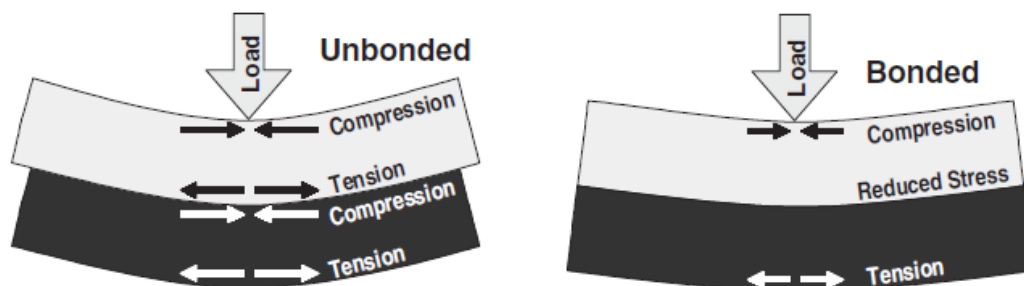
**Figure 8. Comparison of theoretical unbonded and bonded overlay strain profiles (Rasmussen and Rozycki 2004).**

The trend of increasing compression at the top surface is no surprise; however, the bottom sensors are expected to be measuring tensile strains under the thermal loadings and vehicular loadings being measured. Unbonded overlays are designed to have the overlay slab and existing slab bend separately under traffic and environmental loads due to the placement of a separation layer, shown in Figure 8.

Nevertheless, it is possible that partial bonding has occurred between the original concrete slab and the overlay concrete slab. The evidence of compressive strains throughout the thickness of the overlay suggest that both slabs may be behaving monolithically. In this case, a single neutral axis is found in the both slabs, lying in the old slab. The bonding of the concrete layers effectively adds additional structural capacity to the pavement, since the bottom slab is serving as more than a high quality base layer. Studies have shown that partial bonding may enhance overlay performance (Rasmussen and Rozycki 2004). However, bonding in an overlay that has been designed as unbonded is generally undesirable because it may allow reflective cracking to occur, particularly if the overlaid slab was well deteriorated (Harrington 2008).

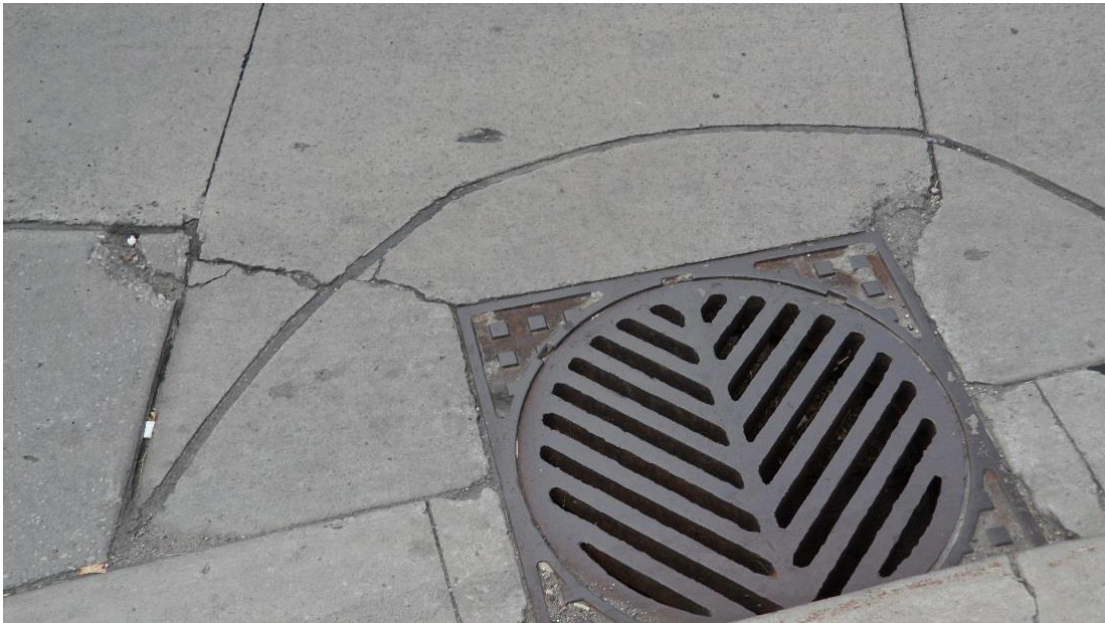
**Figure 9. Cracking near catchbasin.**

Less than optimal joint detailing and isolation of the drainage appurtenances has resulted in minor cracking the adjacent concrete near catchbasins and manholes, as shown in Figure 9. The most severe distress in the overlay section is two cracked slabs near the north-south crosswalk on the east side of the intersection, seen in Figure 10.

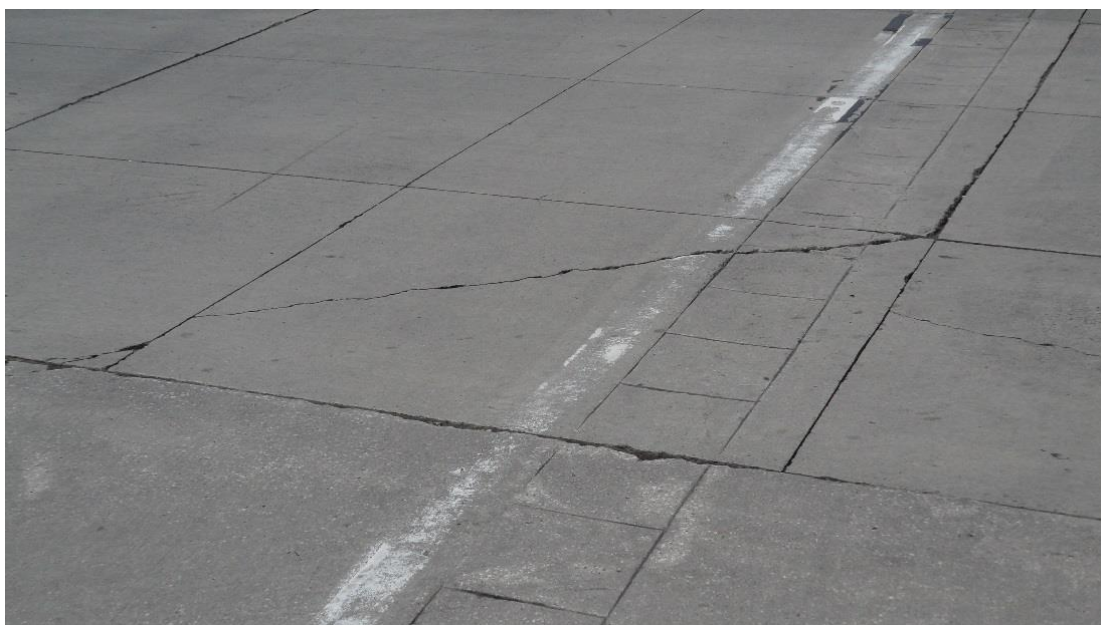
**Figure 10. Cracked slabs in crosswalk area.**
