# Spragues Road Rehabilitation with an Unbonded Concrete Overlay Region of Waterloo, Ontario, Canada.

## Abstract

The work of this project includes the rehabilitation and widening of a 1.2 km (0.75 mile) section of Spragues Road (Regional Road No. 75) from Wrigley Road to the Region of Waterloo boundary in the Township of North Dumfries. The existing road is a rural two-lane composite pavement with partially paved and gravel shoulders. An initial geotechnical investigation determined that conventional road resurfacing strategies of the asphalt / concrete composite pavement were no longer cost-effective and additional assessments were completed to evaluate alternate rehabilitation strategies. Through this process, non-destructive testing was conducted to determine the structural adequacy of the concrete base and suitability for pavement preservation. Comprehensive field investigations determined the 80-year old concrete base was generally in good condition and should be preserved as part of the project. The final pavement design consists of re-profiling or cold planing the existing asphalt surface to meet proposed design gradients, installation of an asphalt intermediate separatio

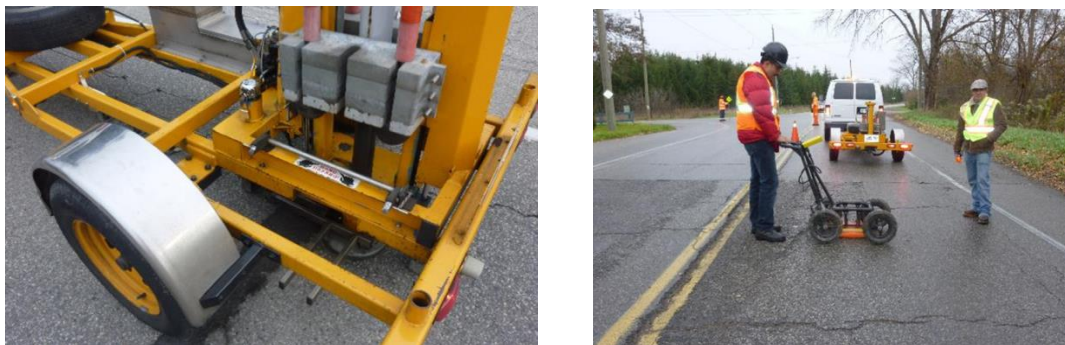
Figure 3: FWD and GPR Investigations Photos (Holt 2014).

- **Falling Weight Deflectometer (FWD)** testing to determine the structural adequacy, pavement deflection and load transfer of the concrete base between slabs; and
- **Ground Penetrating Radar (GPR)** to collect longitudinal / transverse thickness data to determine the depth and edge of the existing concrete base throughout the corridor.

FWD is a non-destructive method of determining the structural adequacy of an existing pavement. The testing process involved a series of dynamic loads ranging from 40 kN to 70 kN (approx. 9,000 lbs-f to 15,800 lbs-f), applied to the surface of the pavement by dropping a standard weight on a circular loading plate. FWD tests were completed for each location with a load applied to a plate positioned on the ‘approach’ side of the joint / crack and measurements were taken from deflection sensors at set distances from the load, some of which were on the ‘leave side’ of the joint / crack. For this particular investigation, one sensor was located at the centre of the loading plate with additional sensors located at intervals of 300 mm, 450 mm, 600 mm, 900 mm and 1,500 mm (11.8”, 17.7”, 23.6”, 35.4” and 59.1” respectively).

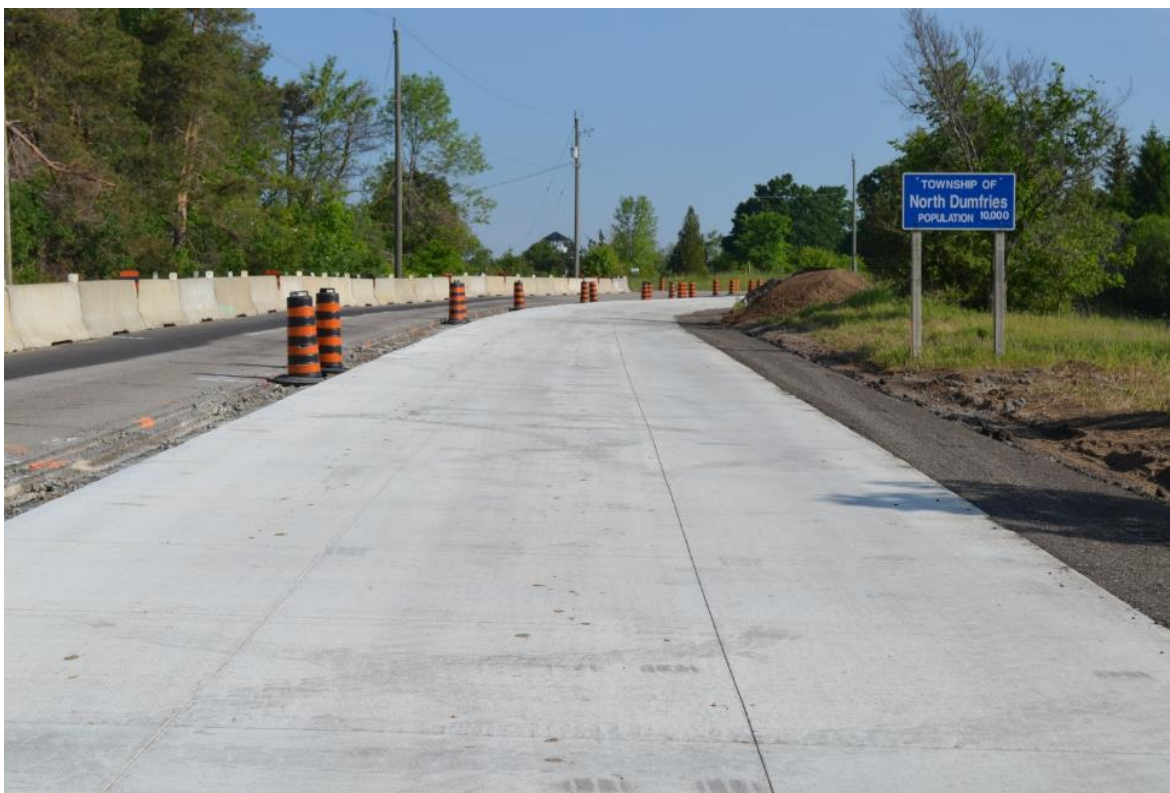
Figure 7: Northbound concrete pavement with RAP shoulder (Priour 2015).

The first stage of rehabilitation work was performed on the east side of the road and traffic control delineators were placed 1.5 m (5.9') between the limit of construction and northbound vehicular traffic. A minimum 1.5 m (5.9') offset was required to provide additional space beyond the centerline of the road to allow for cold planing, asphalt and concrete paving equipment. Roto-Mill Inc. was subcontracted to re-profile the existing asphalt surface to meet the proposed design depths / elevations in order to correct geometric deficiencies and improve super-elevations / vertical curves. Once the cold planing process was complete, Capital Paving placed an asphalt padding layer where additional material was required to meet proposed design gradients, followed by a 25 mm (1.0") separation layer throughout the limits of the concrete overlay. The separation layer was critical to ensure the overlay would be placed on a smooth surface and provide an unbonded plane to mitigate reflective cracking from the concrete base.

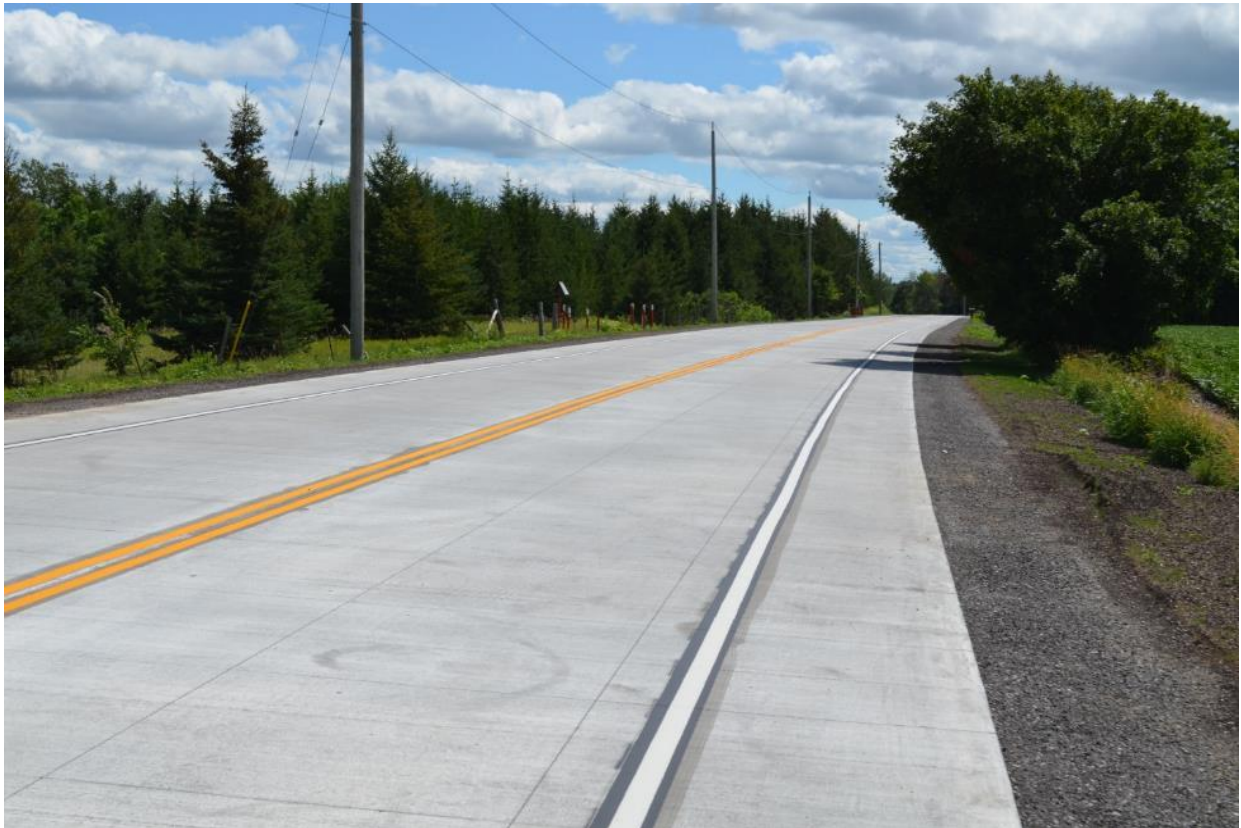
Figure 7: Unbonded Concrete Overlay with MMA Pavement Markings (Prieur 2015).

Once the northbound lane was constructed, the temporary travel lane was relocated to the new concrete surface and the second stage of rehabilitation work (TCB removal, cold planing, HMA and concrete placement) progressed on the west side. Following completion of the concrete pavement, Capital Paving installed Reclaimed Asphalt Pavement (RAP) and HMA shoulders. The road was then cleaned and Methyl Methacrylate (MMA) pavement markings were installed with a black silhouette around the white lines to enhance visibility for motorists.

The Unbonded Concrete Overlay was completed in the summer of 2015 and has performed quite well with no signs of reflective cracking from the concrete base. The long-term performance will be monitored by the Region's Transportation staff for consideration and continuous improvement on future projects. One of the design elements to be monitored is the long-term performance and maintenance requirements of the saw-cut joints. It was the design team's preference to include closer joint spacing to minimize uncontrolled cracking in the concrete although, recognized joint sealant would not be practical and would require on-going maintenance to ensure effectiveness. With this in mind, the team decided to reduce the width of the saw-cuts to 3mm (0.1") in effort to minimize the amount of incompressible material entering the joints and causing the concrete to chip during seasonal freeze / thaw cycles. In hindsight, some sections of shoulders where placed using RAP and material has been observed in the joints which will require cleaning and sealing of the shoulders in the future to reduce further migration.
