# **Evolution of Pervious Concrete Pavement at the Ministry of Transportation Ontario, Canada**

David Rhead<sup>1</sup>

## **Abstract**

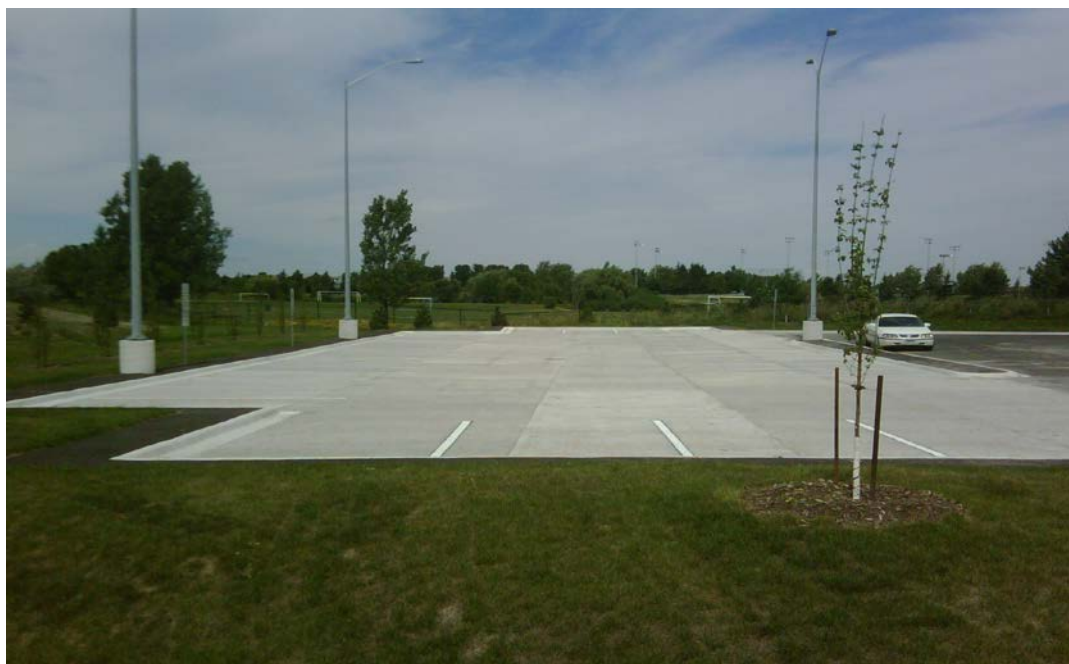
The Highway 410 and Williams Parkway Interchange GO Transit commuter parking in Brampton, Ontario was completed July 2011 is shown in Figure 1. This commuter carpool lot includes two parking areas along with a GO Transit bus loop. This facility is located within the Regional Municipality of Peel, and with strict stormwater runoff limits imposed is able to connect to the Region’s stormwater sewers. Permeable pavement was brought forward both as a “green alternative” and as a stormwater management solution for the project.

Figure 1. Highway 410 and Williams Parkway Brampton GO Commuter Parking

Pervious concrete was selected for the smaller of the two parking areas (30 parking spots, 919 m<sup>2</sup>) as this would limit stormwater entering the sewer system to below the Region of Peel limits. As MTO experience with the maintenance of pervious concrete is still under development the designer also elected to include supplementary stormwater drainage with the pervious concrete pavement design to provide an additional factor of safety should the pervious concrete fail to function effectively over time.

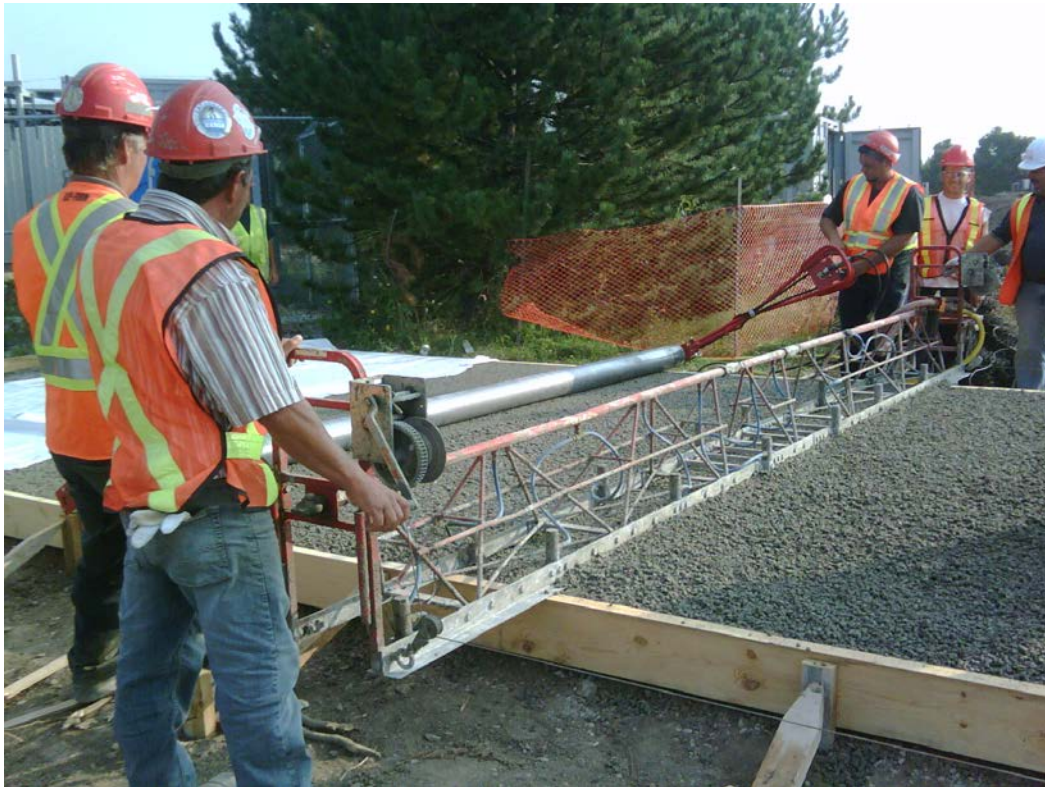
The first trial slab was constructed on August 31, 2010. The contractor opted to use a vibratory steel screed running on 10 mm spacer strips placed on top of the forms followed by a hydraulically actuated rotating tube screed as shown in Figure 2. The spacer strips were removed prior to compaction with the hydraulic roller screed. The roller screed had a weight of 65-75 kg per linear metre.

Figure 2. Trial Vibratory Screed on 10 mm strips followed by Hydraulic Roller

During placement, the consistency of the concrete was found to vary throughout the load. The vibratory screed brought excessive paste to the surface and didn't appear to aid in concrete compaction. In order to improve compaction by the roller screed, an additional layer of spacer strips was utilized for part of the placement. This was unsuccessful as the roller screed was incapable of compacting 20 mm of concrete above the top of the forms to finished grade. A second mix incorporating some 20 mm aggregate was also included at the contractor's initiative in an attempt to provide better compaction.

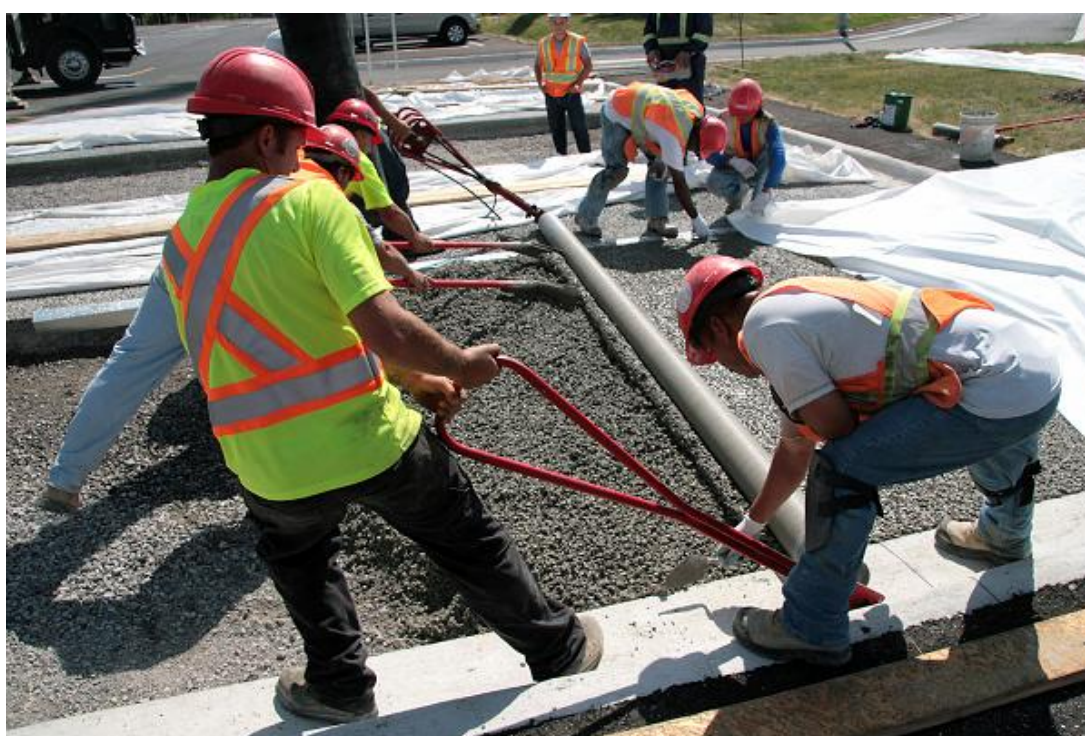
A conveyor was used to place the concrete in front of a hydraulically-actuated rotating tube (roller) screed. Prior to placing the concrete, the subgrade was pre-wetted to prevent moisture loss from the plastic pervious concrete. The roller screed was supported by fixed forms, pervious concrete pavement, or curb and gutter as shown in Figure 3. A protective flashing was placed on the edge of the pervious concrete when the roller screed was spinning on the edge of previously placed pervious sections to reduce the risk of edge ravelling.

Figure 3. Hydraulic roller screed running along pervious concrete and curb & gutter
