## **A Case Study of Slab Cracking and Delamination in BCO Construction at the Bush International Airport (IAH) Part I: Impact on Service Life**

### **Abstract**

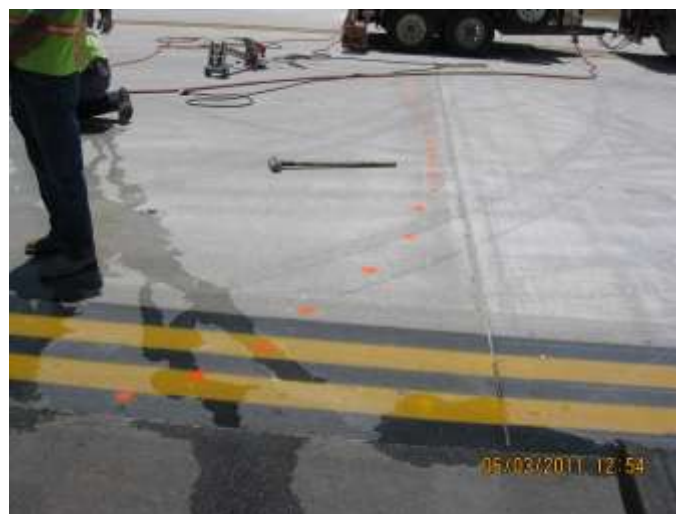
**Figure 1** Hammer for Sounding Delaminated Areas (see red dots).

As previously noted, sounding of the slab corners and edges using a 10 lb hammer was carried out to identify the slabs that had delaminated. In order to validate the sounding, ultrasonic tomography (UST) was used. UST is a method of non destructive testing (NDT) that is proving to be effective in detecting shallow and deep delaminations (White et al. 2011). In this technology, an array of piezoelectric transducers is used to generate and detect shear or SH-waves in a concrete layer. The result is an image of the internal structure of the slab by using pulse-echo principles. The UST device consists of a 4x12 array of dry-point contact (DPC) transducers. Figure 8a shows the row of sensors that are involved in the UST technology where a single row of transducers serve as a source where other rows of transducers serve as receivers. Each transducer is independently spring-loaded which allows testing on uneven surfaces. The system compensates for surface SH-waves providing a clearer image in the near surface area.

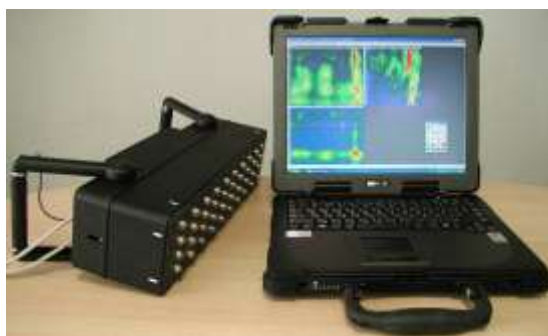
**Figure 8a** Ultrasonic Tomography ([www.pcte.com.au](http://www.pcte.com.au)) View of Sensors.

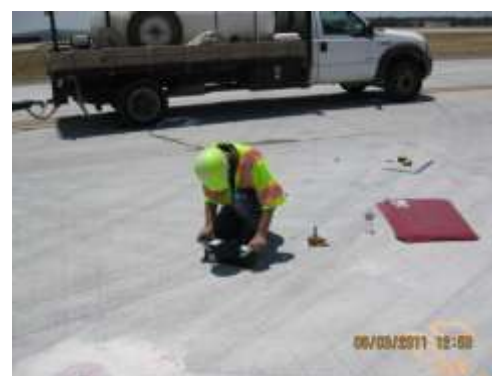
**Figure 8b** Using Ultrasonic Tomography in the Field.

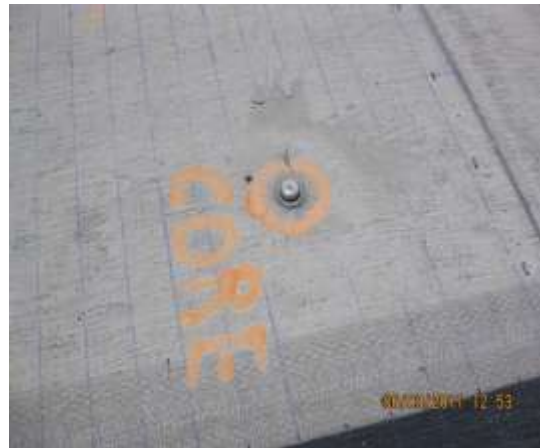
**Figure 9** Cap for Tensile Strength Testing.

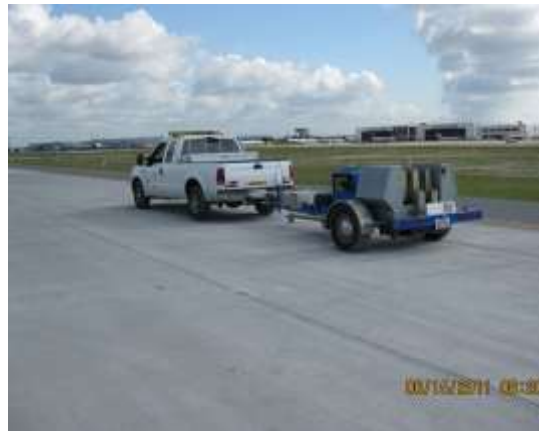
**Figure 11** HWD and Load Plate.

As part of the investigation of the effect of delamination of the 8 inch BCO on the structural capacity of the pavement section, NDT data was also collected using the heavy falling weight deflectometer (HWD). The HWD, (shown in Figure 11) measures deflections due to a dynamically applied load via a load plate at 7 specific locations referenced to the center of the load plate. The deflection data is recorded for three load drops; 11,400 kg (25,000 lbs), 20,865 kg (46,000 lbs), and 25,401 kg (56,000 lbs). The NDT testing was conducted at selected locations along the T/W WA alignment. The analysis from this collected data (Zollinger et.al., 2005) consisted of the determination of:
