# **Challenges with Construction of Portland Cement Concrete Pavement at Calgary International Airport**

## **Abstract**

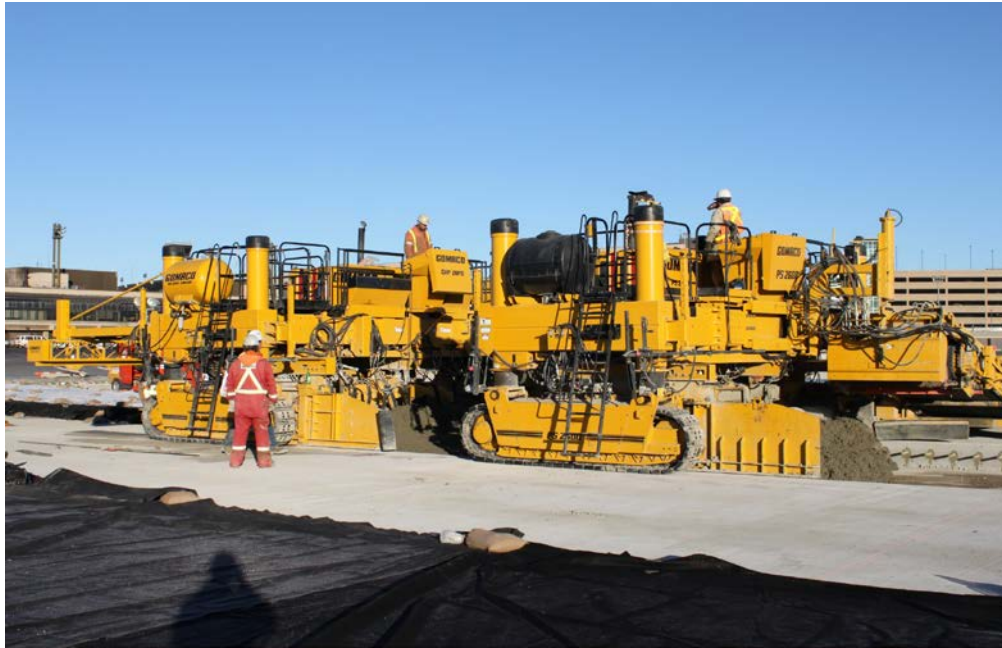
Gomaco's PS-2600 Placer/Spreader and a GHP-2800 slipform paver were utilized for the first time in Alberta (Photo 1). The PS-2600 Placer/Spreader is designed to meet high volume demands in new construction of concrete pavements. It accepts concrete from end dump trucks, conveys material to the grade, and spreads the material to the desired width and depth of the application. The GHP-2800 Slipform Paver features the most up-to-date technology to provide easier set-up operation, troubleshooting, and safety. The majority of concrete pavement was placed using the Gomaco paver. Hand pours were intended for edge panels and around services locations only. However, concrete paving moved to winter time and the majority of concrete constructed after December 2010 was placed by hand and totalled over 30 percent of the entire area. The Terraquip roller screed utilized for hand pours provided an even and smooth finish spanning over the entire 6 m wide PCC slab.

Photo 1. Gomaco's placer/spreader and paver.

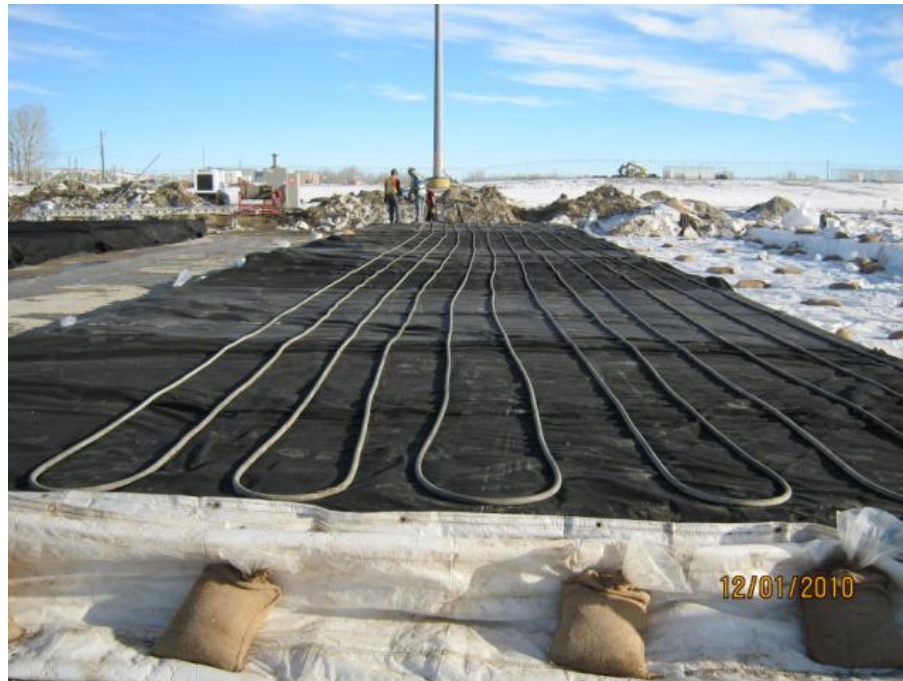
Weather was monitored closely during paving operations. CSB was not placed unless the ambient temperature was above  $-5^{\circ}\text{C}$  and rising and care was taken to ensure that the subgrade soils were not frozen prior to CSB placement and compaction. The minimum temperature of CSB prior to concrete paving was  $+5^{\circ}\text{C}$  and was achieved either by insulated tarps alone or by use of glycol heating lines, depending on the ambient temperature. Once the PCCP was placed and finished, the temperature probes were installed. The probes were inserted about 5 cm below the pavement surface and at the mid-section and bottom of the slab, and the temperatures were recorded continuously for seven days by data loggers. The purpose of the near-surface locations of the temperature probes was to identify the risk of low ambient temperatures on the future performance of the pavement surface. Shortly after initial set of the concrete, a non-woven filter cloth was applied top, sides, and ends of the paved lines followed by a second filter cloth layer. On the pour dates, when the ambient temperature was dropping below  $-5^{\circ}\text{C}$ , insulated tarps were placed to maintain concrete temperature. The risk of damaging the surface of fresh concrete by these activities was considered to outweigh the risk of freezing the surface and compromising pavement durability. Within less than 24 hours, green cutting of control joints was setup. The filter cloth and the tarps were gradually removed at specific joint locations and the surface of the concrete was quickly covered with tarps soon after the joint was completed to minimize thermal shock and cracking. Surface temperature probes were monitored and when the temperature of PCCP was falling below  $+5^{\circ}\text{C}$ , glycol heating lines were placed and covered with tarps to maintain the concrete temperature at  $+5^{\circ}\text{C}$  for at least seven days or until 75% of specified strength was achieved by maturity calculations (Photo 2).

Photo 2. Installation of glycol heating lines on the PCCP.
