## Quebec Contractor Experience with Unbonded Concrete Overlays

Jean-Pierre Turgeon<sup>1</sup> and Pierre-Louis Maillard<sup>2</sup>

### *Highway 40 Concrete Overlay Project in Vaudreuil*

### **Highway 40 Concrete Overlay Project in L'Assomption**

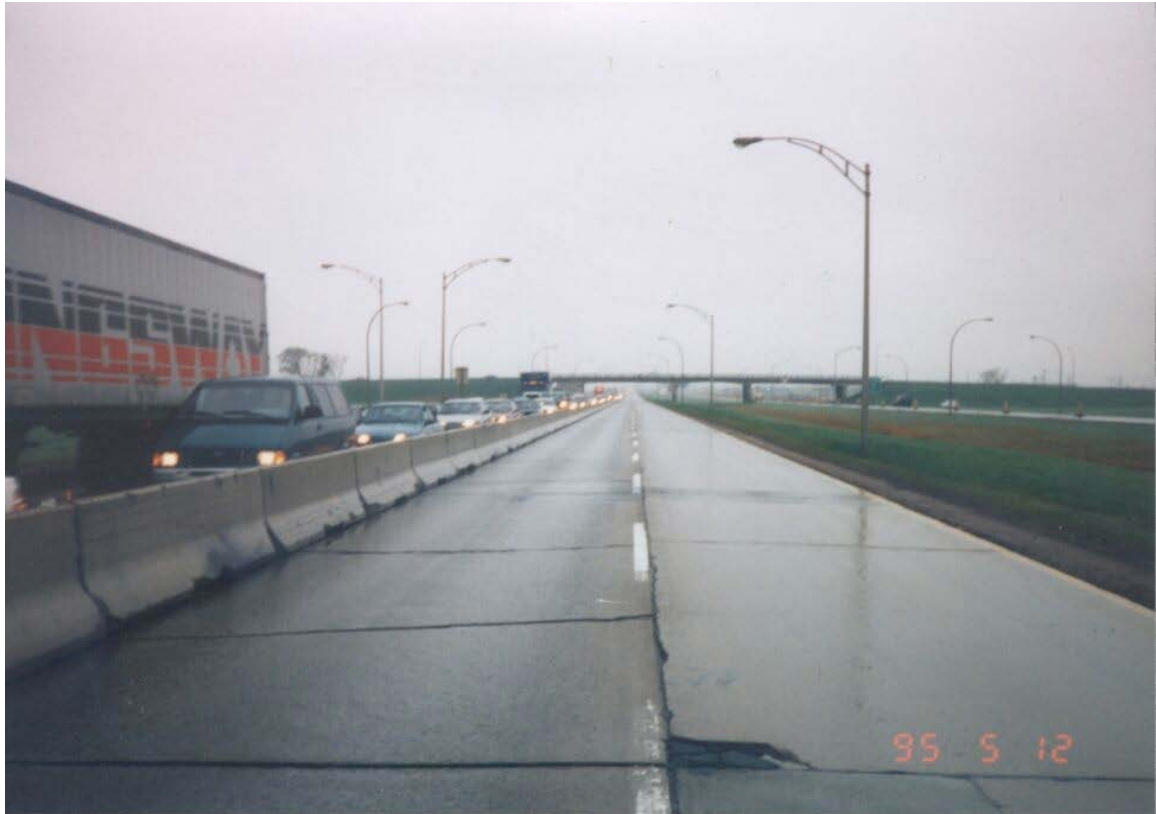
Figure 2 – Deteriorated Pavement

The existing concrete pavement built in 1966 was severely deteriorated (Figure 2) mainly due to the considerable volume of heavy vehicles and poor subbase drainage. In addition, the long slabs reinforced with a metal mesh presented transverse cracking and deterioration at the joints.

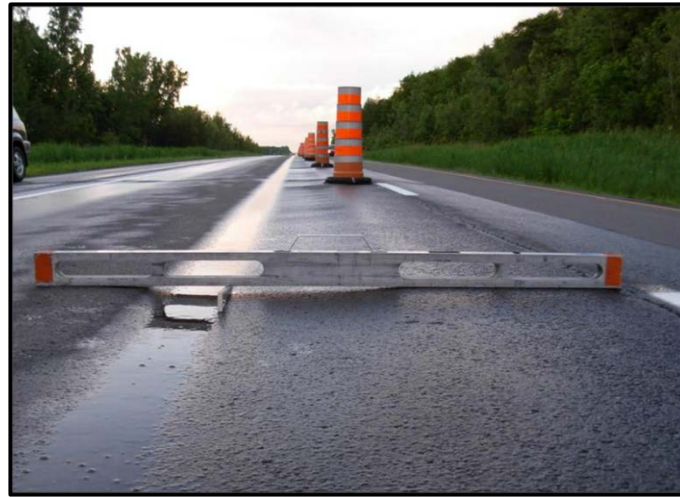
Figure 5 – Condition of Existing Pavement

This section of highway was built in the 1970s. The issues encountered in this sector mainly concern the surface course. The right-hand lane is subject to intense heavy vehicle traffic and was showing significant and recurring rutting despite numerous asphalt mix resurfacing operations. Bore samples show that the asphalt mix was up to 350 mm thick in places and that the subbase was made up of granular materials on a sand subgrade. These materials are not susceptible to frost and their behavior is well suited to their use. They also provide sufficient drainage.

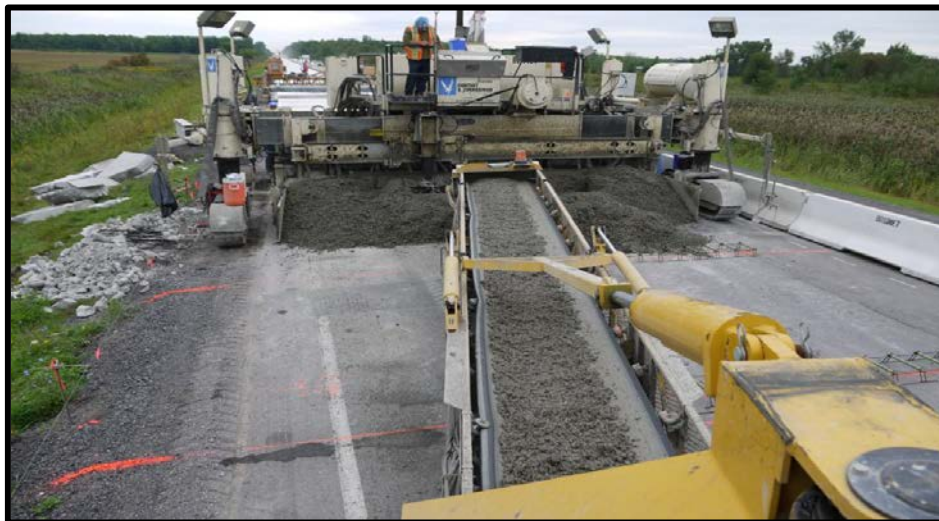
Figure 9 – Concrete Distribution in Front of the Paver

A material transfer vehicle was used in Phase 1 of the work (right-hand shoulder and lane) to convey concrete from the trucks to the front of the paver (Figure 9).
