# Behavior and Performance of Continuously Reinforced Concrete Pavement

Moon C. Won, Ph.D., P.E.<sup>1</sup>, Seongcheol Choi, Ph.D.<sup>2</sup>, Jeonghee Nam, Ph.D.<sup>3</sup>

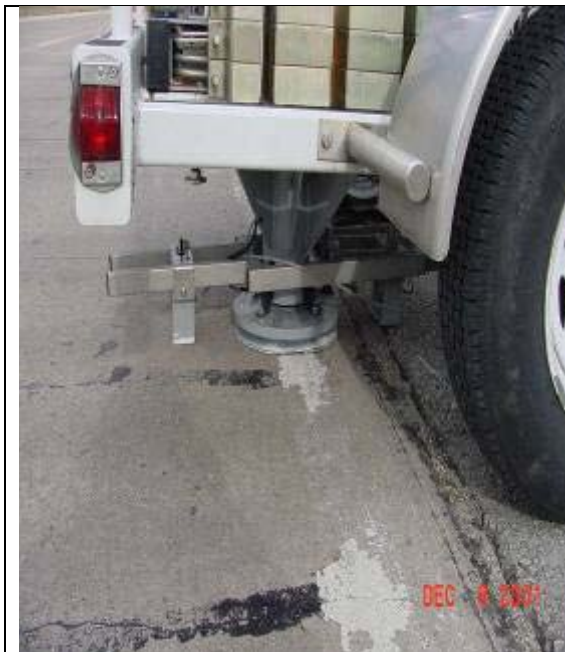
Deflections were measured at the pavement edges as shown in Figure 7-(a) (asphalt shoulder) and 7-(b) (tied concrete shoulder).

Figure 7-(a) Edge deflection measurement with asphalt shoulder

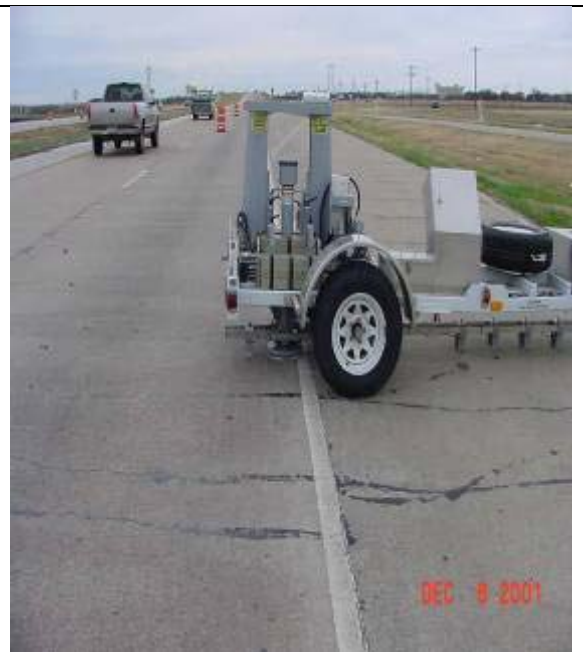
Figure 7-(b) Edge deflection measurement with tied concrete shoulder

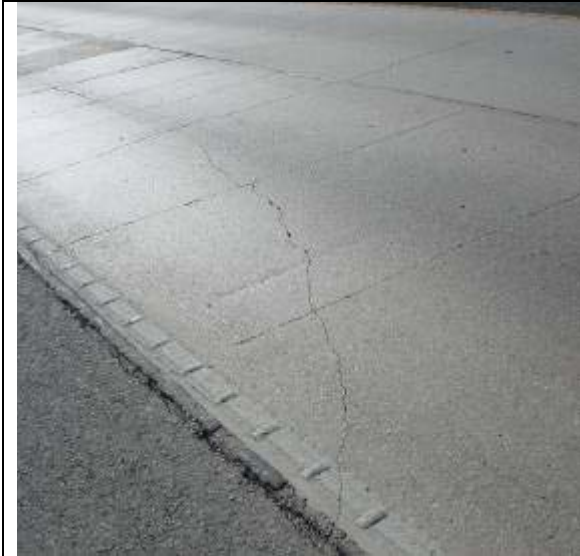
Figure 9-(a) Half moon shape longitudinal crack

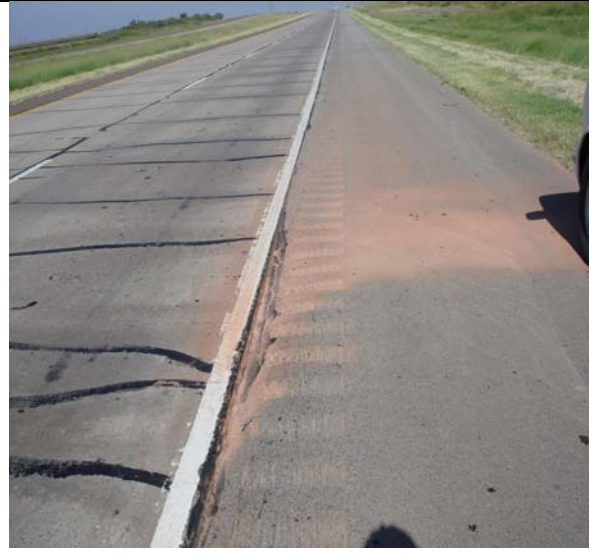
Figure 9-(b) Severe pumping in CRCP with asphalt shoulder

Figure 9-(b) shows severe pumping of the CRCP which is about 40 years old with heavy truck traffic. Note that asphalt shoulder was used in this project, and the edge of the concrete slab was depressed about one and a half inches, indicating voids underneath the slab edge. No deterioration was observed in transverse cracks yet. It is expected that a half-moon longitudinal crack might eventually form here.

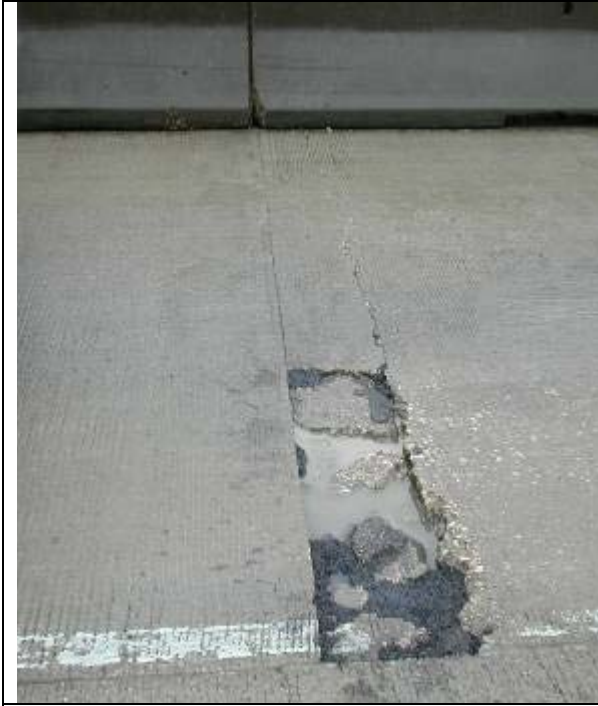
Distresses also take place in CRCP, not due to structural deficiency, but due to inappropriate design practices. Figure 12-(a) shows distresses that could take place at transverse construction joints. The concrete was placed in the direction from left to right. Note that the transverse crack, about 60 cm (2-ft) away from the joint, is parallel to the transverse construction joint. This type of failure is not uncommon, and field investigation was conducted to identify the causes. Figure 12-(b) illustrates the installation of LVDTs in the longitudinal direction. This section was completed Friday, August 26, 2005. Note the addition of extra longitudinal bars, about 60 cm (2 ft) from the end of completed paving section.

Figure 12-(a) Distress due to improper use of additional rebars

Because the first concrete poured in the morning at the construction joint is placed mostly by hand, which sometimes requires the addition of water to improve workability, the quality of the material and construction could be compromised. Also, the temperature of concrete placed in the early morning increases more than that of concrete placed in the late morning or in the afternoon. Accordingly, there is a large thermal strain and stress developed near the transverse construction joint, which could lead to more cracks and sometimes distresses. The placement of extra longitudinal bars might not address the real cause of distresses near transverse construction joints. Rather, stricter quality control of materials and construction might help resolve the performance issues near transverse construction joints. If extra longitudinal bars are to be used, the ends of the bars in the new concrete side should not end at the same line. They should end in different locations by using different lengths of bars.
