# **Repeated Load Behavior of Continuously Reinforced Concrete Pavements**

Erwin R. Kohler<sup>1</sup>, Member ISCP and Jeffery R. Roesler<sup>2</sup>, Member ISCP

## **Abstract**

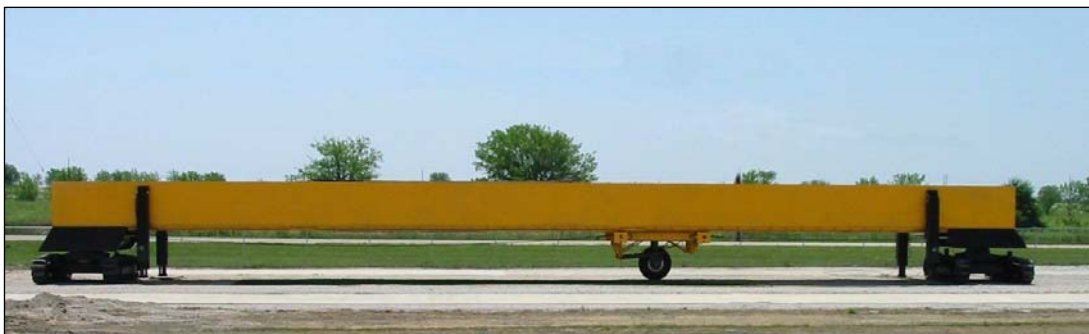
**Figure 4. ATLAS full view**

The full-scale pavement sections were loaded with the “Advanced Transportation Loading Assembly” (ATLAS). The ATLAS can apply vertical loads of up to 350 kN and can traverse the 26 m test section up to 16 km/h. A picture with a full view of the ATLAS device is shown in Figure 4.

The loading was primarily applied with a single aircraft tire with inflation pressure of 1.48 MPa. Most of the testing was done at a wheel speed between 9 and 13 km/h, under bi-directional trafficking mode, and at a fixed lateral position. To accelerate the pavement failure, the wheel load was applied along the edge of the pavement to produce the greatest deflection and stress. Pavement testing with the ATLAS started in August 2002 and lasted for two years. Section 1, 2, and 3 were tested to failure. Sections 4 and 5 were tested, though pavement failure was not achieved. The sections were tested in different seasons and consequently under different thermal conditions, as shown in Table 1.

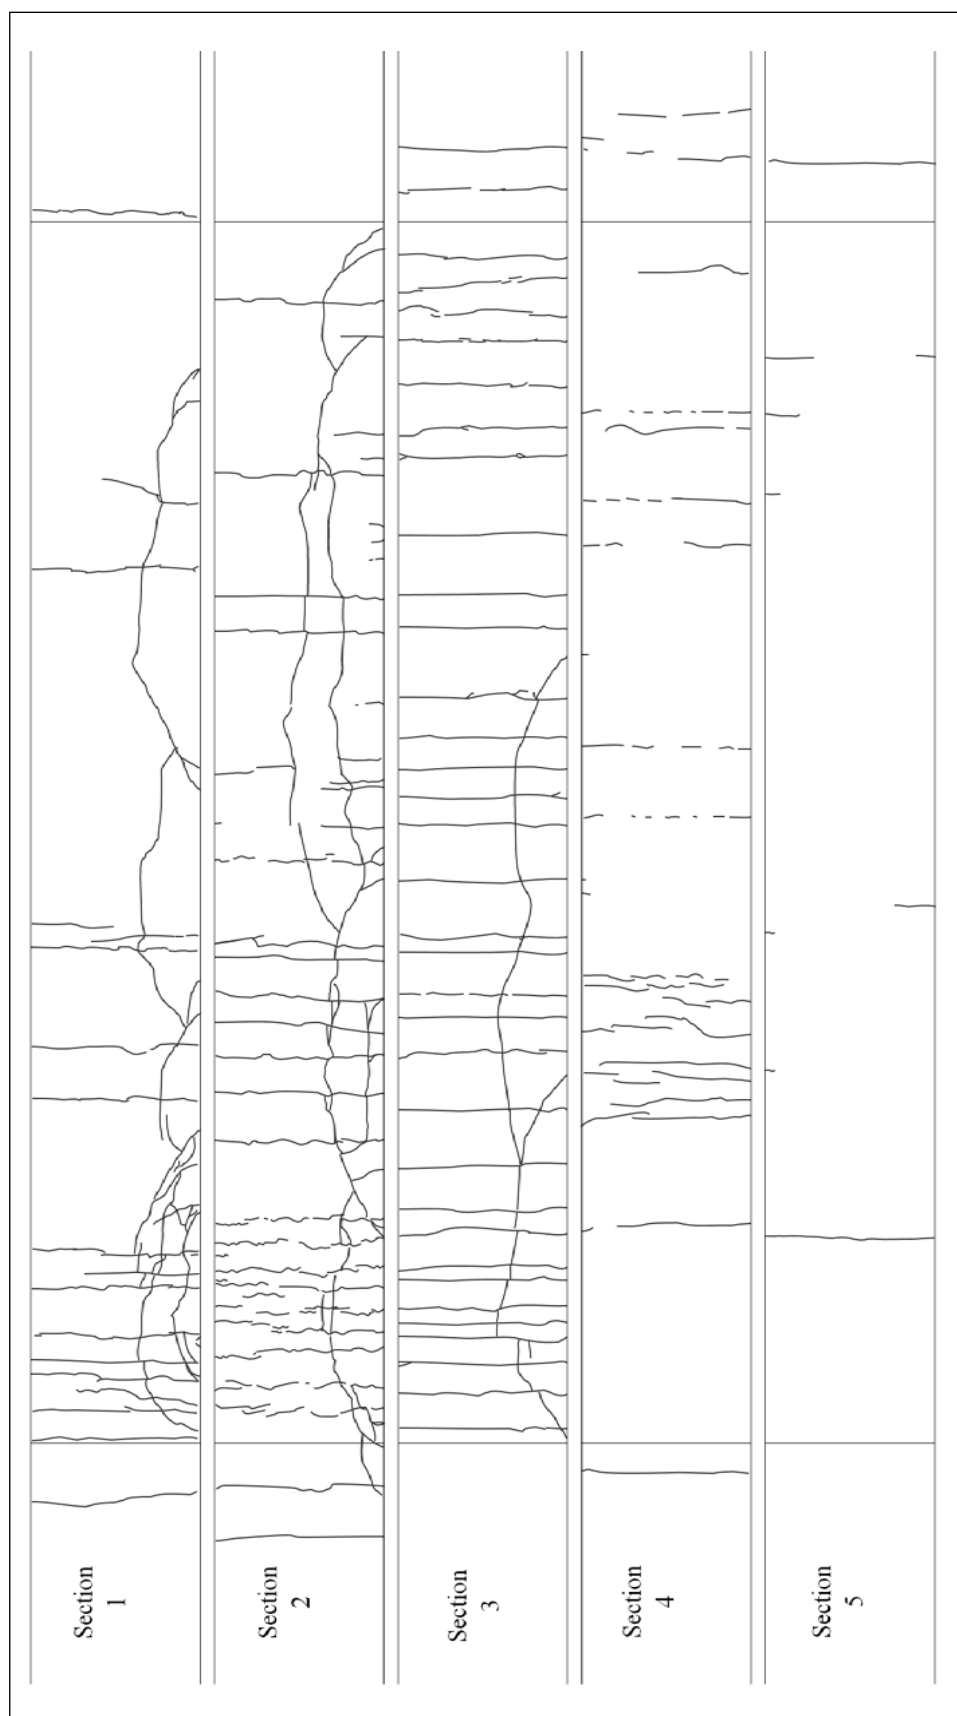
**Figure 12. Crack maps at the end of loading.**

Longitudinal cracks initiated 1.2 to 1.5 meters from the loaded edge at transverse cracks and eventually propagated toward the pavement edge with the applications of more load repetitions. At the end of loading, they resembled half-moon cracks. The locations where the longitudinal crack extended to the edge in general coincided with longer panels. The presence of other closely spaced transverse cracks allowed the crack to continue propagating longitudinally through multiple transverse cracks. The half-moon cracks had the potential to develop faulting and the enclosed area was considered a punchout. A cascade effect created failures associated with the original punchouts, affecting a considerable length of the test section. The length of each punchout was between 3 and 14 m. Secondary longitudinal cracks formed closer to the edge in sections 1 and 2. Figure 12 presents the crack maps for all sections after the loading was finished.
