# Use of Innovative Pre-Cast Concrete Slab Repair Technology in Canada

## Abstract

In 2004, the Ministry of Transportation Ontario (MTO) carried out a trial project to evaluate construction techniques for pre-cast concrete slab repairs in concrete pavement. The trial was carried out on Highway 427, a heavily trafficked freeway in Toronto, Canada. The trial project required demonstrations of three pre-cast concrete pavement full-depth repair methods: the Fort Miller Super-Slab™ Intermittent Method, the Fort Miller Super-Slab™ Continuous Method, and the Michigan Method. Each method involves designing and fabricating pre-cast concrete slabs to replace deteriorated concrete pavement. The methods differ in how the base is prepared and how the pre-cast slab is installed and dowelled to the existing concrete pavement. Non-destructive testing using a Falling Weight Deflectometer (FWD) was undertaken after construction to assess load transfer efficiency (LTE) and to detect loss of support underneath the pre-cast slab. Details of the methodologies, site conditions, contract specifications, construction and FWD analysis are presented. This is the first construction experience in Canada with

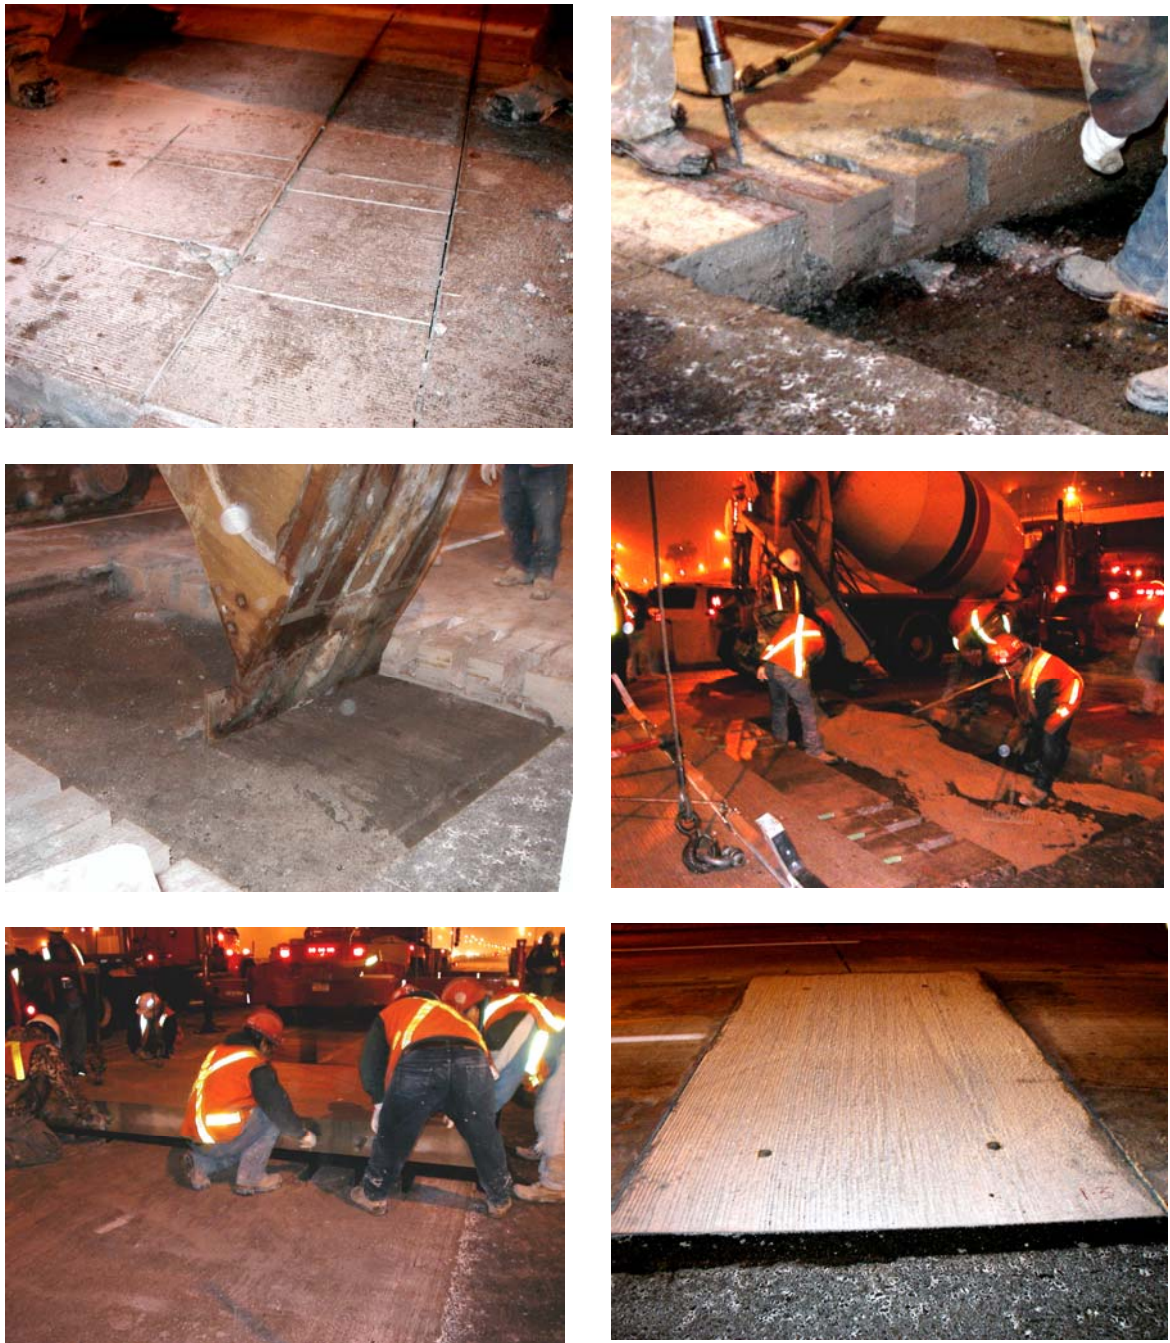
**Figure 2.** Construction sequence for Michigan Method pre-cast slab installation: a) perimeter sawcuts and sawcuts for dowel slots made the previous night, b) removal of dowel slots by jackhammer, c) scraping of CTB using a modified backhoe bucket, d) placement of flowable fill, e) lowering of pre-cast slab, and f) final product (slab 3).

**Slab Placement.** The Michigan Method pre-cast slabs were manufactured locally by the Contractor. The transversely tined slabs appeared to be well made, with no voids evident. Four lift hooks were embedded in the slabs.

The first slab was lowered by crane onto the flowable fill at approximately 1:30 am, with all 12 cast-in dowel bars fitting into the sawcut slots. The removal area was larger than the pre-cast slab, with at least 25 mm clearance around the slab.

This first slab was placed slightly high. The contractor attempted to drive heavy equipment over the slab to settle it deeper in the flowable fill, but the slab was set. The end result was a slightly high spot on the leave edge of the slab.

**Grouting.** At 1:45 am, a crew arrived on site to grout the dowel bar slots and perimeter of the slab. The grout (HD-50) was mixed on site and poured manually into the slots from the small mixing unit. The grout was thin and watery, no vibration was used, and there was no curing compound, plastic or blankets. The grout required 3 hours to set, which meant that the first slab would have the required 3 hours curing time but the next two slabs would not (without an extension of the 5:00 am opening to traffic). The Contractor was required to cast grout cubes and complete testing before opening to traffic. Strength test results were 21 MPa in 3 hours.

**Observations.** All three Michigan Method slabs were placed between 10:00 pm and 3:00 am. The second slab was the best of the three slabs, being flush with the existing concrete pavement. The other two slabs sat slightly higher than the existing concrete, resulting in a slight bump. These slabs will require diamond grinding to meet surface tolerances.

Excavation of the dowel bar slots was not carried out with a desirable level of care. Dowel bars were not centered in the dowel slots and where the dowel bars were resting against the walls or base of the dowel slots it will be difficult to get full encasement with grout. Some of the dowel bar slots were spalled down to the base and there were also cracks extending from some dowel slot removal areas into the existing concrete. This method requires good workmanship to ensue that the removal area is precisely delineated and the dowel bars slots are carefully chipped out without damaging the existing concrete.

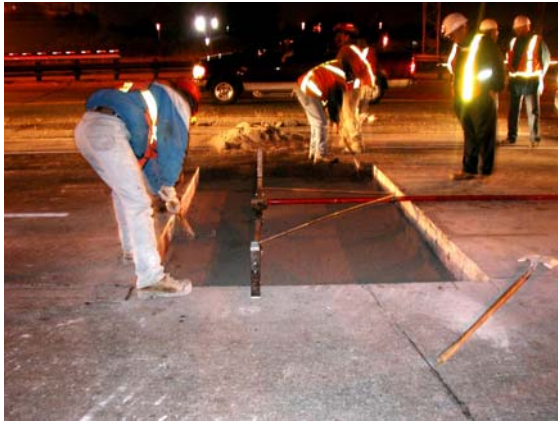
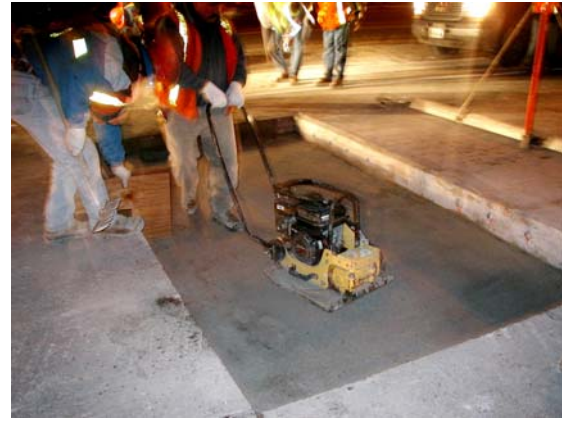
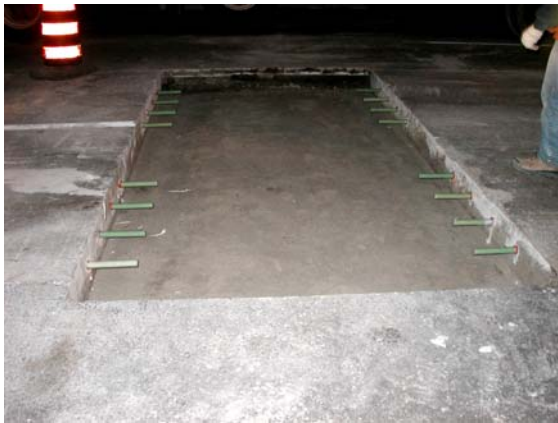
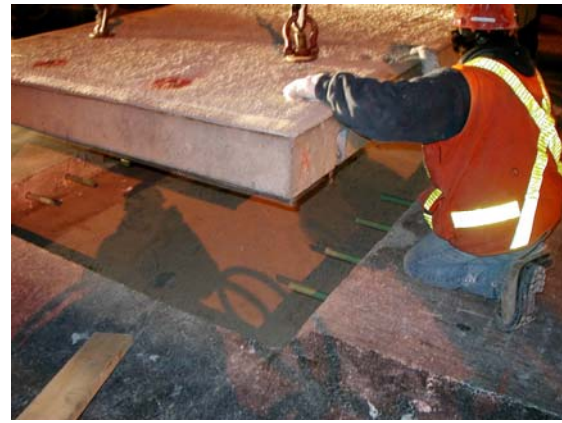
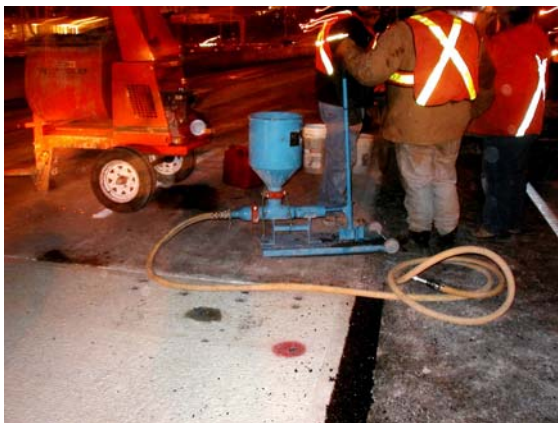
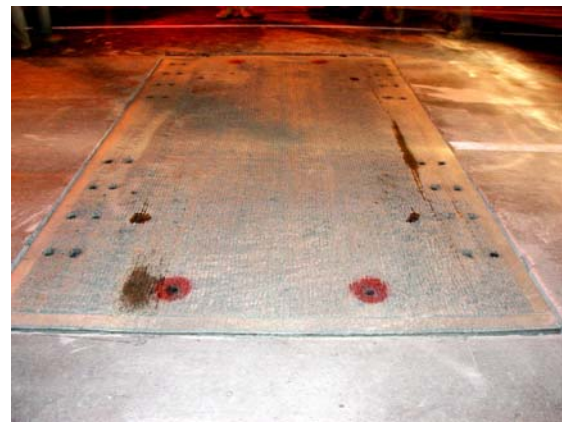
**Figure 3.** Construction sequence for Fort Miller Intermittent pre-cast slab installation: a) using full lane width leveling screed to fine grade crusher screenings, b) compacting crusher screenings using plate packer, c) dowel bars installed, ready to place pre-cast slab, d) lowering pre-cast slab, e) grout pump for grouting dowel bars, and f) final product, prior to grouting.

**Base Preparation.** The Fort Miller Method uses crusher screenings for leveling material beneath the pre-cast slabs. Aggregate for base preparation was required to be 100% crushed fine aggregate, with a plasticity index of 0% according to LS-704 and a maximum micro-Deval abrasion loss of 35 according to LS-619. Fine aggregate means 100% passing the 4.75 mm sieve when tested according to LS-602.

The crusher screenings were placed, then screeded with the Contractor's full lane width leveling screed working off the longitudinal joint between lanes 2 and 3, and the shoulder. Crossfall on the shoulder meant that the crushed screenings were higher at the edge of lane 2 than at the edge of pavement due to cross-fall in the shoulder. A plate-packer arrived on site at 12:15 am to compact the fine aggregate base material.

**Installation of Dowel Bars.** In the Fort Miller Intermittent Method, dowel bars are drilled in the existing concrete, and block-outs are cast into the pre-cast slabs, so the slabs can be placed over the protruding dowel bars. A gang-drill consisting of four independently powered pneumatic drills was used to drill the dowel bars, which were placed with 4 bars in each wheel path. The location of the dowel bars was accurately marked with a template, which arrived on site at 11:50 pm. The gang-drilling operation began at 12:05 am, taking approximately 6 minutes per side, and resulted in some spalling at the face of the adjacent slab. At 12:25 am, the Contractor had blown out the dowel bar slots, injected epoxy adhesive into holes and was inserting dowel bars.

**Slab Placement.** At 12:30 am, the crane arrived on site, accompanied by the pre-cast slabs on a flat bed truck. The first slab, lowered in place at 12:50 am, matched flush with the existing concrete pavement.

**Grouting.** In the Fort Miller Method, the dowel bars are grouted through ports in the pre-cast slab. At 1:10 am, grouting of the dowel bars began with a manually operated grout pump. The grouting operation was slow, finishing the first slab at 1:45 am. On site staff from the Fort Miller Company indicated that grouting should only take 10 minutes per slab.

**Observations.** The Contractor began his removal at the second slab replacement area at 11:35 pm, excavated the CTB, placed and fine-graded the screenings by 1:10 am, and placed the pre-cast slab at 1:20 am. The slab was placed flush with the existing concrete pavement. Grouting of the second slab began at 2:00 am and was completed at 2:40 am.

The third pre-cast slab was placed at 1:45 am, but was sitting low. The slab was lifted out and it was decided that additional screenings were required. Because the dowel bars were all in place, the leveling float could not be used. At 2:10 am, more fines were brought on site to try to raise the slab. By 2:30 am, the fines had been placed and compacted, and slab 3 was lowered into place flush with the existing pavement. It was decided not to grout the third slab, due to problems with a clogged grout hose. The grouting was carried out the next night.

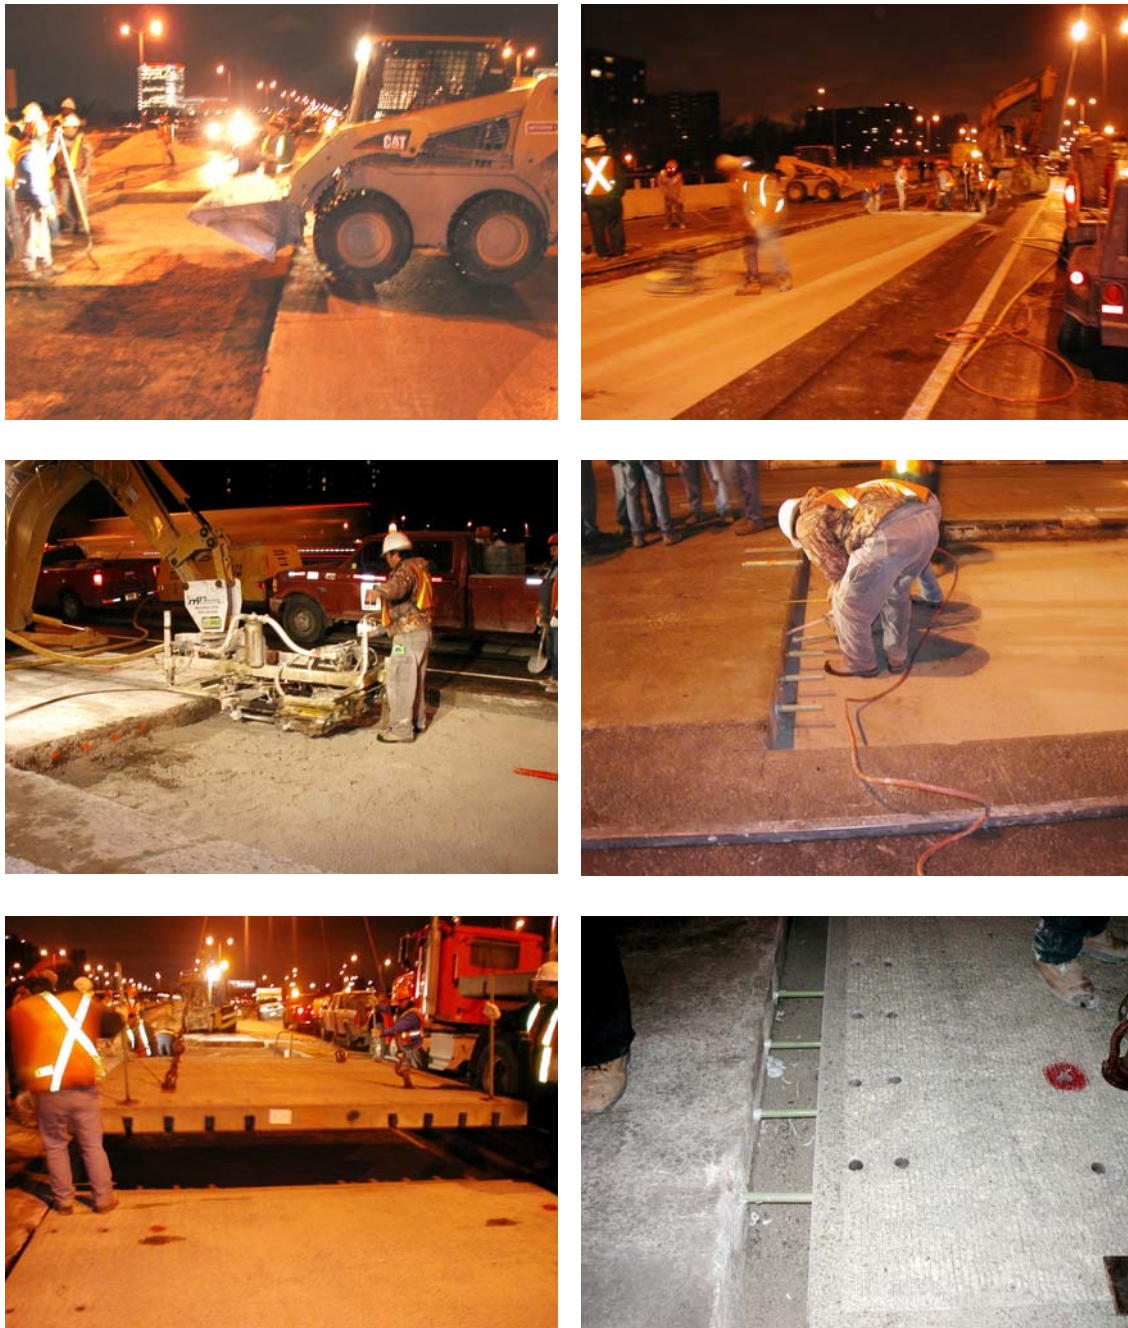
**Figure 4.** Construction sequence for Fort Miller Continuous pre-cast slab installation: a) placing crusher screenings into excavation with Bobcat, b) compacting crusher screenings using plate packer, c) gang-drilling dowel bar locations, d) fixing dowel bars with epoxy adhesive, e) lowering pre-cast slab, f) 180 mm gap between slab 6 and existing concrete.

**Base Preparation.** By 1:00 am, excavation of the CTB with a backhoe bucket was underway. A stringline was used to measure down for depth of the excavation. A template and the lane width leveling screed were also used to ensure the base was excavated to the correct depth. At 1:55 am, with the CTB excavation two-thirds complete, the Contractor began placing crusher screenings in the removal area using a Bobcat. At 2:25 am the backhoe had finished excavating the CTB, and placing of the crusher screenings was 75% complete. Base preparation for the entire removal area was completed by 4:10 am.

**Slab Placement.** The six pre-cast slabs which make up the 25 m long continuous slab replacement arrived on site by 2:30 am, and a crane began lowering the first slab in place at 2:45 am. The first slab was placed too low, with a gap of 35 mm between the slab and the existing concrete.

Slab 6 was placed at 4:35 am. The slab looked good, except for a gap of 180 mm between slab 6 and existing concrete. The Contractor had over-cut the excavation area. He proposed to mix grout with pea gravel to fill gap, since there was no fast-track concrete available to carry out a repair.

**Observations.** The Contractors plan to space the slabs 35 mm apart meant that they had over-excavated the removal area. The surplus area at one end was temporarily filled with grout and pea gravel. This will need to be addressed next construction season. The continuous removal area also had a 150 mm gap between the precast slabs and the hot mix shoulder along the entire 25 m excavation. The gap was filled with crusher screenings and 75 mm of cold mix.
