# WHY DO OUR CONCRETE PAVEMENTS STILL FAIL?

Raymond S. Rollings, member ISCP<sup>1</sup>

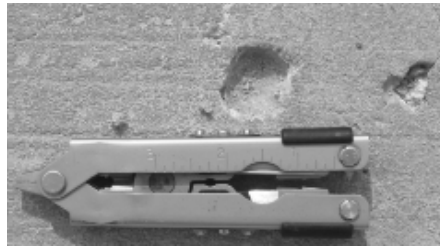
Figure 1. Example of severe popouts, Middle East Airbase

**Specification Limits.** In the 1959, Selfridge AFB had a massive problem with popouts from unsound aggregates that led to reconstruction in 1964. This failure received considerable press and triggered a Congressional investigation. The popouts posed a potential foreign object damage (FOD) hazard to the then new Air Force jet aircraft, and the whole affair was quite embarrassing for the US Army Corps of Engineers and the Air Force. As a result, military engineers developed a consensus specification that strictly limited the deleterious material in aggregates to be used in military airfield concrete pavements to avoid future popout and FOD hazard potential. This was much tighter than conventional limits such as in ASTM C-33, and the requirements remain in military guide specifications. Meeting these military

There are periodic calls to drop these restrictive aggregate quality requirements. However, they address a major failure we had in the past, and the user (US Air Force) continues to demand pavements with low potential foreign object damage hazard. Recently, the Corps of Engineers rejected a contractor's submitted aggregate for a ramp at an Air National Guard Facility because of excessive deleterious material. The aggregate was then used on a civil airport feature on the other side of the runway. Problems with popouts rapidly appeared, and the local authorities are tightening aggregate requirements for future projects. In another case, a US Air Force military engineering unit was building a large airfield ramp at an important base in the Middle East. Time was critical so many of the conventional material quality tests were ignored for expediency to get the job done. Soon after placement, aggregate popouts became widespread (over 100 per slab in some cases, Figure 1) and intense sweeping and maintenance efforts were required to reduce the FOD hazard and allow aircraft operation. As investigation afterwards would find, the local aggregates are unsound and unsuitable for concrete. Even in a military emergency where time is crucial, their use proved highly unsatisfactory and military operations were seriously impeded because of the simple mistake of using a bad aggregate in the concrete mixture. Even on a wartime footing, blindly casting away "overly restrictive" conventional peacetime requirements may prove unwise.

The engineering community struggles constantly to balance quality requirements and costs, and the task is not easy. We need to assess the durability of aggregate in service; yet, our existing tests simply do a poor job (e.g., Rollings and Rollings 1996, Marek 1991, Dolar-Mantuani 1978). As aggregate sources become more constrained the importance of this durability testing and qualifying of aggregates becomes even more important; yet we continue to rely on methods and requirements that simply are not up to the task.

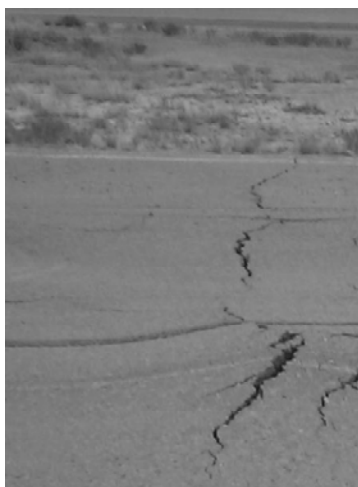
However, simply using sulfate-resistant cements will not confer protection in all cases. Figure 3 shows heaving of cement-stabilized base course made with Type V cement. In such cases, the alumina needed for formation of ettringite is provided from clay minerals in the stabilized base, and the low-alumina Type V cement provides no protection (Rollings et al 1999). In 1995, a 40-year old concrete apron made with Type V cement was recycled as fill and base course under two buildings and airfield pavements at an Air Force base. Within a few years, this nominally sulfate-resistant recycled concrete was undergoing sulfate attack with resulting heaving of pavements and building foundations (Rollings et al 2005). The recycled concrete was far more pervious and existed under wetter conditions with more extreme sulfate exposure than when it had been a concrete apron. These factors along with possibly exposing more alumina reaction sites when the concrete was crushed are thought to be the main reasons why the normal protective measure of using Type V cement failed in this instance. Even though we have effective methods of resisting sulfate attack of concrete for conventional paving applications, if we change how or where we use this technology, we may find it ineffective. Because a protective measure works under one condition does not mean it will work in all other situations.

Figure 3. Heaving from sulfate attack on Type V cement-stabilized base, Holloman AFB, NM
