## FAULTING EVOLUTION IN UNDOWELED PCC PAVEMENTS WITH SLABS CURLED UPWARDS

M.Poblete, R.Valenzuela, E.Clasing, Universidad de Chile, Santiago;  
J.Salgado, P.Gutiérrez, Ministerio de Obras Públicas de Chile.

The evolution of faultings in the Chilean in-service undoweled JPCP, after 3½ years of measurements, is presented. A systematic buildup of faultings was observed in Winter in all new pavements up to 10 years old, followed by a decrease during the dry seasons, which is attributed to an accumulation of sandy fines under the approach slab edges, rather than to erosion under the leave edges. In general, the magnitude of faultings in Chile's PCC paved network, is of slight to moderate severity (<4 mm); while imperceptible (<2 mm) in old pavements built on granular subbases. In new pavements, rigid cement treated bases seem to have been of no benefit by opening a slab-base interface under the uplifted edges, thus creating one basic condition for pumping. Influence of thermal conditions (joint openings) and rainfall (infiltrated water) seem to counteract themselves through out the country, making no territorial difference as regards to faulting development. Faulting evolution is pre

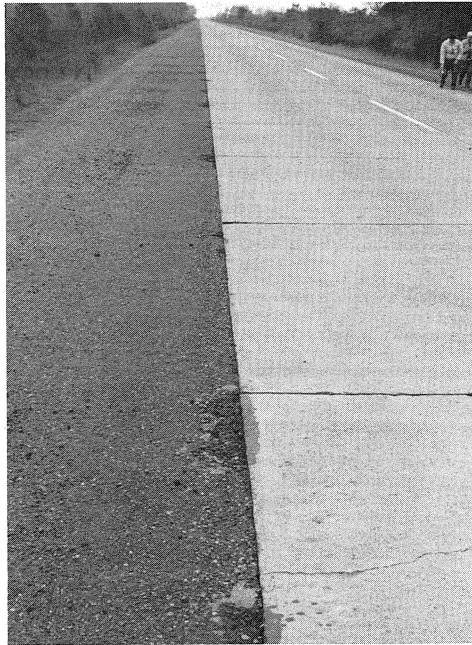
FIGURE 7.- SYSTEMATIC EROSIONS AT LEAVE EDGE CORNERS AND VISIBLE FAULTINGS.

Another sign of pumping is visible by holes in the shoulders, close to the slabs outer edge, as illustrated in Figures 7,8,9. Erosion starts systematically at leave corners, destroying the asphalt cover, to proceed later towards the approach side at more advanced states of distress. With respect to the magnitude of shoulder holes, a high dependence on the erosion susceptibility of the shoulder fill material has been observed; being very important in sandy fills, which is the case of TS-13 (15-17% passing through sieve #60 ASTM) and almost negligible in coarse granular, as in TS-06 (less than 10% passing sieve #60). The complete particle size distribution of all shoulder materials is well graded and low permeabilities can be expected when they are compacted to a high degree and therefore very susceptible to trap the rain water.

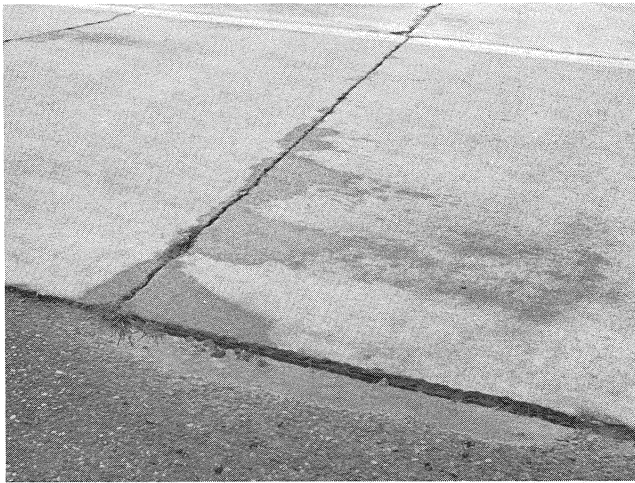
FIGURE 8.- EVIDENCE OF PUMPING AND EROSION AT LEAVE EDGE CORNER IN A 9 - 10 YEAR OLD PAVEMENT.

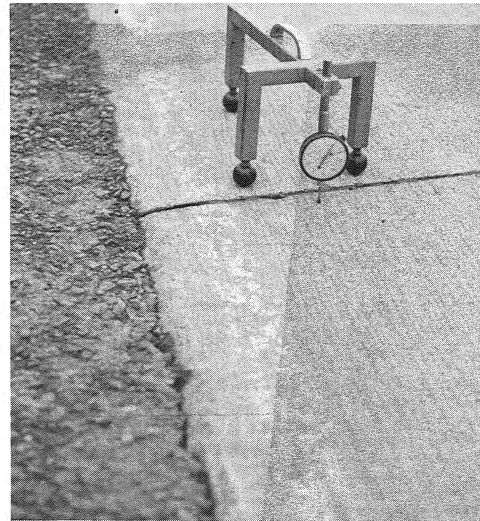
FIGURE 10.- APPARATUS USED FOR THE MEASUREMENTS OF ABSOLUTE FAULTINGS.

In order to quantify the absolute faultings in all concrete pavements, a simple apparatus was devised (Figure 10), that needs no fix reference bases but yields a precision estimated in  $\pm 0.25$  mm. Individual readings from joint to joint show typically a high variability around the average that is beyond the precision range of the measurement and independent of the joint spacing.
