# INTRODUCTION OF RECENT THIN BONDED CONCRETE OVERLAY CONSTRUCTION AND EVALUATION OF THOSE PERFORMANCES IN JAPAN

Shiro Ibukiyama, Shuichi Kokubun, and Ken Ishikawa,  
Ohbayashi Road Construction Co., Ltd., Japan

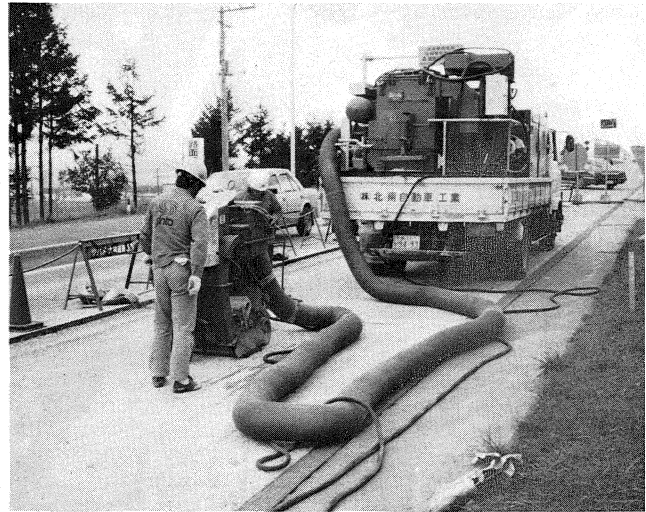
Photo 2 Shot blasting with  $\phi 1.4$  mm steel balls

The bonding to the boundary surface of existing concrete pavement is very important for TBCO. Therefore, further precaution was taken before the execution of the work. The first step was to perform shot blasting with  $\phi 1.4$  mm ( $\phi 0.055$  in.) diameter steel balls commonly used for removing rust from a deck of a ship. The polished dust was able to be collected and the steel balls were retrieved with the vacuum device. The shot blasting density, which means the weight of steel balls for shot blasting, per square meter can be adjusted. The density was set to  $100 \text{ kg/m}^2$  (approx.  $184 \text{ lb/sy}$ ) to create minute irregularities on the cut concrete surface, and then the loose aggregate was eliminated by shot blasting. The second step was to select an adequate adhesive and to apply it on the shot blasted concrete surface. The construction efficiency and the bond strength of the adhesive were superior when a new concrete was placed onto a completely dried shot blasted surface. This was

demonstrated in the adhesion experiment indicated later. Because of the abovementioned effects, this method was chosen.

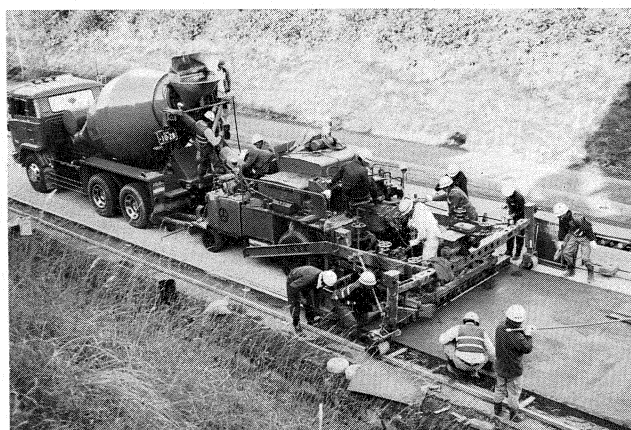
Photo 3 Concrete placing by using a paver

Cost of concrete paving were rationalized, by using a paver capable of placing, compacting, and surface finishing the concrete by itself after receiving concrete from the agitator truck. Since the ultra rapid setting cement is available in only a short time, a moving mixer carrying concrete material was moved to the site, and man power was used to compact the concrete.

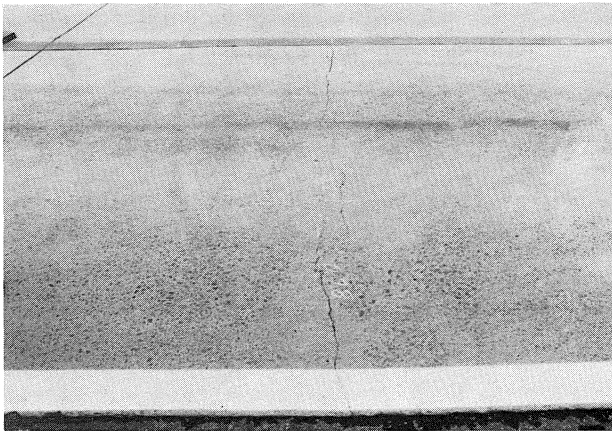
Photo 4 Typical cracks of TBCO on existing CRCP

which were classified as being Type I in CRC. Therefore, there in practice are only two types. There are 63 cracks classified as being Type 3 among the 93 cracks occurring 6 months after going into service. The 63 cracks are also divided into the 39 cracks reflecting passing-through of cracks from the existing slab and into the 24 cracks reflecting nonpassing-through cracks. If the reflection crack occurs due to a great movement of the existing slab crack portion, it is clear that the 39 cracks are large cracks with relatively wide hinge effect that occurred during the early construction phase (1 to 2 weeks). The 24 cracks are classified as being Type III. However, since the passing-through cracks were not found on the existing slab, the actual cracks may have occurred because the volume change (i.e. Shrinkage) of TBCO is restricted by the existing CRC, which is the same phenomenon as the cracks classified as being Type II. It is also clear that the greater part of dense cracks closed to each other which are characteristic of CRCP do not influence the crack occurrence in TBCO.
