# Experiences with Dowel Bar Retrofit in California

E. Kohler<sup>\*</sup>, J.T. Harvey<sup>†</sup>, and B. Steven<sup>‡</sup>

## Abstract

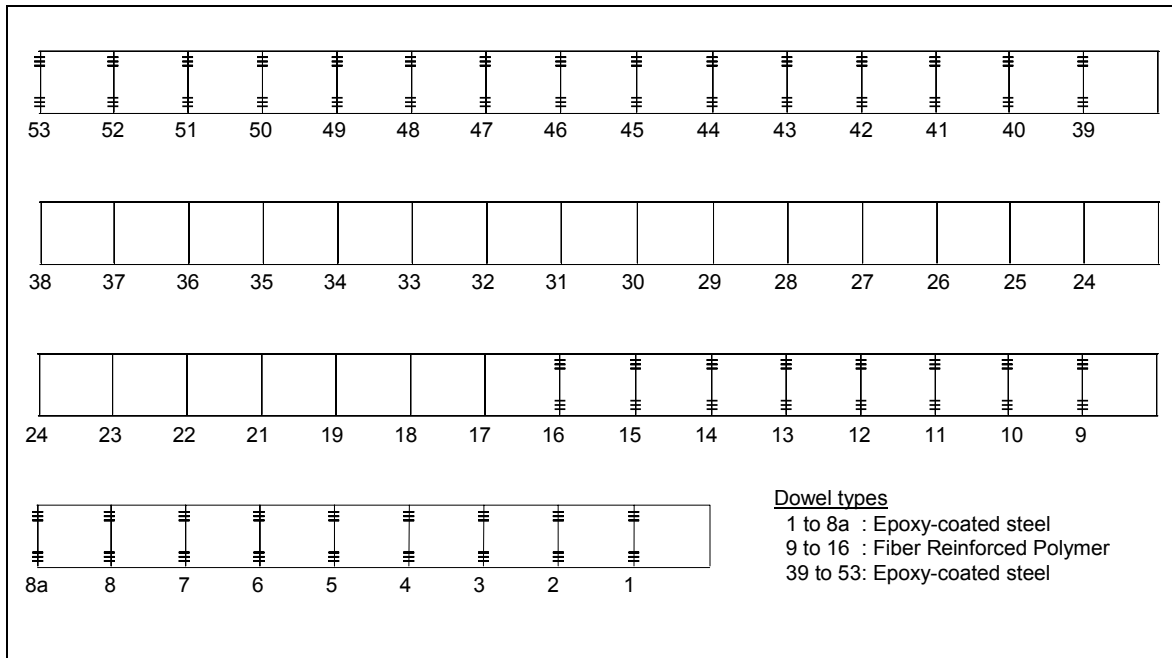
**Figure 13. Colfax test site slab and dowel layout.**

Figure 13 shows the location of the DBR joints within the project. FRP dowels are installed in Joints 9 through 16; all the other dowels are epoxy-coated steel.

**Visual Condition.** A survey in March 2001 (two-and-a-half years after DBR) indicated that the pavement was in good condition overall, a few panels had third-stage cracking, and a number of transverse joints had spalled. The retrofit installations were in very good condition. The backfill grout remained intact and showed no signs of bond failure or cracking.

The site was visited again in January 2007 (eight years after DBR). The backfill material was still in good condition, with some higher levels of wear on the surface of the slots relative to the surrounding concrete, but without signs of debonding or the presence of loose material. Figure 14a shows a general view of the DBR area, clearly showing the three slots per wheelpath. Figure 14b and Figure 14c present the typical condition of the surface, the original texture from diamond grinding has been abraded.
