# **AN EVALUATION OF RETROFIT LOAD TRANSFER MATERIALS AND DOWEL BAR CONFIGURATIONS**

## **ABSTRACT**

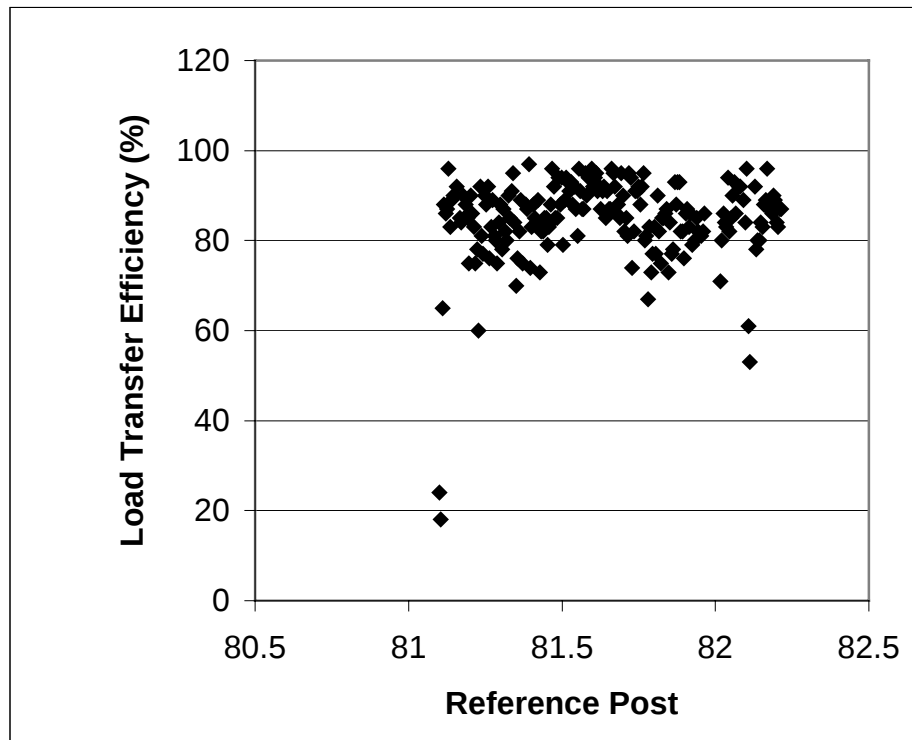
Figure 8. Retrofit Dowel Load Transfer Efficiency, 11/07/1995 (Right Lane, Right Wheel Path)

Prior to the start of the project, a falling weight deflectometer (FWD) was used to measure the load transfer efficiency (LTE) of each of the cracks in the right wheelpath of the right lane for both the control section and the test sections (see figure 7). The majority of the cracks still had LTE values above 90% (calculated using the equation  $((D_l/D_{ul}) \times 100\%)$ ), but there were several cracks where the LTE had dropped below 50% (between RP 81.3 and 81.5 and between RP 82.0 and 82.2). The LTE of the right lane test sections were measured again in November of 1995, one year after the retrofit dowels had been placed, and a substantial improvement was seen in these areas (see figure 8). The LTE of the entire section appears to be lower than in 1994, with an overall average of 85% and several cracks below 80%. This is most likely due to the relatively high pavement surface temperature during the testing in 1994 that may have contributed to the load transfer between slabs due to expansion of the pavement. The pavement temperatures at the time of the FWD testing were between 22°C and 41°C in 1994 and between 5°C and 8°C in 1995.
