# Performance of Bonded CRCP Overlay in Texas

Pangil Choi, Ph.D.<sup>1</sup> and Moon Won, P.E., Ph.D.<sup>2</sup>

In this paper, three BCO projects that have significance in terms of performance and technical development are presented. They are 4-in BCO on Loop 610 North in the Houston District, 7-in CRCP BCO on US 75 in the Paris District, and 4-in CRCP BCO on US 287 in the Wichita Falls District.

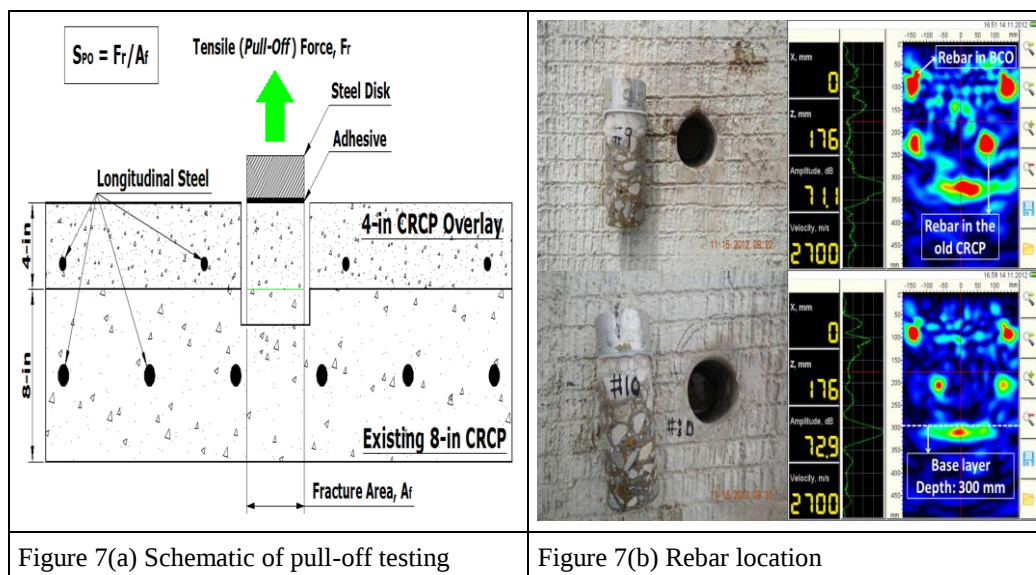
The bond strength was evaluated between existing concrete and the BCO to verify whether the both CRCPs will behave monolithically in accordance with the ASTM C1583/C1583M-13 (ASTM International 2013). The testing was conducted in 14 locations. Figure 7(a) illustrates a schematic of pull off test. The ultrasonic shear-wave tomography was applied to locate rebar before concrete coring (Bishko et al. 2008; Kozlov et al. 2006). Figure 7(b) shows the analyzed images of the ultrasonic testing at the bond strength test locations. The longitudinal steels are clearly identified for both the BCO and old CRCP. The thickness of the old CRCP is 8-in and the BCO thickness is 4-in.
