# **Failure Modes in Unbonded Concrete Overlays**

Kevin Alland, Julie Vandenbossche, Steven Sachs, John DeSantis, Thomas Burnham and Lev Khazanovich

## **Abstract**

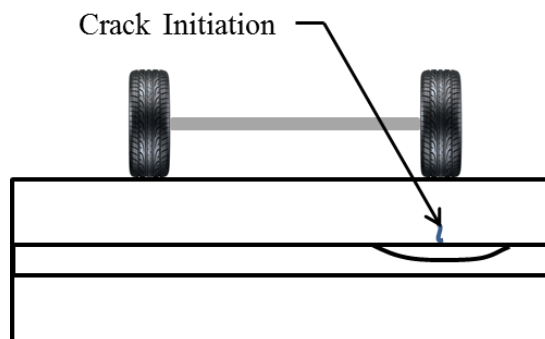
**Figure 1: Longitudinal Cracking in the Wheelpath Mechanism**

**Wheelpath Longitudinal Cracking** A common location for the development of longitudinal cracks is the wheelpath. These cracks develop in both the outside and inside wheelpath, and can initiate on both the leave and approach side of the transverse joint or crack. Once these cracks initiate, they may propagate longitudinally to the adjacent transverse joint, or they may turn and propagate toward the adjacent longitudinal joint (lane-shoulder or centerline), appearing as a diagonal crack.

The high stress contributing to the initiation of this crack can be the result of a void or gap in the interlayer beneath the overlay. A void can form beneath the slab in the wheelpath in several ways. Consolidation in the HMA interlayer may occur in the wheelpath at the joint. Also, a portion of the interlayer may be pumped from beneath the joint resulting in faulting on the approach side of the joint and a void on the leave side of the joint. Finally, less stable interlayer systems, such as an open graded asphalt mix or a dense graded HMA where localized stripping has occurred in the vicinity of the transverse joint, may also fatigue and breakdown in the wheelpath. These can all lead to loss of support in the wheelpath starting at the joint, and eventually propagating the full length of the slab. When a wheel load is applied over this area, the slab must bridge this loss of support region, creating stress at the bottom of the slab and eventually bottom-up cracking in the wheelpath. This mechanism can be seen in Figure 1. Bonded Concrete Overlays of Asphalt (BCOA) with 1.8x1.8 m panels experience a similar distress mechanism (Li and Vandenbossche 2013).

There are several ways to mitigate this distress mechanism. Increasing the thickness of the concrete overlay will decrease the stress on the interlayer, and therefore decrease the risk of degradation and/or consolidation. Reducing differential deflections and minimize pumping by using load transfer devices will also be helpful. Finally, using an interlayer system which is not prone to consolidation or stripping, will help minimize this distress as well.

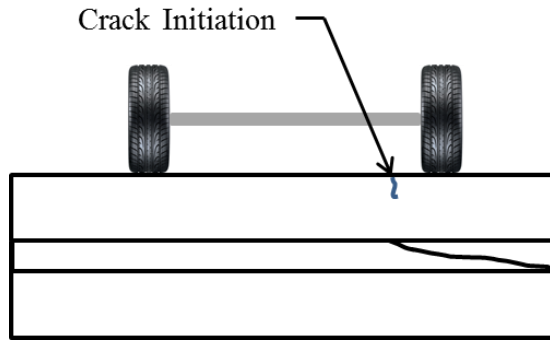
**Figure 3: Loss of Support Mechanisms in UBOLs**

***Random Longitudinal Cracking*** In traditional JPCPs, longitudinal cracking can develop as a result of loss of support beneath the slab due to erosion of the underlying layer along the roadway. It is often the result of consolidation or transport of base layer materials due to poor drainage. Similar distress is found in UBOLs when the interlayer erodes away. These cracks usually occur on the shoulder side of mid-lane but do not necessarily occur in the wheelpath. This mechanism can be seen in Figure 3.

A survey of Michigan UBOLs found these cracks often occurred in clusters, when proper drainage was not provided. MDOT has identified proper drainage as a crucial aspect necessary for good performing UBOLs. Without a means of escaping, water can become trapped along the interlayer. Figure 4 shows a random longitudinal crack on I-75 near West Branch, Michigan.

Careful attention to pavement drainage details are important for preventing random longitudinal cracking. A clear path must exist for any water entering the pavement to reach the drainage system. Proper maintenance of the drains and outlets is extremely important for these structures as well. The backup of water from a clogged drain can quickly strip and erode the interlayer. Drainable interlayers such as open graded asphalt or non-woven geotextile fabric will only improve drainage characteristics if there is a suitable method for removing the water from away from the pavement structure.

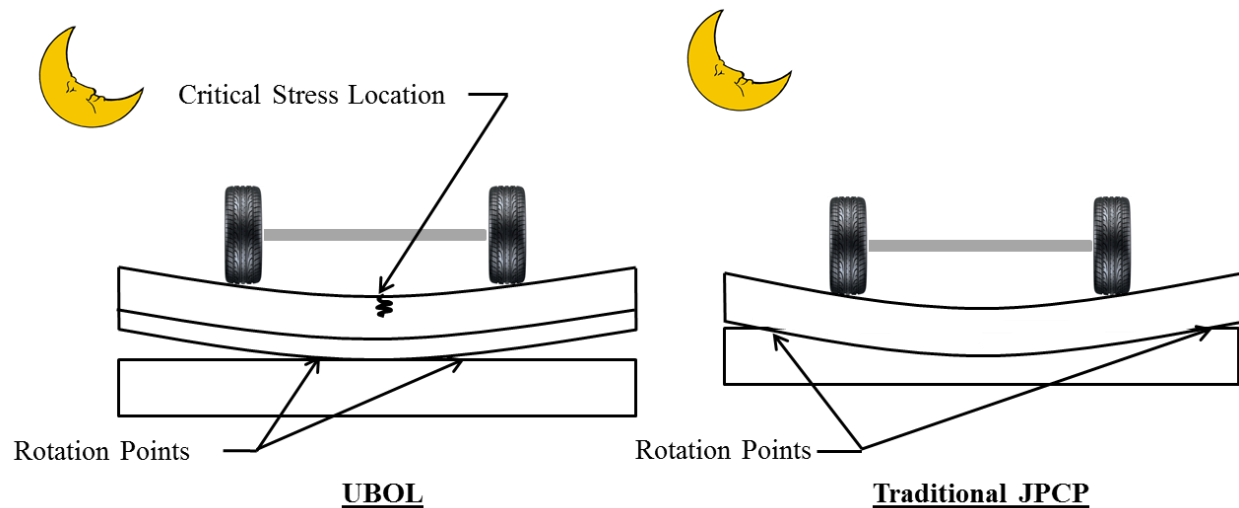
**Figure 5: Mid-slab Longitudinal Cracking Mechanism**

***Longitudinal Cracking at Mid-Lane*** In pavements thinner than 205 mm thick, longitudinal cracking often develops at the transverse joint at mid-lane. Similar to the longitudinal cracks that develop in the wheelpath, these cracks sometimes propagate longitudinally to an adjacent transverse joint or crack, while other times will turn and propagate diagonally towards the lane-shoulder joint. For the mid-lane longitudinal cracks observed, albeit a small data set, all of the

cracking appears to initiate on the leave side of the joint and propagate to a longitudinal joint or the approach side of an adjacent joint. Sometimes the crack would propagate on the approach slab, but only after the leave slab cracked. These cracks occurred primarily in thinner (less than 200 mm) sections. It is possible that higher curling and warping stresses may contribute to the development of these stresses. In a traditional JPCP, the less stiff base layer allows the pavement to “settle in,” and the wheelpaths primarily fail near the rotation point (the point whose position is constant throughout the daily temperature gradient cycle) (Vandenbossche 2003)(Asbahan and Vandenbossche 2011). This results in the critical stress being in the middle third of the slab in the transverse direction, leading to longitudinal cracks. It is possible that with the stiff base provided by the existing pavement and interlayer, the rotation point is much closer to the center of the lane. If this is the case, an axle load when the slab is experiencing a negative gradient could cause a critical stress at the top of the slab in the transverse direction, as can be seen in Figure 5. UBOLs also tend to have full width panels with short (3.1-3.7 meters) transverse joint spacing. This further increases the likelihood that the critical stress causes longitudinal cracking at mid-lane, rather than transverse cracking at mid-slab (they are shorter than they are wide).

An effective way to decrease the stresses due curling and warping in the slab coupled with wheel loads is to increase the thickness of overlay. A thicker pavement will experience lower flexural stresses from wheel loads, and smaller effective temperature and moisture gradients. A less stiff interlayer, such as a non-woven geotextile fabric or open graded asphalt should allow the pavement to sink into the interlayer more under its own self weight. This will decrease the portion of the slab which is unsupported when the slab is curled upward and thereby decrease curling stresses. Stress reductions can also be achieved by using smaller slab sizes, such as 1.8 x 1.8 m. This will both decrease the curling and warping stress, and eliminate the negative moment due to wheel loading, as the slabs would only be loaded by half the axle at a time.

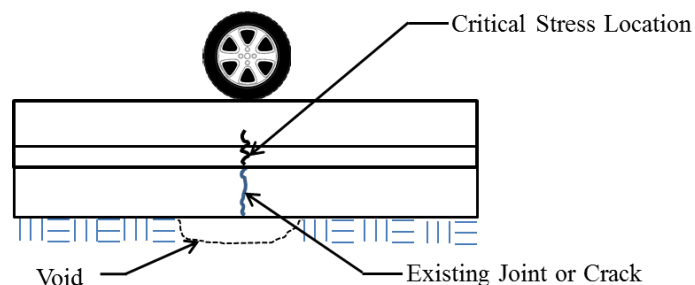
a. Reflective Cracking

**Reflective Transverse Cracking** A discrete transverse crack or joint in the existing pavement can reflect into the overlay. This can be exacerbated by a lack of support underneath the joint. A laboratory study revealed that a discrete joint or crack in the existing pavement will not reflect up into the overlay under normal wheel loads if the existing pavement is fully supported. When a void is simulated under a crack or joint in the existing pavement, a reflective crack can develop (Sachs et al. In Review). A wheel load in the middle third of the slab will cause a tensile stress at the bottom of the slab. This stress will be higher if there is a loss of support area underneath the joint than if the slab is fully supported. The damage caused by this loading can be intensified by the stress concentration at the discrete crack in the existing layer. This mechanism is shown in Figure 7a.

### Figure 7: Reflective Cracking and Reflective Distress Mechanisms

When selecting a rehabilitation alternative it is important to consider the support conditions of the existing pavement. UBOLs are a good rehabilitation alternative for pavements which are distressed, but uniformly supported. If voids are present, uniform support should be restored by subsealing prior to the construction of the overlay.

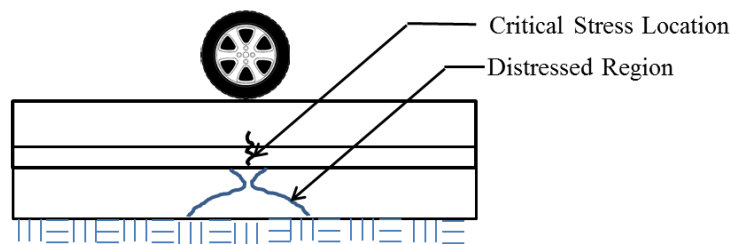
b. Reflective Distress

**Reflective Distress** The long term performance of concrete pavements requires uniform support conditions. A distressed region in the existing slab can result in a reduction in support that must be bridged by the overlay. This will be referred to as reflective distress to differentiate it from a reflected crack that develops in the overlay above a discrete undeteriorated crack. An example of reflective distress can be seen in Figure 7b.

Deteriorated sections of the existing pavement should be checked for uniform support. If any voids occur, uniform support should be restored by subsealing. Any large gaps in the existing pavement should also be filled.
